Artikel: Fujigawa Bridge rehabilitation project (Japan)
Autor: Matsuo, Yoshio
DOI: <https://doi.org/10.5169/seals-20937>

7. Fujigawa Bridge Rehabilitation Project (Japan)

Owner:	<i>Shizuoka Prefecture</i>
Contractor:	
<i>Substructure:</i>	<i>Sumitomo Construction</i>
<i>Deck replacement:</i>	<i>Japan Bridge</i>
<i>Superstructure:</i>	<i>Yokogawa Bridge Works</i>
Work's duration:	<i>6 months</i>
Date of repair:	<i>1987 – 1988</i>

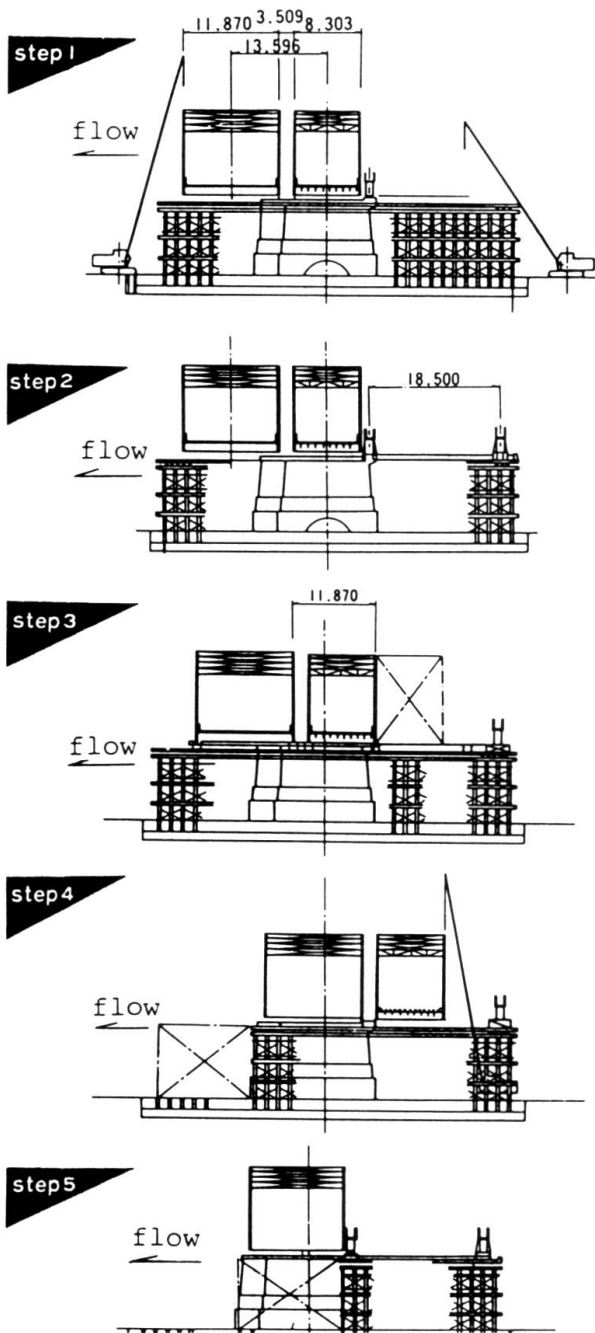
Fig. 2 Erection sequence

The superstructure replacement procedure is as follows (Fig. 2):

- step 1. Make foundation for erection work.
Assemble bent for assembly and lateral transfer.
Assemble new superstructure along side of existing bridge.
Concrete deck is finished.
- step 2. Two span of walkway bridge is transferred upstream to make room and replaced by temporary walkway bridge.
- step 3. Lateral transfer equipment are set in place.
Two span of new and old superstructures are lateral transferred separately upstream (Fig. 3).
- step 4. Disassemble existing superstructure.
Disassemble assembly bent.
- step 5. Lateral transfer walkway bridge to original position.
Disassemble lateral transfer bent.

For widening on the two spans to the right bank side, the roadway could not be widened by just adding stringers because the original bridge was a through truss. Because of this, it was decided to replace the bridge with the same type of truss (curved chord pratt truss) having wider floor beams. According to the replacement procedure, a new bridge was erected along the existing bridge, and the deck work, pavement work and painting work were carried out for the new bridge. Then, the bridge was laterally transferred in place of the original

bridge while the traffic was stopped for a short period. A walkway bridge alongside the bridge will be also laterally transferred in the process.

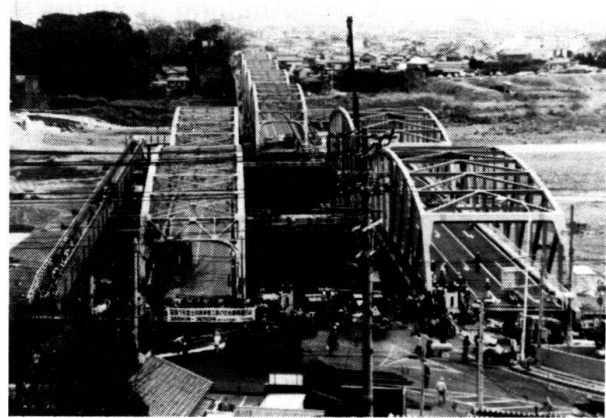
Fig. 3 Lateral transfer

The replacement of the bridge after assembly, deck and pavement completed required the handling of a large weight (830 tons/series). But the lateral transfer method was still capable of moving the superstructure with the least period of traffic stop. The lateral transfer procedure took 60 hours but a considerable time was taken for setting and anchorage of bearings. This was due to the time required for opening anchor holes and bearing mortar to harden. With some modification and improvements, it may be possible to reduce the time. The lateral transfer itself took only a short time with the up-to-date equipment that was employed.
