9. Rehabilitation of a Lenticular Steel Truss in New Jersey (USA)

Engineer: A. G. Lichtenstein and Assoc.
Fair Lawn, NJ

Date of repair: September 1983 – April 1984

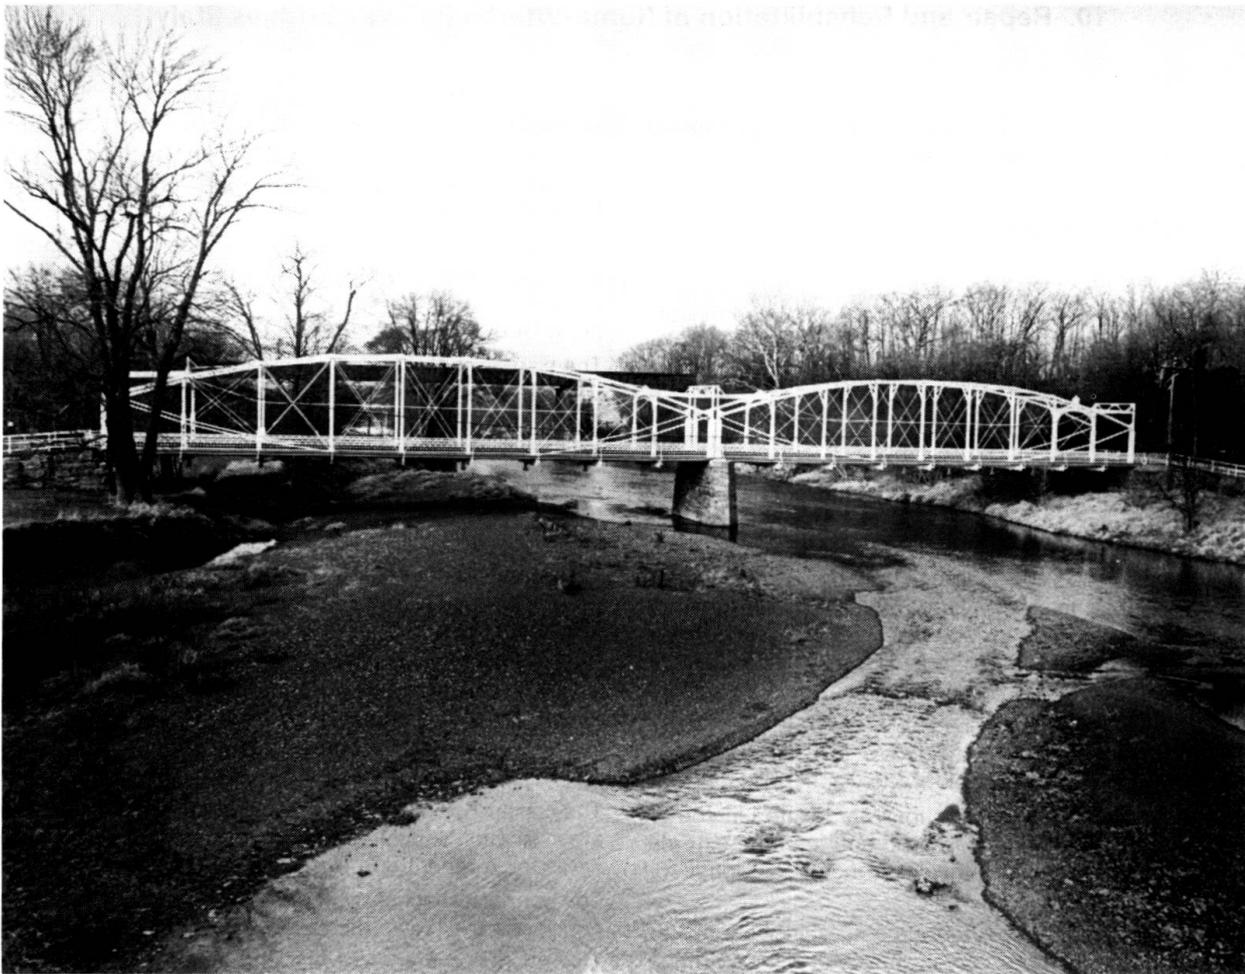
Fig. 4 General elevation

Neshanic Station is a small town in Somerset County, New Jersey. In this community there exists Bridge No. CO 601 which is composed of two spans 44.20 m (145 feet) each, over the South Branch of the Raritan River. The bridge accommodates one traffic lane in two directions and one sidewalk.

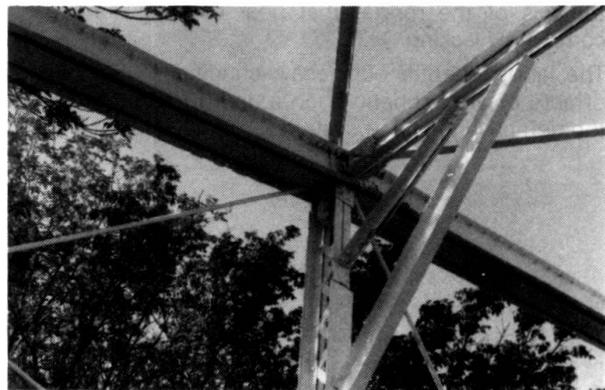
Fig. 5 View of upper chord with new member in place

An indepth inspection of the bridge was conducted by the Consulting Engineer including non destructive testing of the eye bars, pins and other main connections of the bridge. All the elements of the trusses have been found to be in good condition except the *top chord*. The existing channels in the upper chord have completely corroded (holed through in many places) so that the bridge could barely support its own weight. The bridge was closed to traffic.

The assignment then was how to reconstruct the upper chord economically without changing the historic appearance of the bridge. This challenge was met by the interesting idea of installing new high strength steel beams between the existing corroded channels in the top chord and transferring the stresses from these channels to the new beams via specially designed web plates and bolts. A new steel beam was hoisted in this space between the channels and kept in place by bolting to the top cover plate of the upper chord. The contractor then installed the web plates which were detailed to have a perfect half round contact surface on one side, abutting the existing pin. After these web plates were bolted to the new beam on both sides, the contractor jacked these web plates in a horizontal direction so that contact between web plates and the pins was as tight as possible. In this way, a new upper chord was created, hidden within the confines of the old deteriorated upper chord without changing the distinctive appearance of the parabolic Lenticular Truss.
