Zeitschrift: IABSE structures = Constructions AIPC = IVBH Bauwerke
Band: 12 (1988)
Heft: C-47: Repair and rehabilitation of bridges: case studies II

9. Rehabilitation of a Lenticular Steel Truss in New Jersey (USA)

Engineer: A. G. Lichtenstein and Assoc.
Fair Lawn, NJ

Date of repair: September 1983 – April 1984

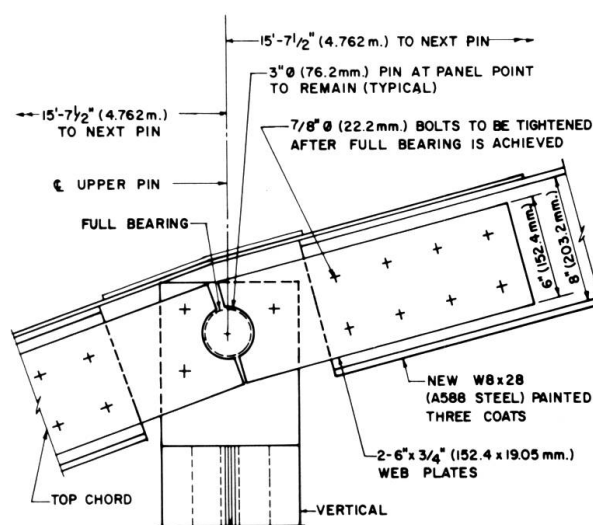
Fig. 1 Section along top chord

The assignment then was how to reconstruct the upper chord economically without changing the historic appearance of the bridge. This challenge was met by the interesting idea of installing new high strength steel beams between the existing corroded channels in the top chord and transferring the stresses from these channels to the new beams via specially designed web plates and bolts. A new steel beam was hoisted in this space between the channels and kept in place by bolting to the top cover plate of the upper chord. The contractor then installed the web plates which were detailed to have a perfect half round contact surface on one side, abutting the existing pin. After these web plates were bolted to the new beam on both sides, the contractor jacked these web plates in a horizontal direction so that contact between web plates and the pins was as tight as possible. In this way, a new upper chord was created, hidden within the confines of the old deteriorated upper chord without changing the distinctive appearance of the parabolic Lenticular Truss.

replaced; the sidewalk timber planking was replaced where necessary and hand railing repaired; tensioning of the tie rods in the King Posts of the floor beams; and reinforcing the tower legs at the piers and abutments. The entire bridge was sandblasted and painted with two coats of paint. Fig. 1 and 2 describe the Repair details of the upper chord, and Fig. 3 the King Posted Floor Beams.

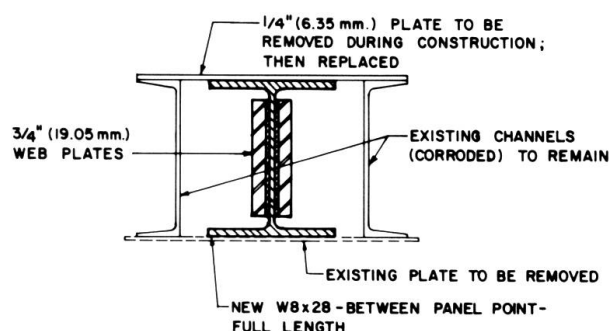
Fig. 2 Section through top chord
