## 9. Rehabilitation of a Lenticular Steel Truss in New Jersey (USA)

**Engineer:** A. G. Lichtenstein and Assoc.  
Fair Lawn, NJ

**Date of repair:** September 1983 – April 1984

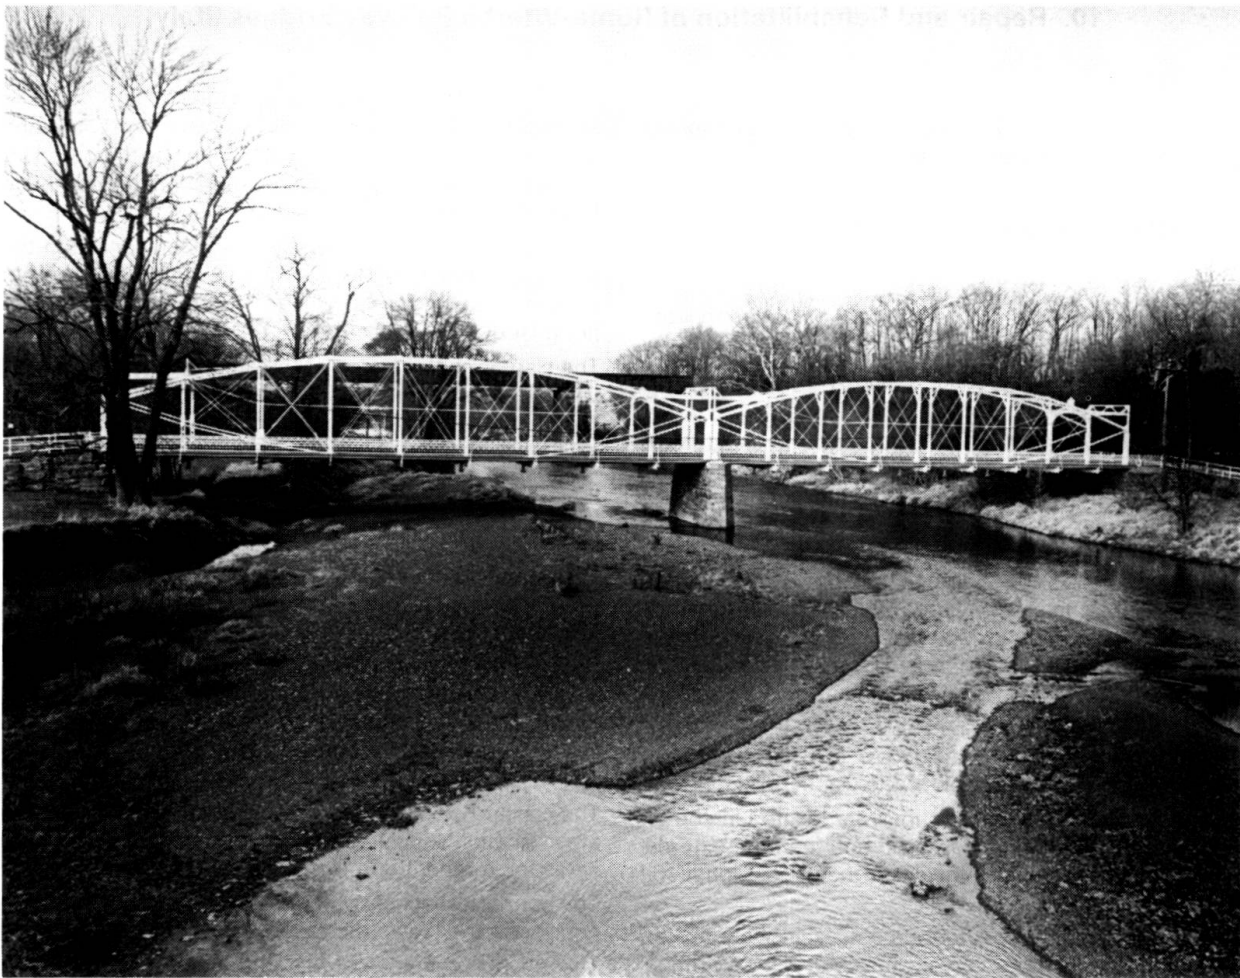
Fig. 4 General elevation

Neshanic Station is a small town in Somerset County, New Jersey. In this community there exists Bridge No. CO 601 which is composed of two spans 44.20 m (145 feet) each, over the South Branch of the Raritan River. The bridge accommodates one traffic lane in two directions and one sidewalk.

The bridge was constructed in 1886 by the Berlin Bridge Company of Berlin, Connecticut as a patented system and still retains its original configuration as a lenticular parabolic truss supported on the original stone abutments and piers. The structure has been judged a Historic Bridge by American Standards and the community of Neshanic Station indicated a desire to preserve and rehabilitate the bridge in lieu of replacement.
