Artikel: Repair of the Todsburg Bridge (Fed. Rep. of Germany)
Autor: Hoscheid, R.
DOI: <https://doi.org/10.5169/seals-20941>

11. Repair of the Todsburg bridge (Fed. Rep. of Germany)

Owner: *Federal Republic of Germany*
Year of construction: *1936/37*
Repairs carried out in: *1983*
Under the supervision of: *Heidenheim Motorway Authority*
Contractors: *Weidle and Ludwig Fischer*

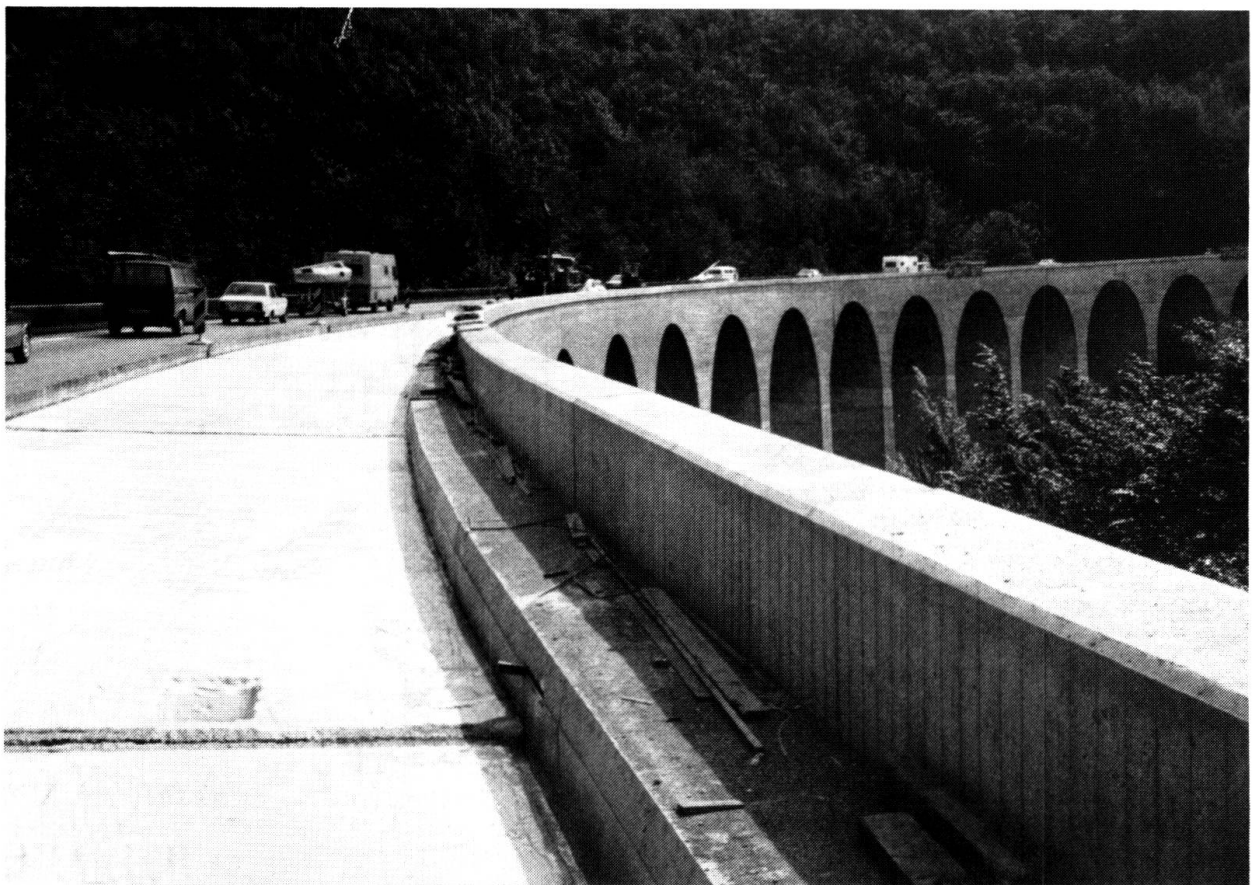
Fig. 1 The Todsburg bridge

The Todsburg bridge (Fig. 1) is located on the A 8 Autobahn between Stuttgart and Munich – one of the busiest sections of motorway in Germany. It stands between Stuttgart and Ulm at a point where the road climbs up into the Swabian Alb. For structural reasons, the two roadway sections are completely separate from each other. Some 30 000 vehicles pass over the bridge in each direction every day. By the beginning of the 1980's the concrete structure was in urgent need of repair – this stretch of motorway now being over 50 years old.

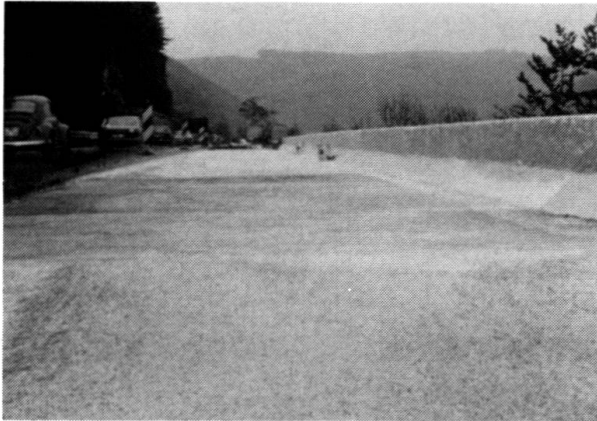
Fig. 2 The finished waterproofing membrane

5. Cleaning the area with high-pressure water jets
6. Applying epoxy mortar to the roadway platform to level those areas where concrete had been chipped away
7. Applying a bonding agents (1-component PU) and covering with silica sand 0.7–1.2 mm
8. Spraying on the liquid plastic waterproof membrane to a thickness of approx. 3 mm (Fig. 2)
9. Applying a bonding agent to the plastic membrane and covering it with granules to improve the shear bond between the membrane and the asphalt layers (the bridge has a gradient of approx. 6% along its length, and 3–5% from side to side)
10. Reconstruction of the new parapet on top of the waterproof membrane (Fig. 3)
11. Applying the bituminous mastic concrete protective layer, the bituminous mastic concrete load-bearing layer and the wearing layer (Fig. 4).

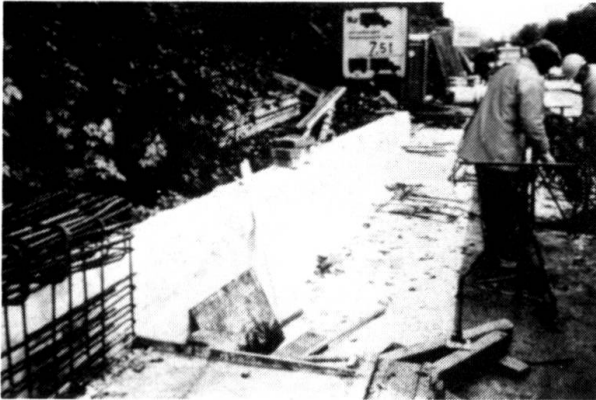
Fig. 3 Working on reinforcements for the construction of the new parapet

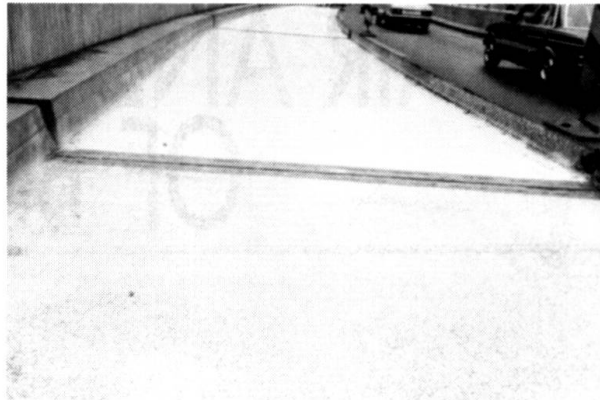
Fig. 4 The bridge complete with its new parapet before surfacing with bituminous mastic concrete
