Florence municipal stadium (Italy)

3. Florence Municipal Stadium (Italy)

Owner: Florence Municipality
Designers: Italo Gamberini, Loris Macci, Enrico Novelli, Giovanna Slocovich, with Orazio Miroddi – Architects
 Raffaello Bartelletti, Enrico Baroni, Alberto Bove – Structures
 Salvatore Di Pasquale – Structural consulting

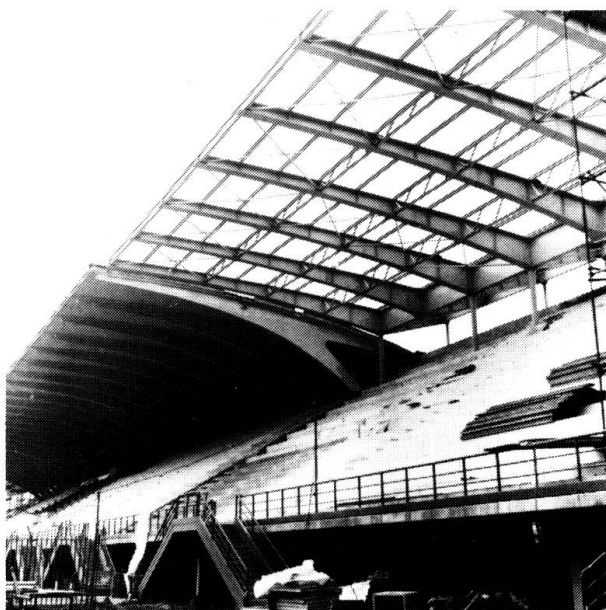
Fig. 1: New cantilever steel cover

perfect visibility is allowed (fig. 1). The new steel cantilevers are made by variable height I profiles and the intrados profile and the span (about 18 m) match those of the Nervi cantilever. The design characteristics of the cantilevers have been subjected to a couple of main conditions: firstly, very slender vertical tie-rods were requested on the back, so that their visual impact on the original main facade could be minimized. Furthermore, since the columns had to pass through the old stands, the demolition had to be limited within a single step, between two adjacent risers. The minimum size of such openings (about 40 cm) dictated the choice of the column section and had also to comply with the maximum values of the computed displacements, due to live loads (earthquake included). The tie-rods are fastened at ground level by reinforced concrete diaphragm walls, 14 m deep. The upper end of each tie-rod has been threaded so that a couple of adjustable rings can block the cylindrical casing of the cantilever back-end. Such a device allowed, during assembly, to easily adjust the pitch of each cantilever beam, until they were lined up with each other and with the reinforced concrete ones.

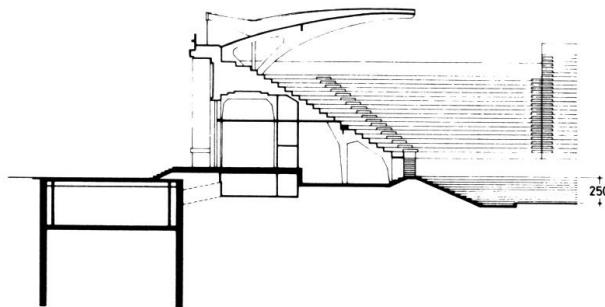
Fig. 2: Section where the lowered field may be seen

With the aim of making place for new tiers around the field, this was lowered (2.50 m) by a 40 000 m³ excavation (fig. 2). Its feasibility had been previously ascertained by hydro-geological surveys and analyses dealing with the water-table depth and the stability of existing foundations. The new reinforced concrete stands cover roomy spaces for deposits and technical systems; there is no expansion joint between them, since they were mostly cast upon the ground. However, a sequence of castings and a series of provisional joints were provided, so that shrinkage effects could be minimized. New spaces for parking, gymnasium, swimming pool, electric and plumbing systems are in most cases underground, totalling about 60 000 m³ (fig. 3). The retaining walls have been built as reinforced concrete diaphragm walls, dug into the ground by use of guided-bucket shovels and bentonite slurry. The diaphragm walls – 14 m deep and 0.8 m thick – were necessary because the new structures are close or even adjacent to the existing foundations. This technique also allowed to limit the drainage during excavation, even when the bottom level was slightly lower than the water-table, which is about 7.70 m deep. Because some underground building has sizable dimensions (the local authority parking, for instance, is 145 m long), some diaphragm walls have been

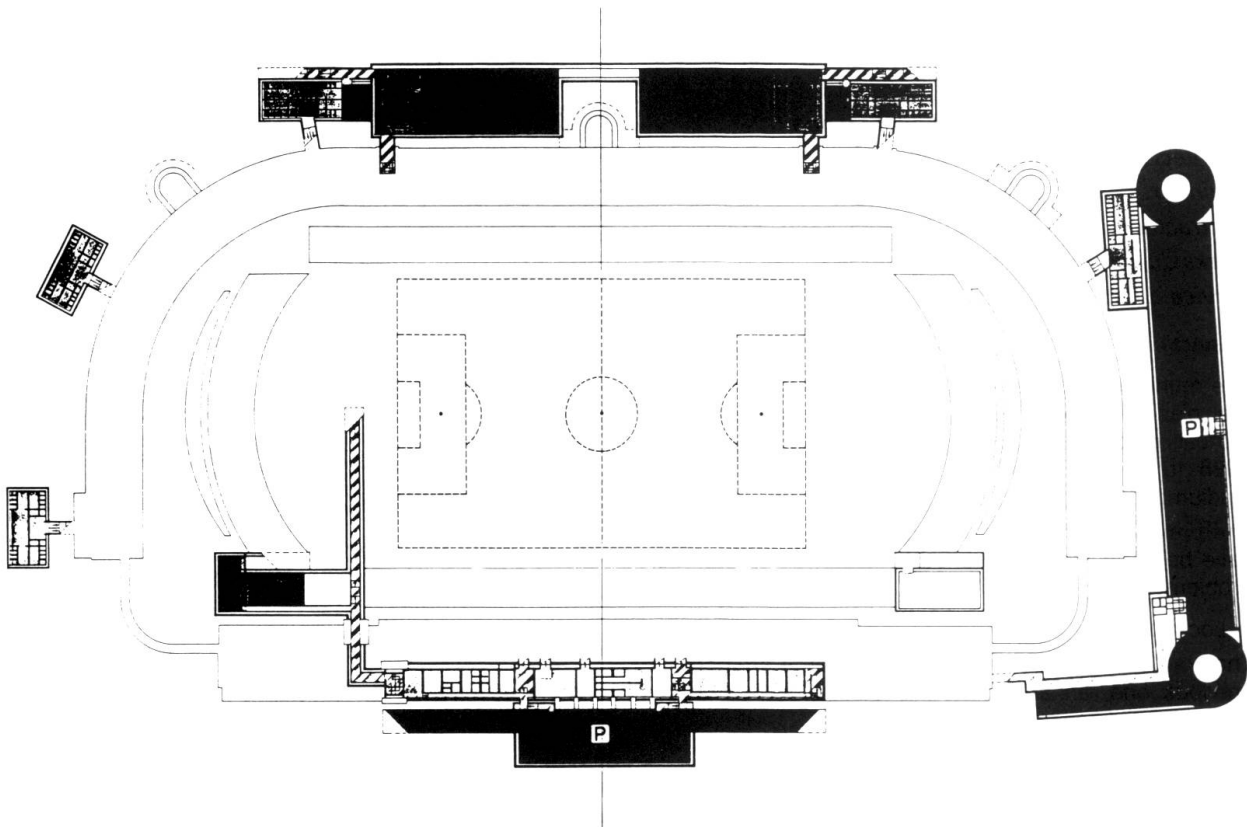
Fig. 3: Plan view of the underground constructions

shortened at the lower end, so that largescale changes in groundwater flow could be avoided. The bottom slabs, which are the lower floors of the underground constructions, are linked to the diaphragm walls by reinforcement stumps, previously placed under cover and then bent out, and also by reinforcement bars inserted in drilled holes, filled by non-shrinking grout. The slabs were designed with such characteristics that could counteract uplift pressures due to a possible long-term rise of the water-table. The upper storey is made by prefabricated prestressed reinforced concrete elements, acting also as struts or braces against the top of the diaphragm walls; on such floors the live loads of second class bridges have been taken into account.

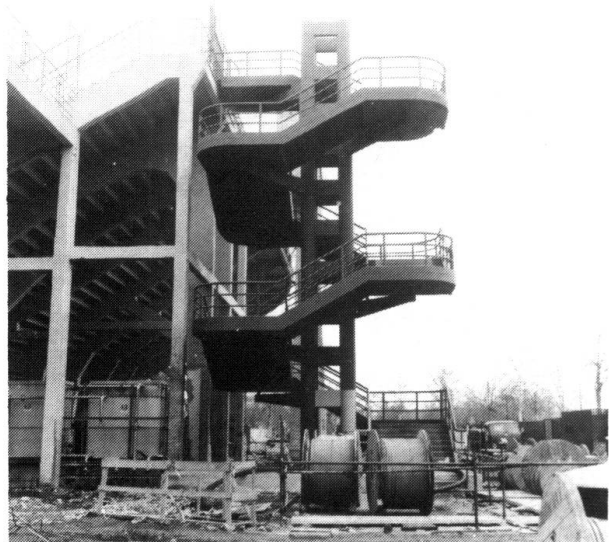
Fig. 4: New steel stairs

walls (dimensions: $3 \times 3 \times 14$ m). A couple of new steel stairs were also constructed, close to the outer side of the stands (fig. 4).
