10. «Marcantonio Bentegodi» Stadium in Verona (Italy)

Owner: *Municipality of Verona*
General Designer: *Dr. Eng. Silvano Zorzi*
General Contractor: *Impresa Mazzi Costruzioni S.p.A., Verona*
Works Duration: *20 months*
Service Year: *1989*

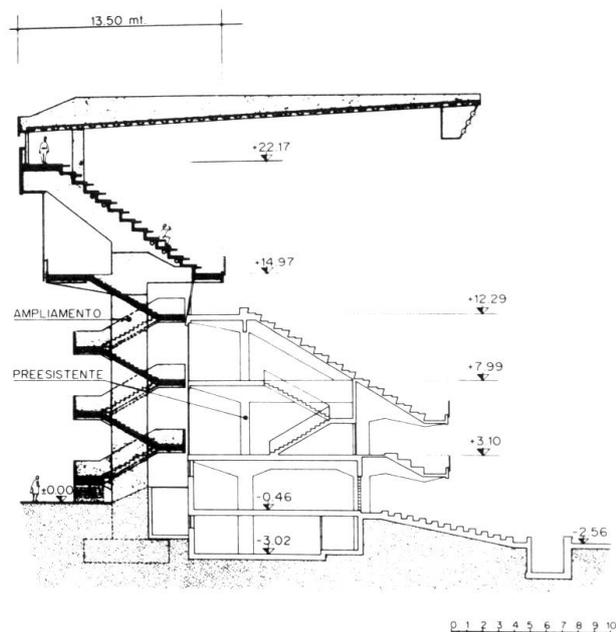
Fig. 3: Typical section

The new structure, consisting of the 3rd tiers ring and in the roofing for all the stands (both the new ones and the existing ones), has been designed to be totally independent of the one already in use for over 25 years.

It consists of a single row of columns standing outside the old structure and aligned radially with the frames supporting it.

Cantilever beams protrude from each column, at three levels, so as to support the horizontal floors for circular paths and services, the elements of the 3rd ring tiers and the new cantilever roof.

The steel roofing conforms to the structural design of the ring underneath: radial beams and floors parallel to the tiers. For the obvious reason of visibility the beam overhangs from a steel column standing on the outer edge of the new tiers and is held by a tie-rod located on the outer edge of the ring (the upper passage of the 3rd tiers ring is situated) between the column and the tie-rod.

The column and the tie-rod are anchored to the tiers-supporting beam by means of rag-bolt plates and prestressing vertical bars, respectively.

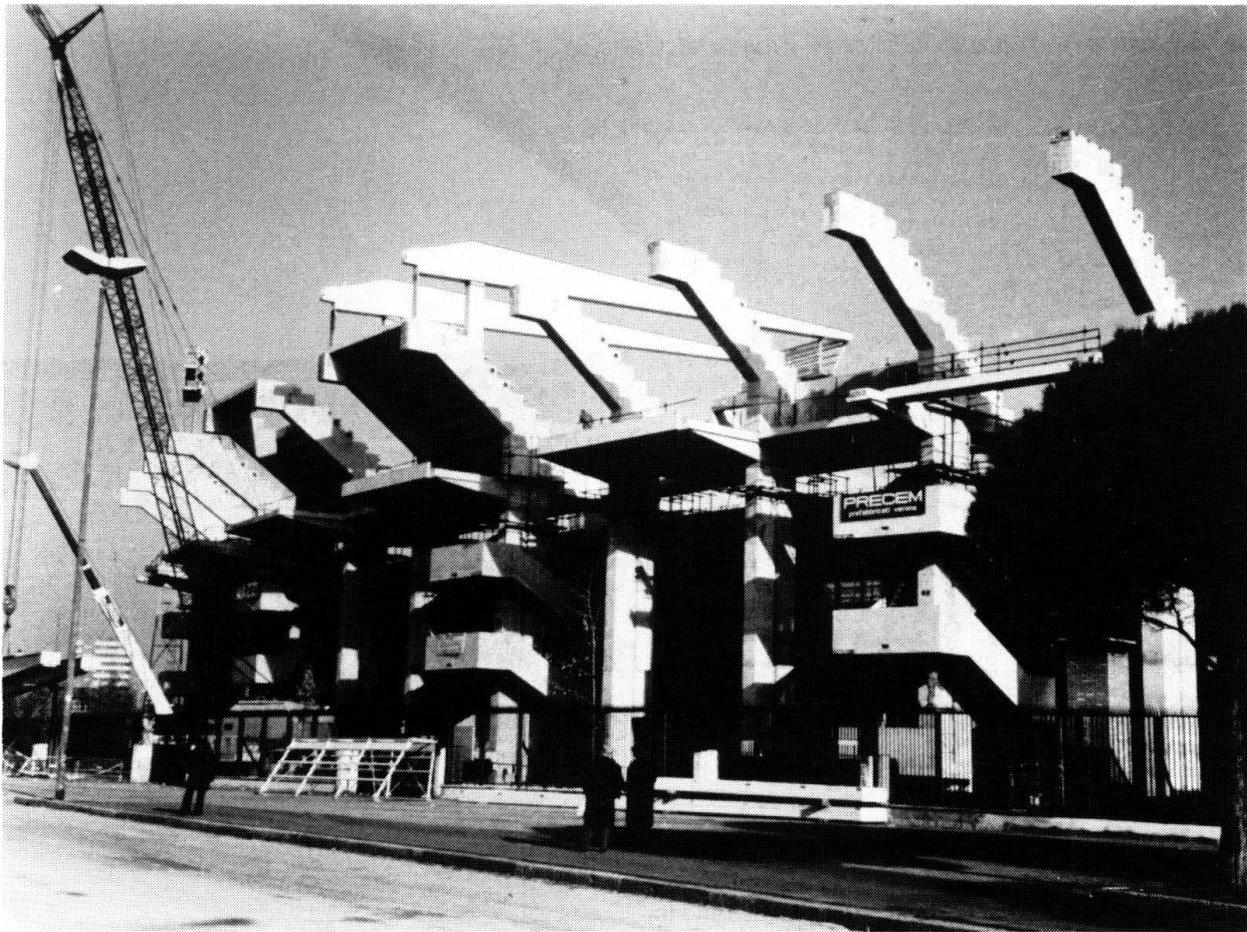
Fig. 4: During construction

As already mentioned, the foundations (consisting of footings, unpiled) and the columns were cast in place and then the precast horizontal cantilever beams of the first level were placed and anchored radially to the field.

The precast floor panels were then laid, arranged orthogonally and supported by the cantilever beams. The panels were jointed together and to the beams by reinforcing bars and in-situ concrete castings. The next construction stage was the placing of a second precast cantilever beam, aligned with the preceding one but with an inclined profile according to the outline of the tiers. The beam was connected to the underlying beam to the column by means of prestressing vertical bars.

The precast tiers were laid on the top faces, properly shaped, of the beams and joined together by a suitable number of dowels and steel plates sealed with non-shrink mortar.
