Zeitschrift: IABSE structures = Constructions AIPC = IVBH Bauwerke
Band: 14 (1990)
Heft: C-52: Football stadiums in Italy

Artikel: "Marcantonio Bentegodi" Stadium in Verona (Italy)
Autor: Zorzi, Silvano
DOI: <https://doi.org/10.5169/seals-22207>

10. «Marcantonio Bentegodi» Stadium in Verona (Italy)

Owner: Municipality of Verona
General Designer: Dr. Eng. Silvano Zorzi
General Contractor: Impresa Mazzi Costruzioni S.p.A., Verona
Works Duration: 20 months
Service Year: 1989

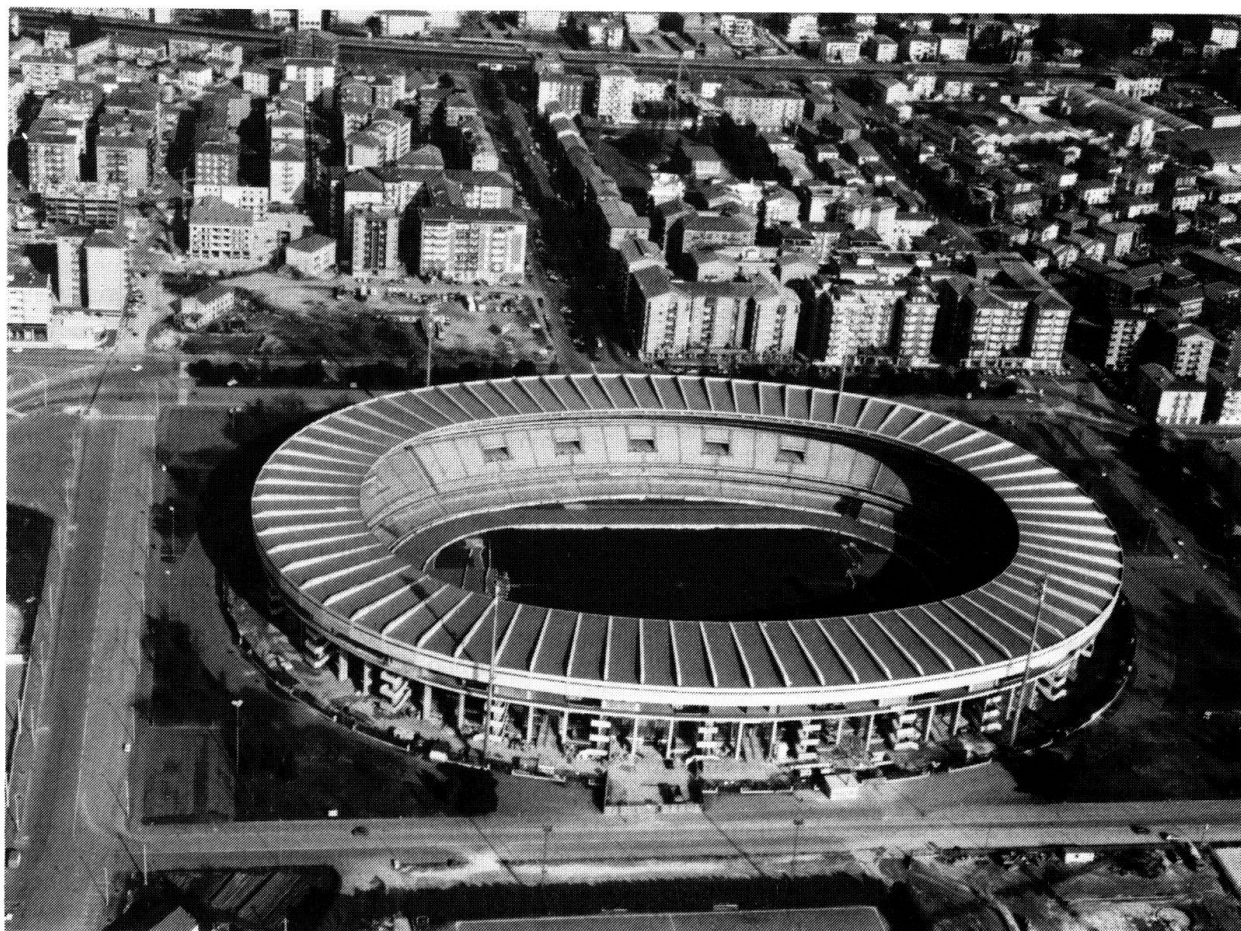
Fig. 1: The completed stadium in Verona (aerial view)

The bowl around the field, which is itself a polycentric figure in plan, is developed into an 11-row lower floor with 10800 seats, a first ring with 5 rows of seats for 5500 seats and further superposed tiers with 14 rows for 15200 seats; the overall capacity is 31500, with a seat to seat distance of 0.45 m.

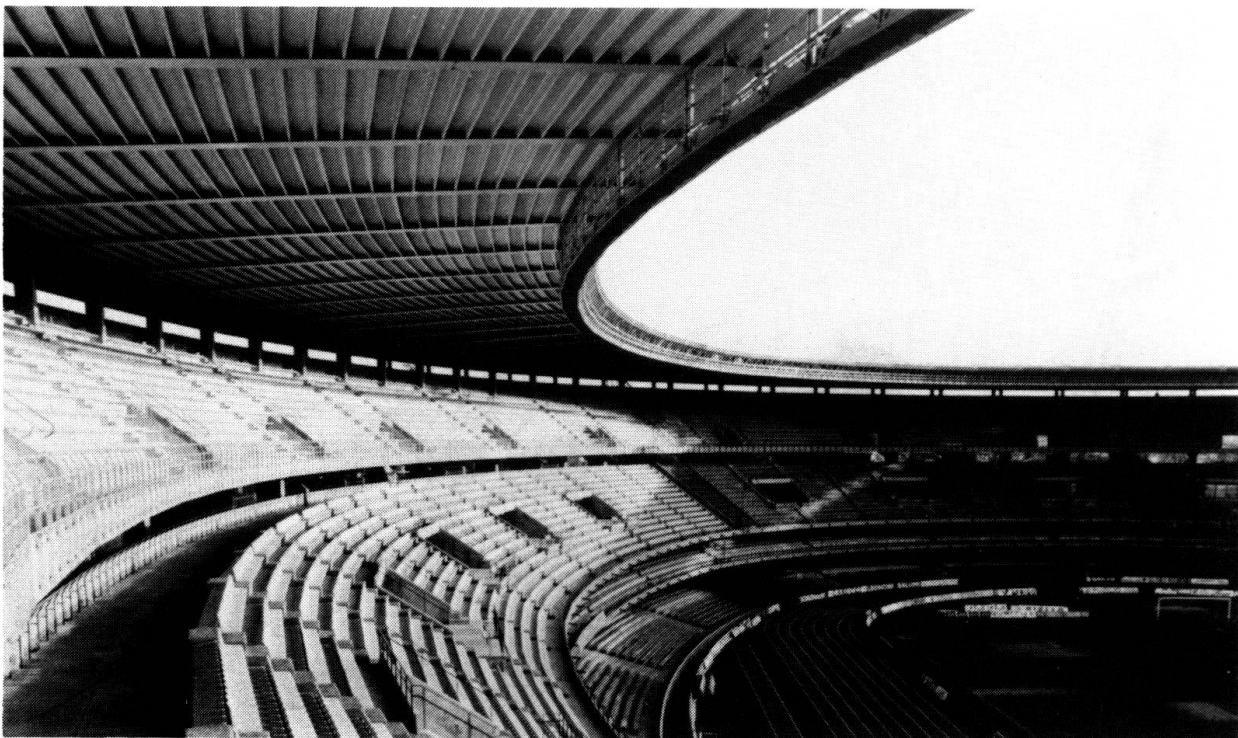
Fig. 2: *The completed stadium in Verona (view from inside)*

In 1986, the completion of a first section of the extension project, which envisaged a third ring of tiers and the covering, by means of a 30-m cantilever roofing, of all the seats underneath, increased the capacity by 4000 seats.

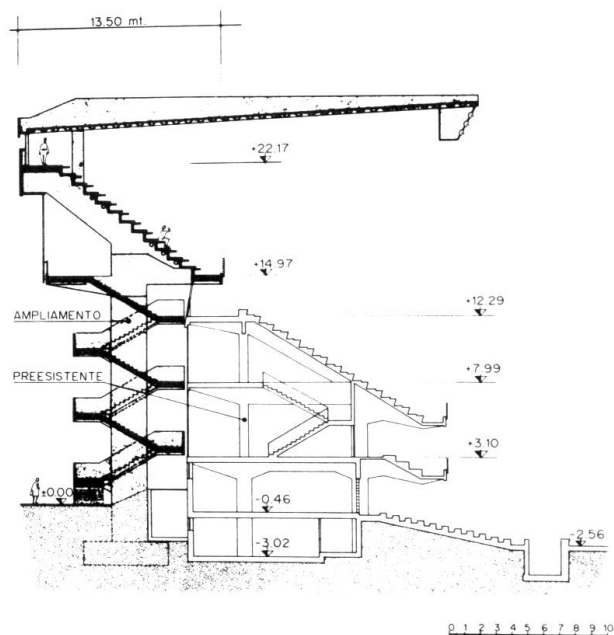
Fig. 3: *Typical section*

It consists of a single row of columns standing outside the old structure and aligned radially with the frames supporting it.

Cantilever beams protrude from each column, at three levels, so as to support the horizontal floors for circular paths and services, the elements of the 3rd ring tiers and the new cantilever roof.

All the cantilever roof structures (corrugated sheet-metal roofing, cantilever box-shaped main girders, tie-rods and columns) are made of steel.

The other structural elements (foundation footings, columns, stairs, cantilever beams, floors and tiers) are of ordinary reinforced concrete or prestressed concrete.

The steel roofing conforms to the structural design of the ring underneath: radial beams and floors parallel to the tiers. For the obvious reason of visibility the beam overhangs from a steel column standing on the outer edge of the new tiers and is held by a tie-rod located on the outer edge of the ring (the upper passage of the 3rd tiers ring is situated) between the column and the tie-rod.

The column and the tie-rod are anchored to the tiers-supporting beam by means of rag-bolt plates and prestressing vertical bars, respectively.

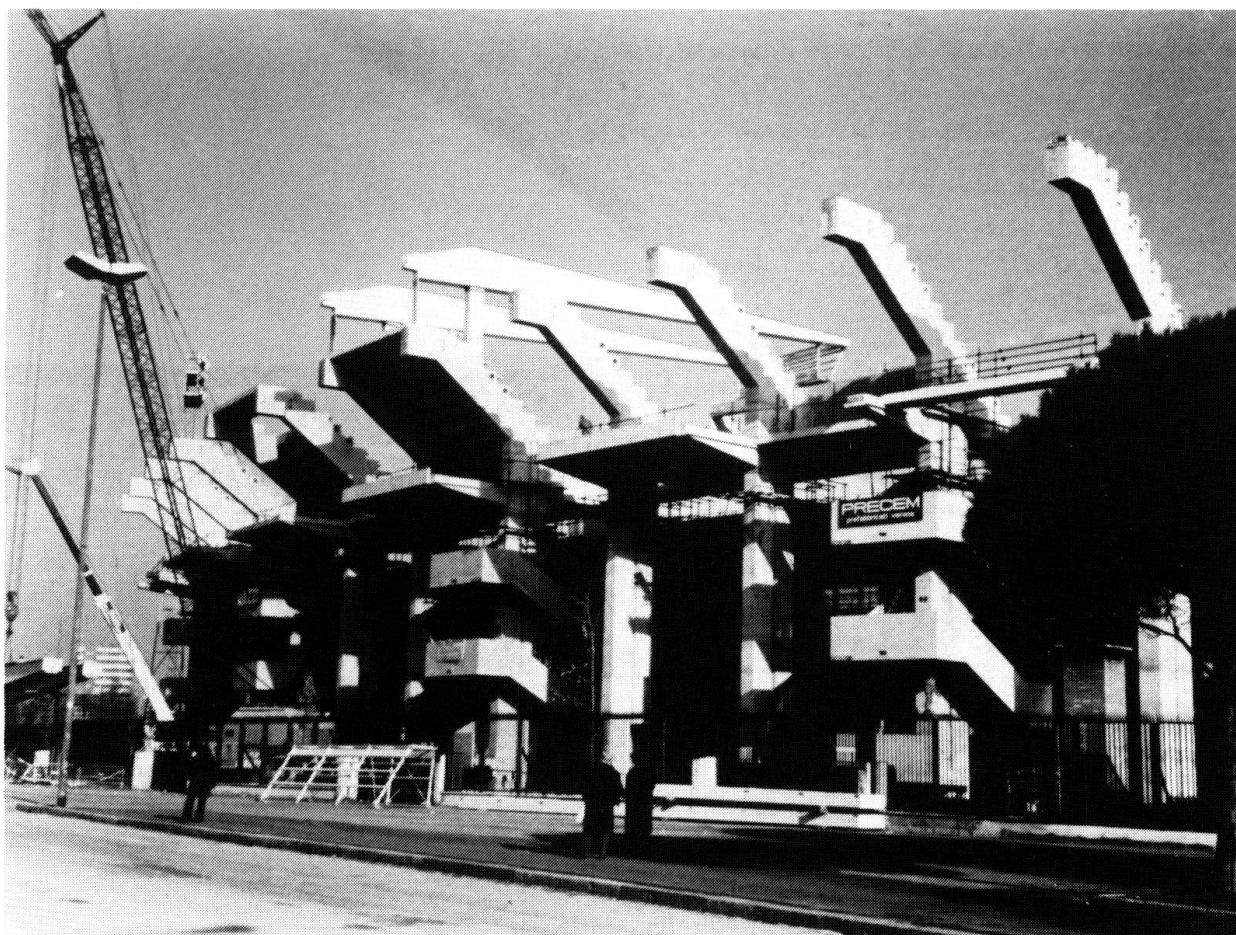
Fig. 4: During construction

As already mentioned, the foundations (consisting of footings, unpiled) and the columns were cast in place and then the precast horizontal cantilever beams of the first level were placed and anchored radially to the field.

The precast floor panels were then laid, arranged orthogonally and supported by the cantilever beams. The panels were jointed together and to the beams by reinforcing bars and in-situ concrete castings. The next construction stage was the placing of a second precast cantilever beam, aligned with the preceding one but with an inclined profile according to the outline of the tiers. The beam was connected to the underlying beam to the column by means of prestressing vertical bars.

The precast tiers were laid on the top faces, properly shaped, of the beams and joined together by a suitable number of dowels and steel plates sealed with non-shrink mortar.

The 3rd ring structure was completed by the placing of secondary elements (prestressed bracing members, top slab, edge ribs, steps, etc.), all precast and connected in place, as stated above.
