**Artikel:** "Marcantonio Bentegodi" Stadium in Verona (Italy)  
**Autor:** Zorzi, Silvano  
**DOI:** <https://doi.org/10.5169/seals-22207>

## 10. «Marcantonio Bentegodi» Stadium in Verona (Italy)

<b>Owner:</b>	<i>Municipality of Verona</i>
<b>General Designer:</b>	<i>Dr. Eng. Silvano Zorzi</i>
<b>General Contractor:</b>	<i>Impresa Mazzi Costruzioni S.p.A., Verona</i>
<b>Works Duration:</b>	<i>20 months</i>
<b>Service Year:</b>	<i>1989</i>

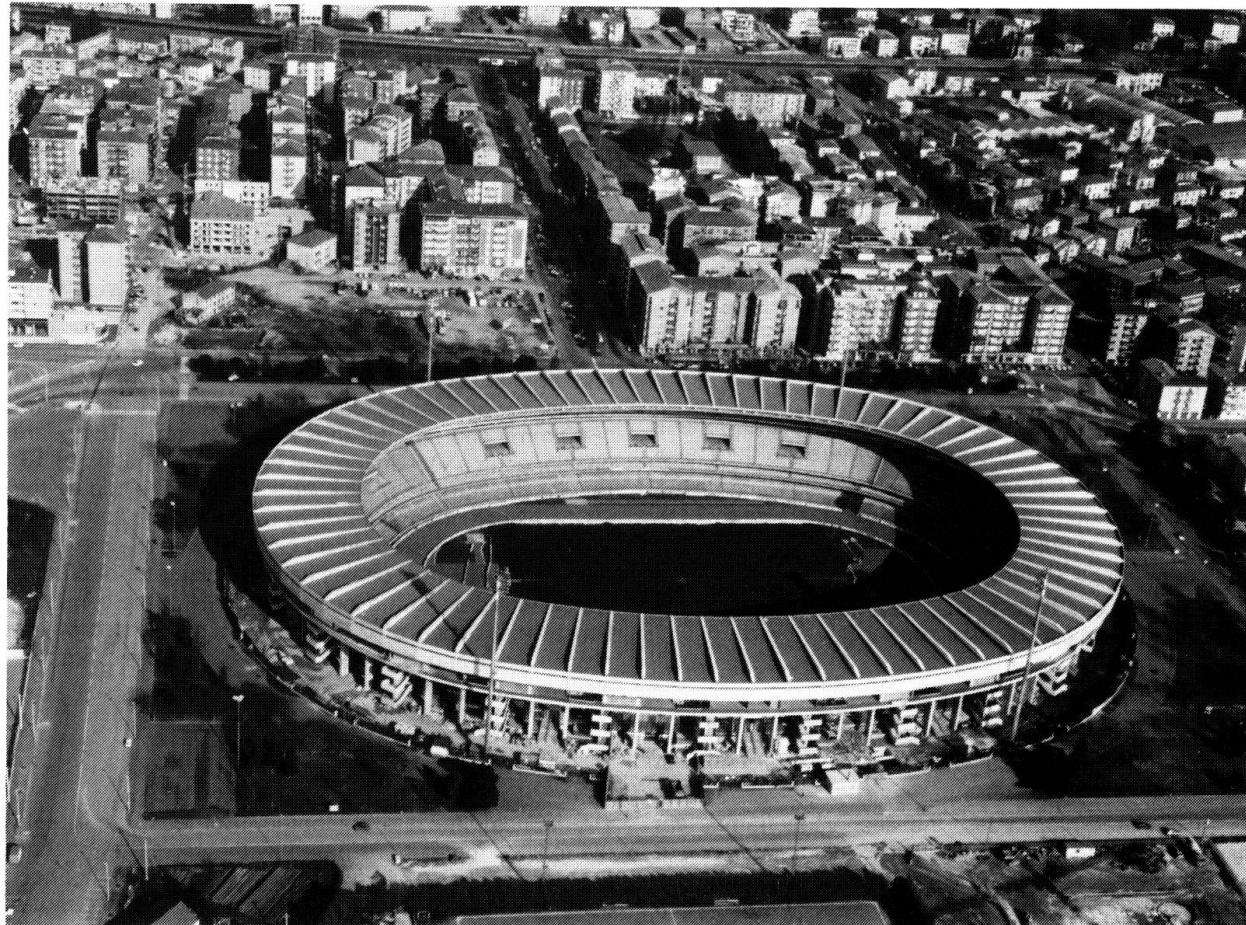
Fig. 1: The completed stadium in Verona (aerial view)

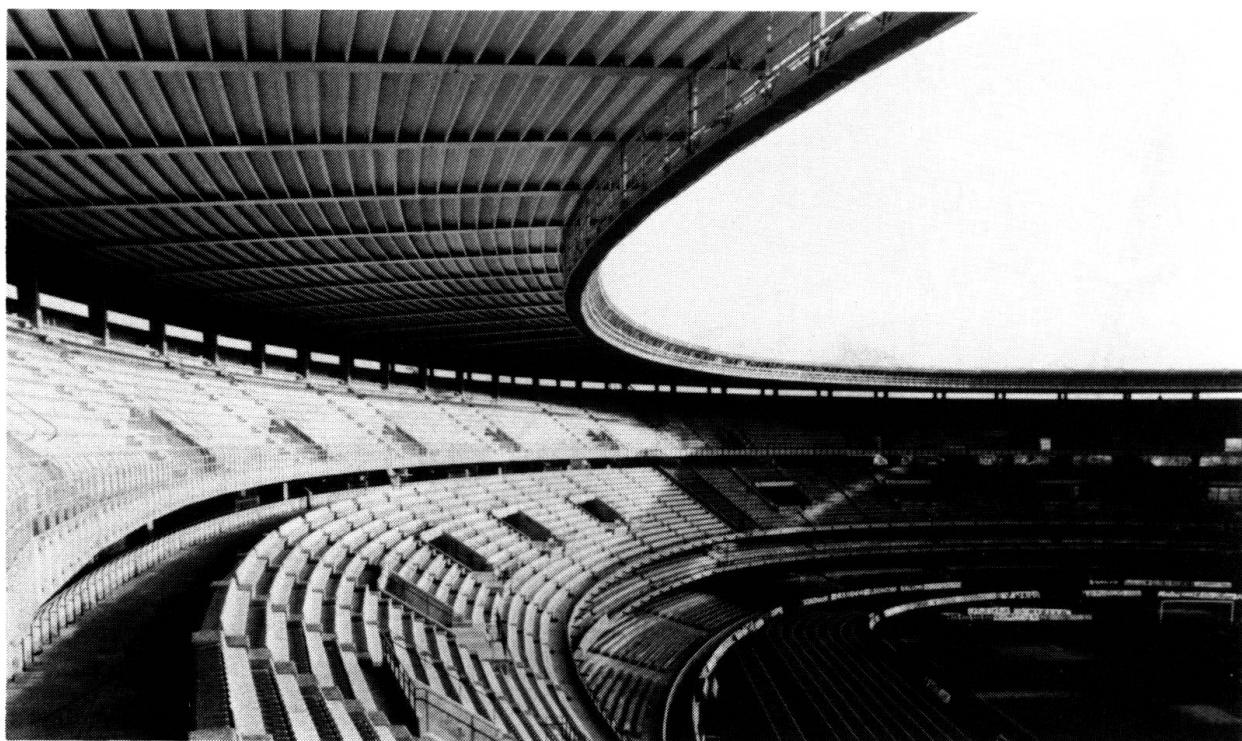
Fig. 2: The completed stadium in Verona (view from inside)

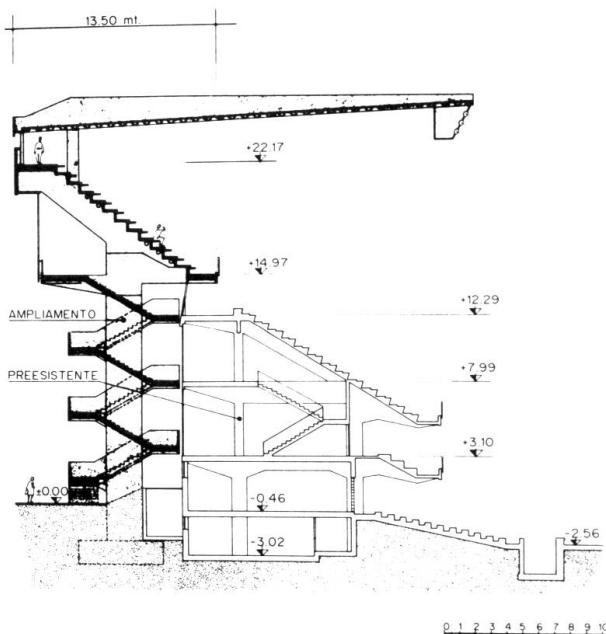
Fig. 3: Typical section

It consists of a single row of columns standing outside the old structure and aligned radially with the frames supporting it.

Cantilever beams protrude from each column, at three levels, so as to support the horizontal floors for circular paths and services, the elements of the 3rd ring tiers and the new cantilever roof.

The steel roofing conforms to the structural design of the ring underneath: radial beams and floors parallel to the tiers. For the obvious reason of visibility the beam overhangs from a steel column standing on the outer edge of the new tiers and is held by a tie-rod located on the outer edge of the ring (the upper passage of the 3rd tiers ring is situated) between the column and the tie-rod.

The column and the tie-rod are anchored to the tiers-supporting beam by means of rag-bolt plates and prestressing vertical bars, respectively.

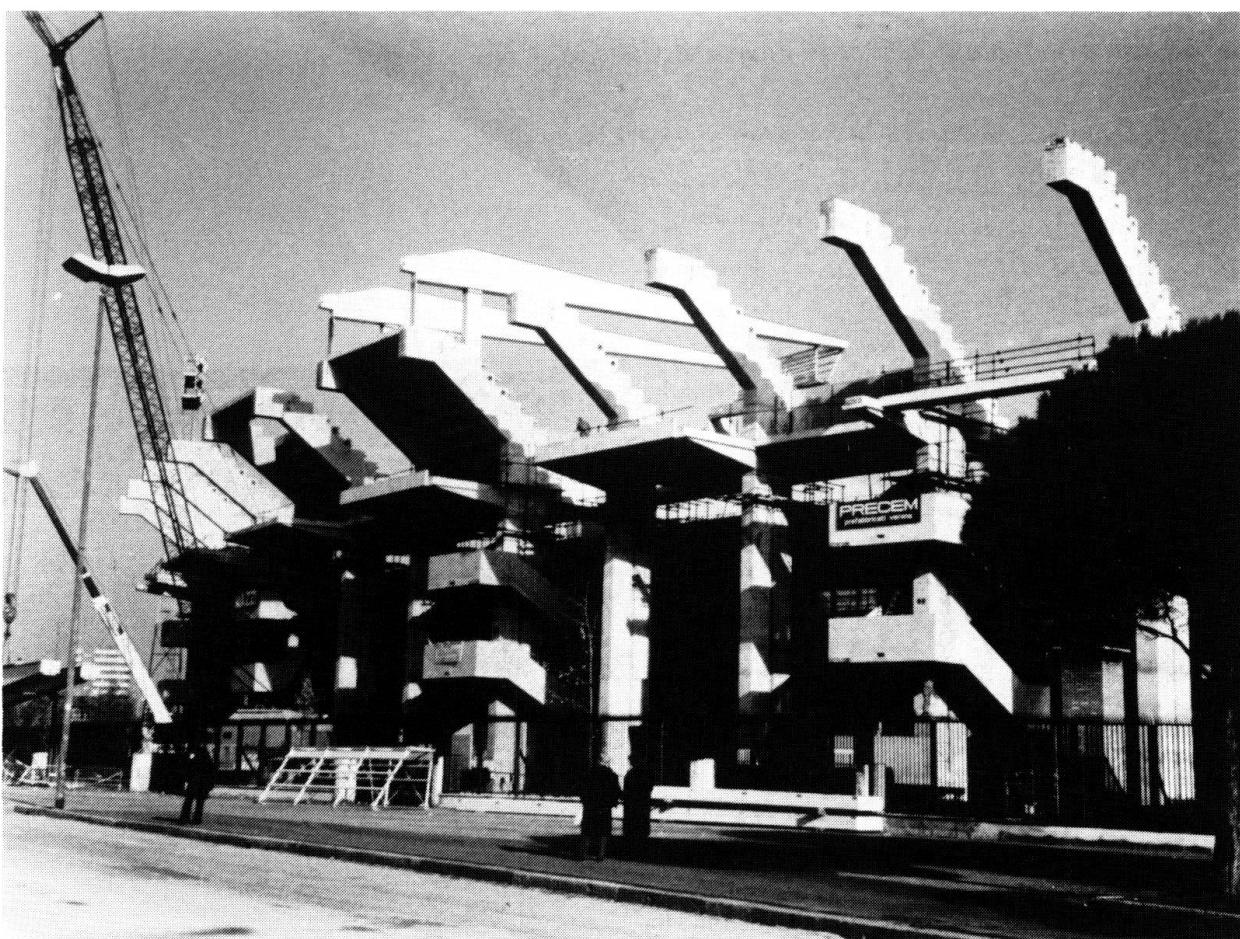
*Fig. 4: During construction*

As already mentioned, the foundations (consisting of footings, unpiled) and the columns were cast in place and then the precast horizontal cantilever beams of the first level were placed and anchored radially to the field.

The precast floor panels were then laid, arranged orthogonally and supported by the cantilever beams. The panels were jointed together and to the beams by reinforcing bars and in-situ concrete castings. The next construction stage was the placing of a second precast cantilever beam, aligned with the preceding one but with an inclined profile according to the outline of the tiers. The beam was connected to the underlying beam to the column by means of prestressing vertical bars.

The precast tiers were laid on the top faces, properly shaped, of the beams and joined together by a suitable number of dowels and steel plates sealed with non-shrink mortar.
