## 10. «Marcantonio Bentegodi» Stadium in Verona (Italy)

**Owner:** Municipality of Verona  
**General Designer:** Dr. Eng. Silvano Zorzi  
**General Contractor:** Impresa Mazzi Costruzioni S.p.A., Verona  
**Works Duration:** 20 months  
**Service Year:** 1989

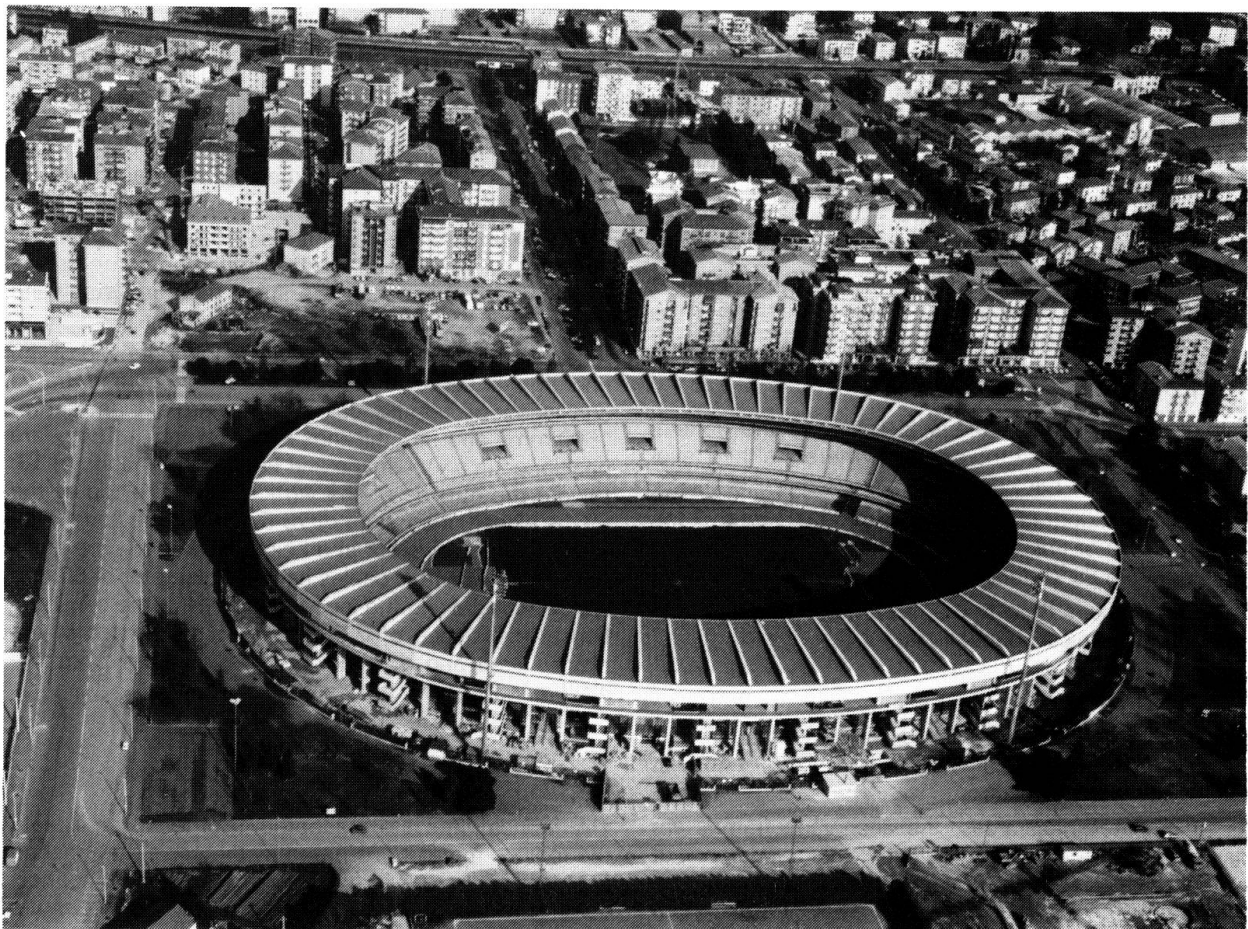
Fig. 1: The completed stadium in Verona (aerial view)

At the beginning of 1989 with a view to «Italia 90», the World Football Cup, the new seating ring and the roofing were already complete, perfectly matching the structures included in the above-mentioned first section of the project, thus reaching a capacity of 46500 seats, all of them covered.
