Artikel: Renewal of the old Quaibridge in Zurich
Autor: Fechtig, Robert
DOI: <https://doi.org/10.5169/seals-28994>

Renewal of the Old Quaibrücke in Zurich

Robert FECHTIG

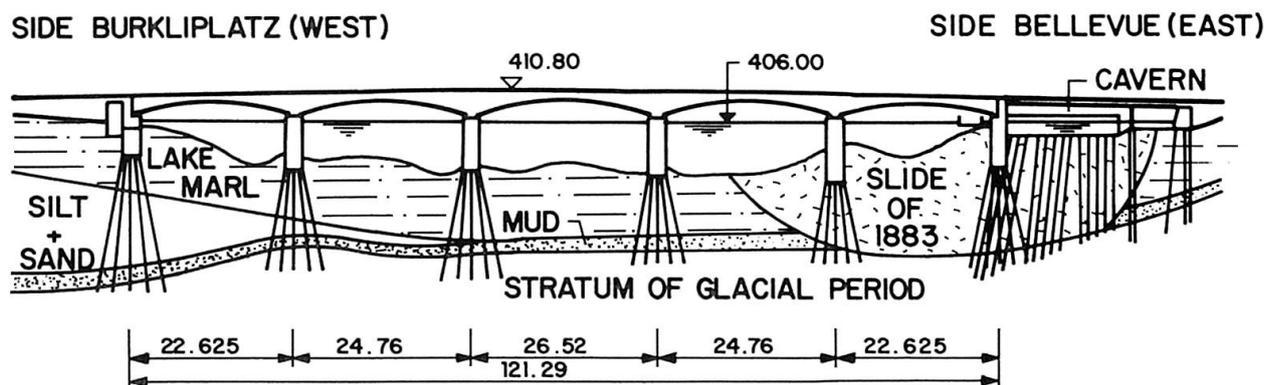
Fig. 1: Longitudinal section with geological cross section

The old Quai-bridge is just over 100 years old. In 1882-1884 it was erected by civil engineer Dr. Arnold Bürkli. As main supporting structure six arch-formed steelgirders served which cross the five sections between the piers and counterfort in an elegant way. For the roadway-slab trough-plate had been used as a normal element of construction. The bad underground was a special problem and brought difficulties. The upper most stratum formed by lakemarl and rotten slime is not fit to bear heavy weights. For this reason pile-gratings have been erected for the four piers and the two counterforts. The foundation of each pier is formed by 130 to 150 pine-wood piles which penetrate the lakemarl and are founded on an ice-age stratum of silt, sand and gravel which bears well. During the construction of the rightside counterfort (Bellevue) in February, 1883, one part of the bad lakemarl and rottenslime stratum slid down and damaged the foundation of the next pier. The counterfort itself coused partly. To diminuate the load on the underground, a free space of about 25 m square was erected behind the counterfort. This one is nearly 3 m high and covered with a construction of steel and concrete, which itself is based with cast-ironed supports on small pile-gratings.

Since 1932 an armed concrete-slab substitutes the old construction. At the same time the iron construction was reinforced. On the occasion of the Swiss National Exhibition in 1939 the bridge was enlarged from 20 to 28,5 m. On both sides of the bridge new arched-formed main-steel-beams were erected, so that the number of main beams was raised to 8. Different small alterations have been made at the counterfort. With this modification the bridge received its present appearance.

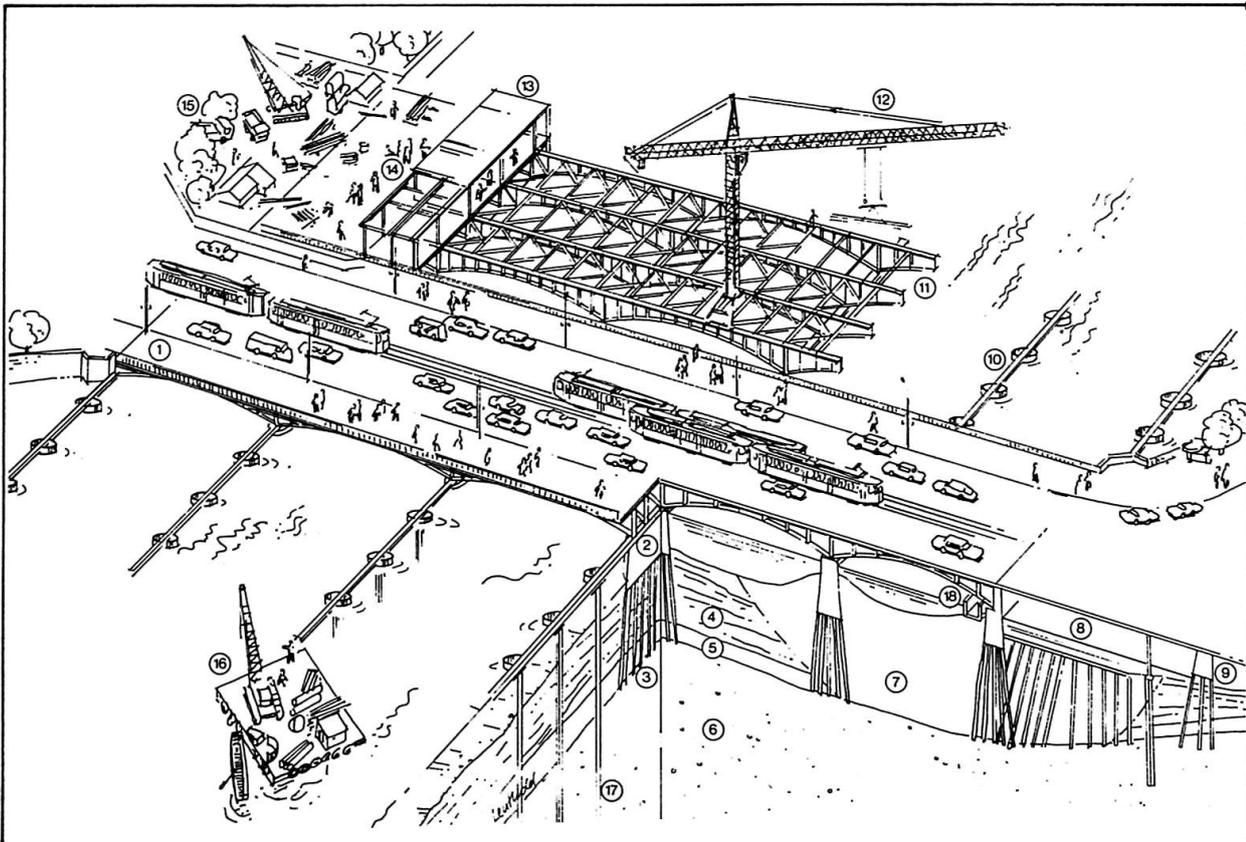
Fig. 2: General view of the work

| 1 | old Quaibrücke, built 1882-1884, widened in 1939 | 11 | four new welded steel girders Fe 510, erected on displacement tracks |
| 2 | pier, concrete with abutment of natural stone | 12 | tower crane |
| 3 | pier pile grating | 13 | removable falsework for the concrete slab |
| 4 | lakemarl | 14 | pouring section, length 12 m |
| 5 | mud | 15 | installation site |
| 6 | stratum of glacial period, foundation of the pile gratings | 16 | floating pile driver |
| 7 | slide of 1883 | 17 | piles of displacement track, quantity - 40, \varnothing - 1.22 m length - 25-35 m |
| 8 | Bellevue cavern | 18 | concrete trough for pedestrian underpass |
| 9 | old embankment | | |
| 10 | displacement track | | |

New bridge spans - consisting of four new steel girders and a post-tensioned concrete slab poured on site - are built on displacement tracks and temporary piles in the River Limmat. The traffic circulates on the existing Quai-Bridge during the construction of the new bridge. In the same period, the existing bridge piers are repaired. The new bridge's girder and deck are then shifted to its definite place during a low-traffic weekend; at the same time the existing girders and deck are pushed on displacement tracks and temporary piles to the lake side of the bridge. Finally, the old bridge's girder and deck are demolished as well as the displacement tracks and the temporary piles.

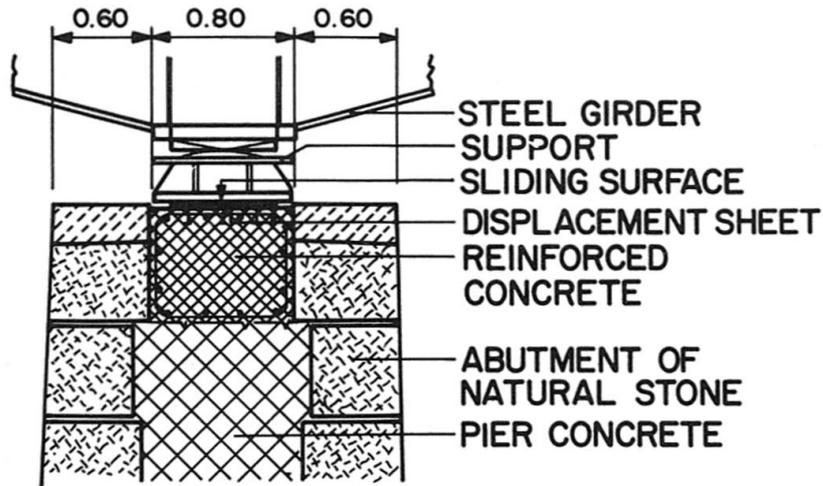
Fig. 4: Bridge support on the existing piers

The old bridge has to be put on slide supports in order to be able to displace it. The new bridge had already been erected on the tracks. The slide supports are locked onto the displacement track until the displacement starts. The upper part of the support will be used later as a part of the whole support. The old supports of the existing bridge had been exchanged against sliding bearings whereby the existing support conditions had to be followed exactly. These tasks were performed in several stages under heavy traffic flow.

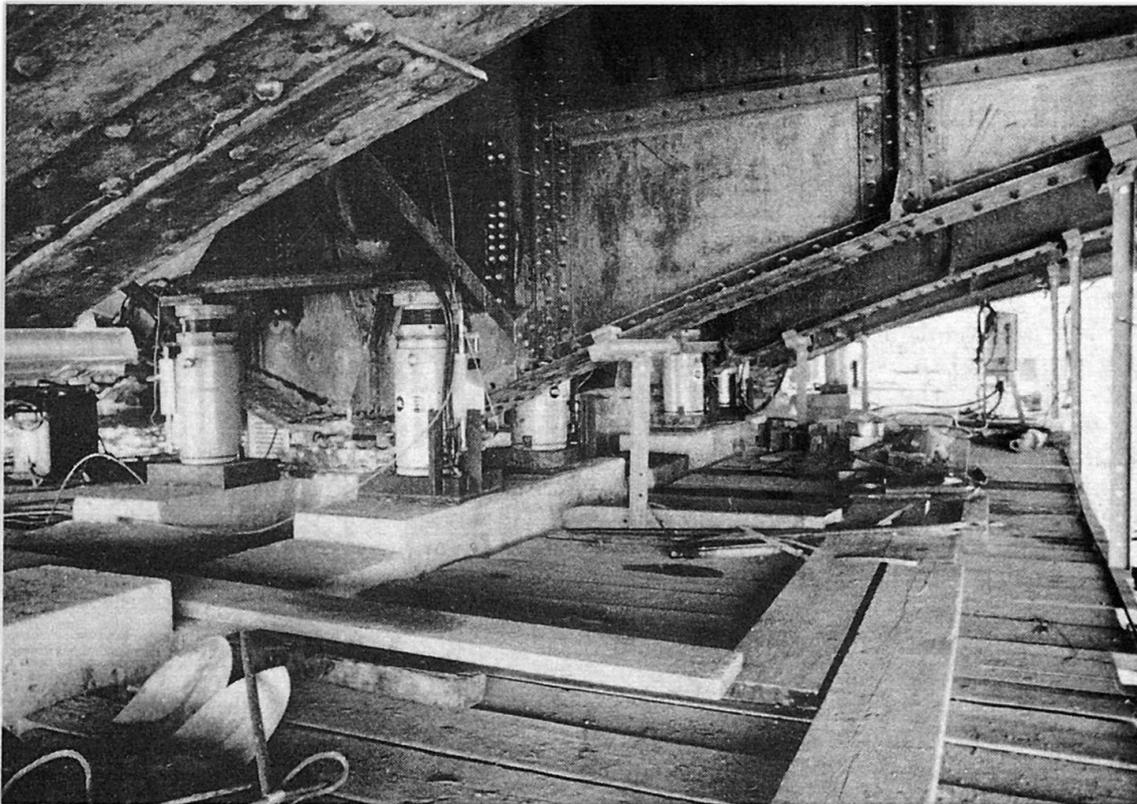
Photo 1: Exchange of the old supports with sliding supports, under traffic flow

The sliding supports are chromed on the underside. They glide on teflon coated neoprene cushions. This disposition allows a secure load-transfer if unevenness of the displacement track should arise.

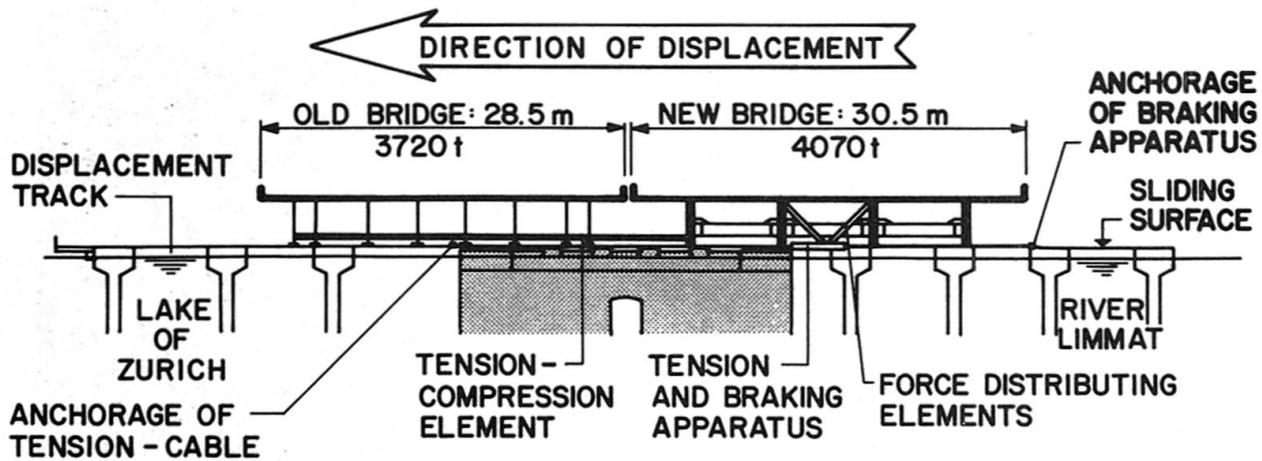
Fig. 5: Transverse section with displacement equipment

Eight VSL-strand tension apparatus will pull the new bridge on cables into the planned position. The existing bridge will be pushed ahead by the new one on to the displacement track in up-stream direction. A special structure between the second and third main girder of the new bridge takes the movement force. The cables are mounted on to anchorage points at the displacement track "Lake". A practically closed power system is produced. Piles and kentledge are stressed only moderately by horizontal power.

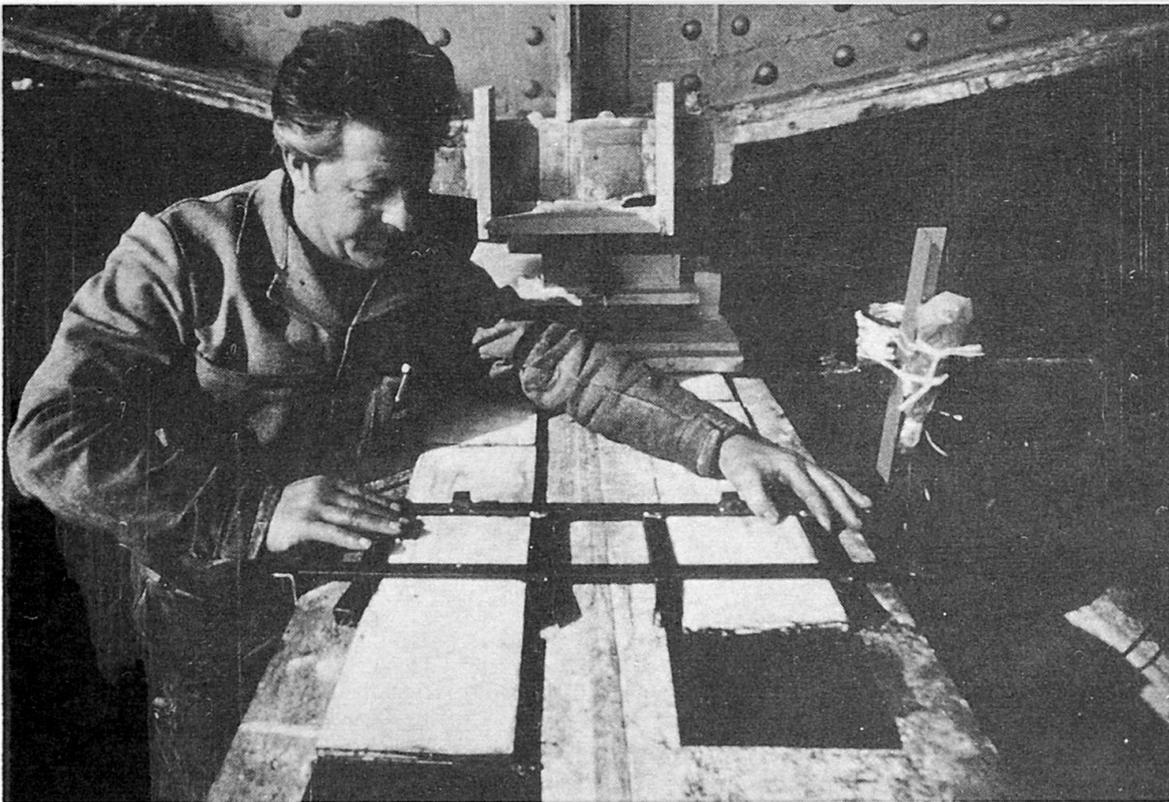
Photo 2: Placing the teflon-coated neoprene cushions

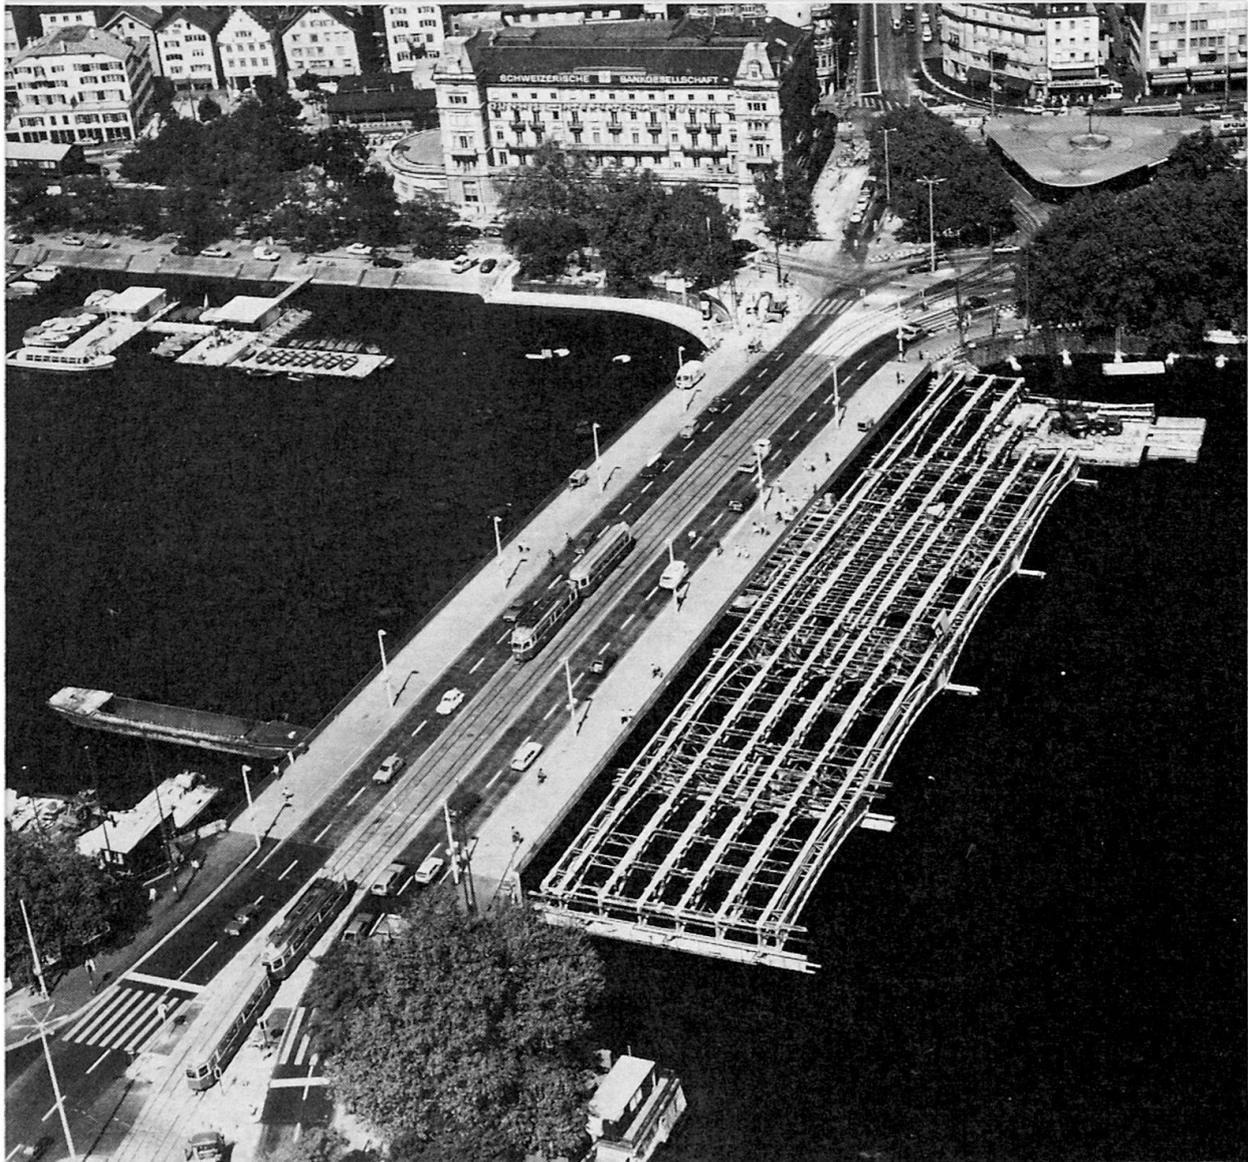
Photo 3: Demolition work on the old bridge (right) after the displacement
