Zeitschrift: IABSE journal = Journal AIPC = IVBH Journal
Band: 10 (1986)
Heft: J-30: Renewal of the old Quaibridge in Zurich

Renewal of the Old Quaibridge in Zurich

Robert FECHTIG

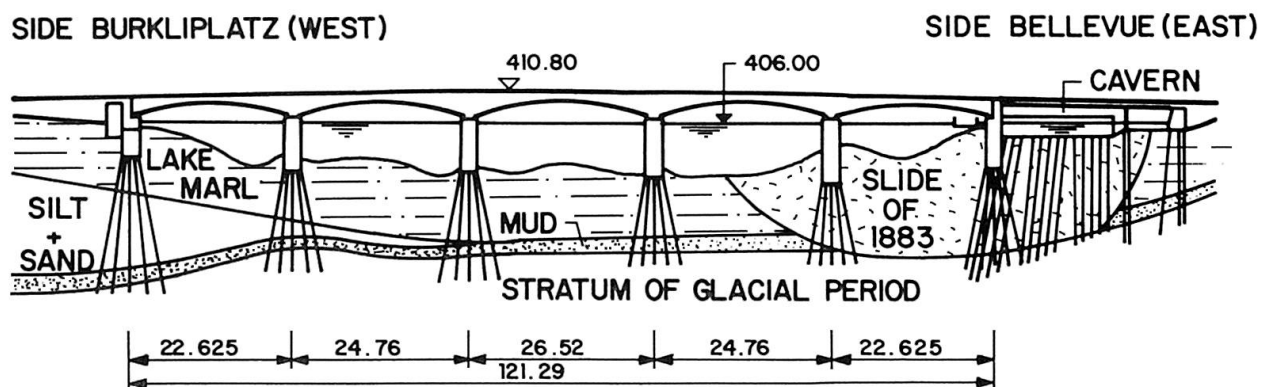
Fig. 1: Longitudinal section with geological cross section

The old Quai-bridge is just over 100 years old. In 1882-1884 it was erected by civil engineer Dr. Arnold Bürkli. As main supporting structure six arch-formed steelgirders served which cross the five sections between the piers and counterfort in an elegant way. For the roadway-slab trough-plate had been used as a normal element of construction. The bad underground was a special problem and brought difficulties. The upper most stratum formed by lakemarl and rotten slime is not fit to bear heavy weights. For this reason pile-gratings have been erected for the four piers and the two counterforts. The foundation of each pier is formed by 130 to 150 pine-wood piles which penetrate the lakemarl and are founded on an ice-age stratum of silt, sand and gravel which bears well. During the construction of the rightside counterfort (Bellevue) in February, 1883, one part of the bad lakemarl and rottenslime stratum slid down and damaged the foundation of the next pier. The counterfort itself couded partly. To diminuate the load on the underground, a free space of about 25 m square was erected behind the counterfort. This one is nearly 3 m high and covered with a construction of steel and concrete, which itself is based with cast-ironed supports on small pile-gratings.

Since 1932 an armed concrete-slab substitutes the old construction. At the same time the iron construction was reinforced. On the occasion of the Swiss National Exhibition in 1939 the bridge was enlarged from 20 to 28,5 m. On both sides of the bridge new arched-formed main-steel-beams were erected, so that the number of main beams was raised to 8. Different small alterations have been made at the counterfort. With this modification the bridge received its present appearance.

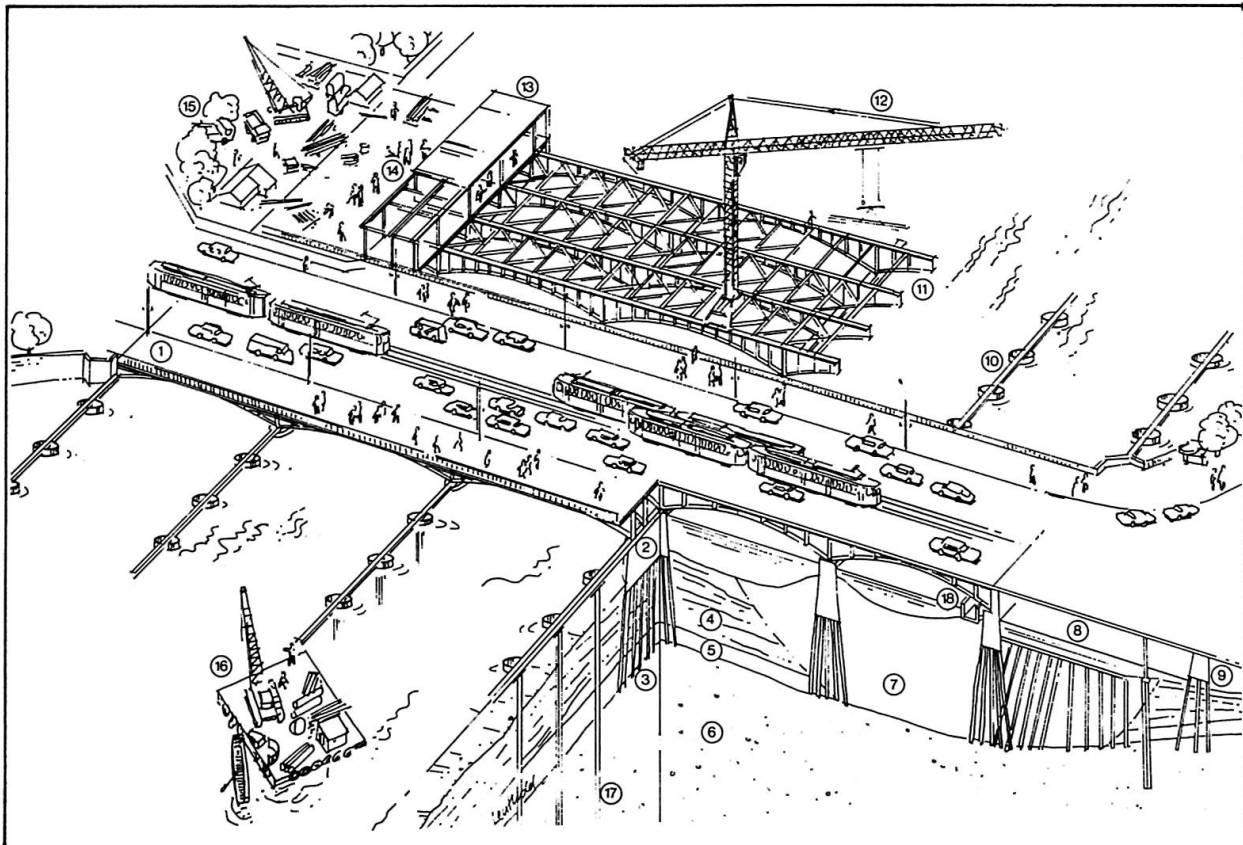
Fig. 2: General view of the work

| 1 old Quaibridge, built 1882-1884, widened in 1939 | 11 four new welded steel girders Fe 510, erected on displacement tracks |
| 2 pier, concrete with abutment of natural stone | 12 tower crane |
| 3 pier pile grating | 13 removable falsework for the concrete slab |
| 4 lakemarl | 14 pouring section, length 12 m |
| 5 mud | 15 installation site |
| 6 stratum of glacial period, foundation of the pile gratings | 16 floating pile driver |
| 7 slide of 1883 | 17 piles of displacement track, quantity - 40, \varnothing - 1.22 m |
| 8 Bellevue cavern | length - 25-35 m |
| 9 old embankment | 18 concrete trough for pedestrian underpass |
| 10 displacement track | |

New bridge spans - consisting of four new steel girders and a post-tensioned concrete slab poured on site - are built on displacement tracks and temporary piles in the River Limmat. The traffic circulates on the existing Quai-Bridge during the construction of the new bridge. In the same period, the existing bridge piers are repaired. The new bridge's girder and deck are then shifted to its definite place during a low-traffic weekend; at the same time the existing girders and deck are pushed on displacement tracks and temporary piles to the lake side of the bridge. Finally, the old bridge's girder and deck are demolished as well as the displacement tracks and the temporary piles.

- A platform was built on the Limmat side of the existing bridge near the West abutment. Prefabricated slabs were fixed on driven-in piles. The platform became the access to the new bridge site. The crane that was installed temporarily on the new bridge entered on this platform.

- Then, the temporary piles for the displacement track were drilled into the river ground.
- In the same phase, the existing bridge piers and abutments were repaired with cement injections. Reinforcing tension and compression members were added on top and at the basis of the piers, respectively.

- Now the pile caps and the displacement tracks were installed. The final position of the tracks was partially below the water surface. The temporary structure was now ready for carrying the new bridge.

- The steel girders were placed in 10 major phases, usually during the night. The tower crane was run on a temporary track that was put in corresponding to the advancing working location of the crane.

- As soon as the girders of the first three spans were placed and welded, the first section of the slab was poured on a removable false work. One section of about 12 m took about one week, i.e. 10 sections were necessary for the whole bridge.

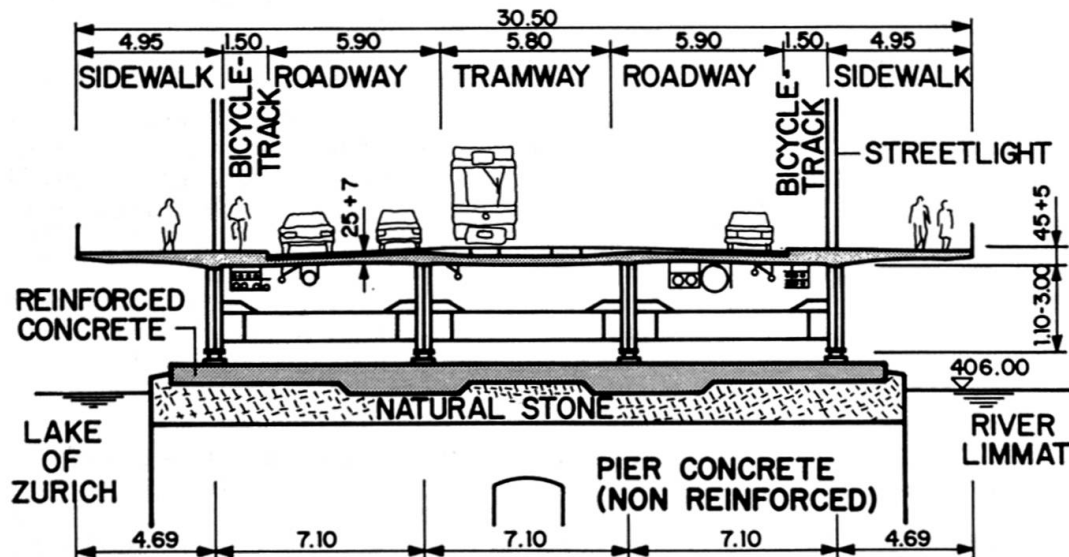
Fig. 3: Cross section of the new bridge with traffic areas

The cast in place slab is made of reinforced and laterally post-tensioned concrete B PC 325 that should resist frost and anti-freezing salt water. The cables have a distance of 90 cm and a tension of 88 tons. There are no longitudinal cables. The framework and scaffold were pulled on removable rails on the temporary bracing of the steel girders.

The deck waterproofing is a reinforced bituminous layer that is covered with an aluminum surface. The waterproofing was head-posted on the complete surface. The cover is a floated mastic asphalt built up in two layers. The thickness is 65 mm on the traffic-way and 55 mm on the side walk. Crushed sand is worked into the coversurface. Waterproofing and covering were determining the construction schedule because of their dependence on good weather conditions.

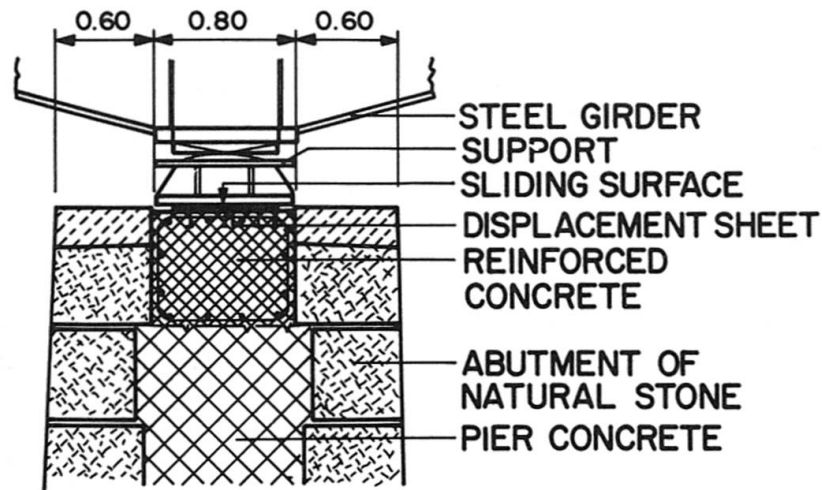
Fig. 4: Bridge support on the existing piers

The old bridge has to be put on slide supports in order to be able to displace it. The new bridge had already been erected on the tracks. The slide supports are locked onto the displacement track until the displacement starts. The upper part of the support will be used later as a part of the whole support. The old supports of the existing bridge had been exchanged against sliding bearings whereby the existing support conditions had to be followed exactly. These tasks were performed in several stages under heavy traffic flow.

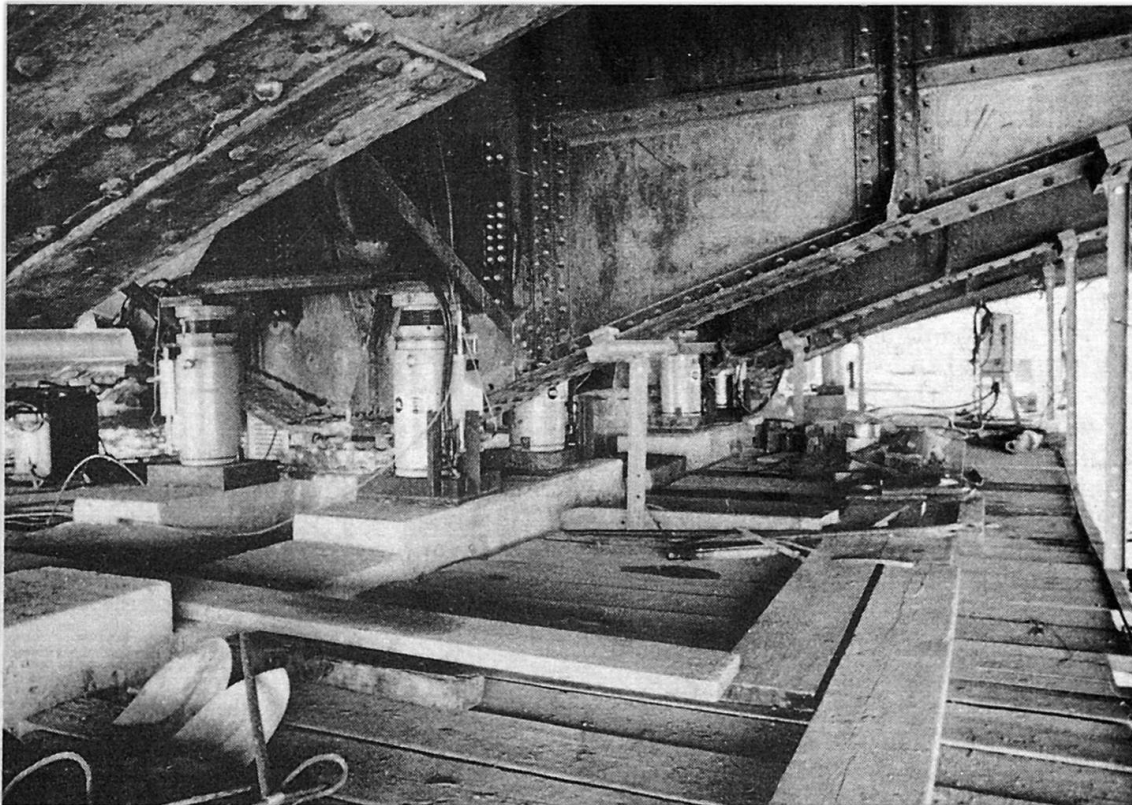
Photo 1: Exchange of the old supports with sliding supports, under traffic flow

The sliding supports are chromed on the underside. They glide on teflon coated neoprene cushions. This disposition allows a secure load-transfer if unevenness of the displacement track should arise.

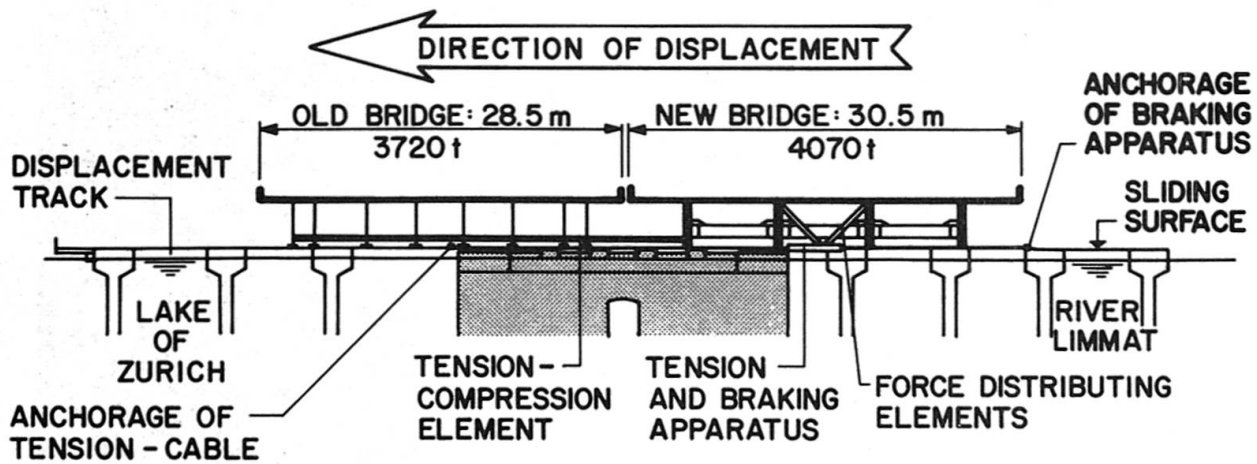
Fig. 5: Transverse section with displacement equipment

Eight VSL-strand tension apparatus will pull the new bridge on cables into the planned position. The existing bridge will be pushed ahead by the new one on to the displacement track in up-stream direction. A special structure between the second and third main girder of the new bridge takes the movement force. The cables are mounted on to anchorage points at the displacement track "Lake". A practically closed power system is produced. Piles and kentledge are stressed only moderately by horizontal power.

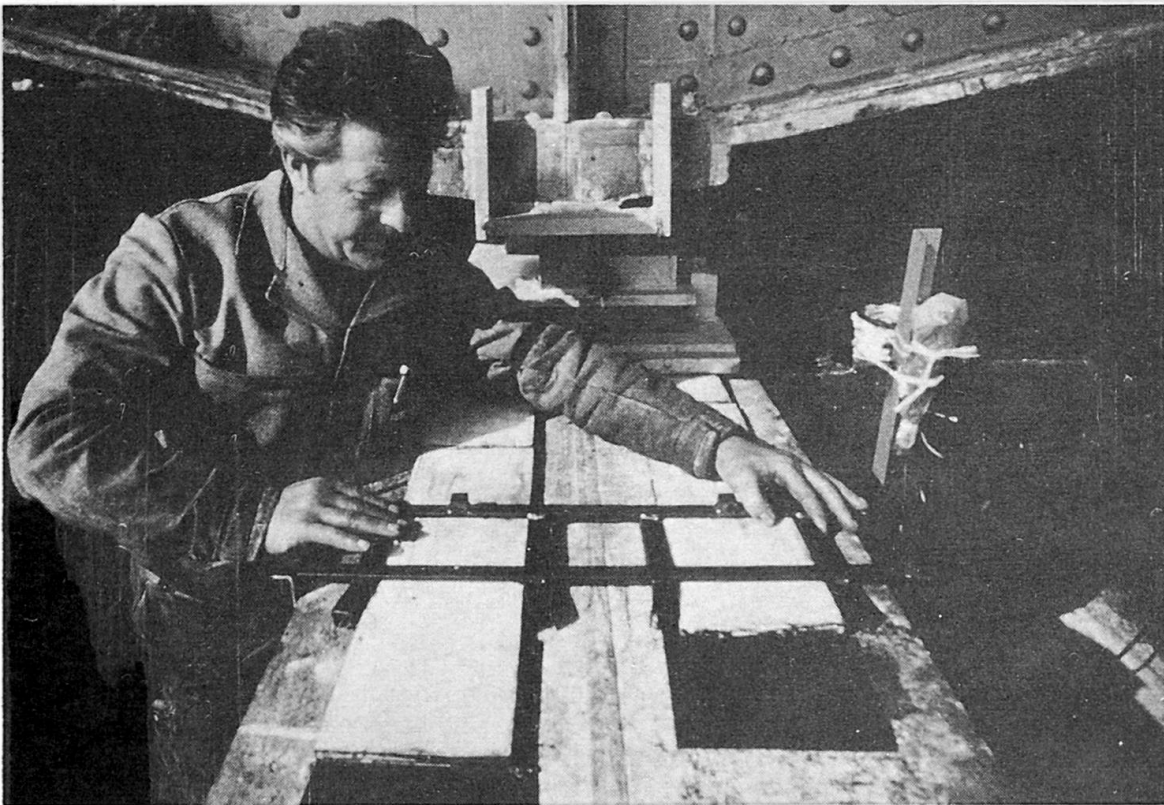
Photo 2: Placing the teflon-coated neoprene cushions
