Zeitschrift: IABSE journal = Journal AIPC = IVBH Journal
Band: 10 (1986)
Heft: J-30: Renewal of the old Quaibridge in Zurich

Artikel: Renewal of the old Quaibridge in Zurich
Autor: Fechtig, Robert
DOI: <https://doi.org/10.5169/seals-28994>

Renewal of the Old Quaibridge in Zurich

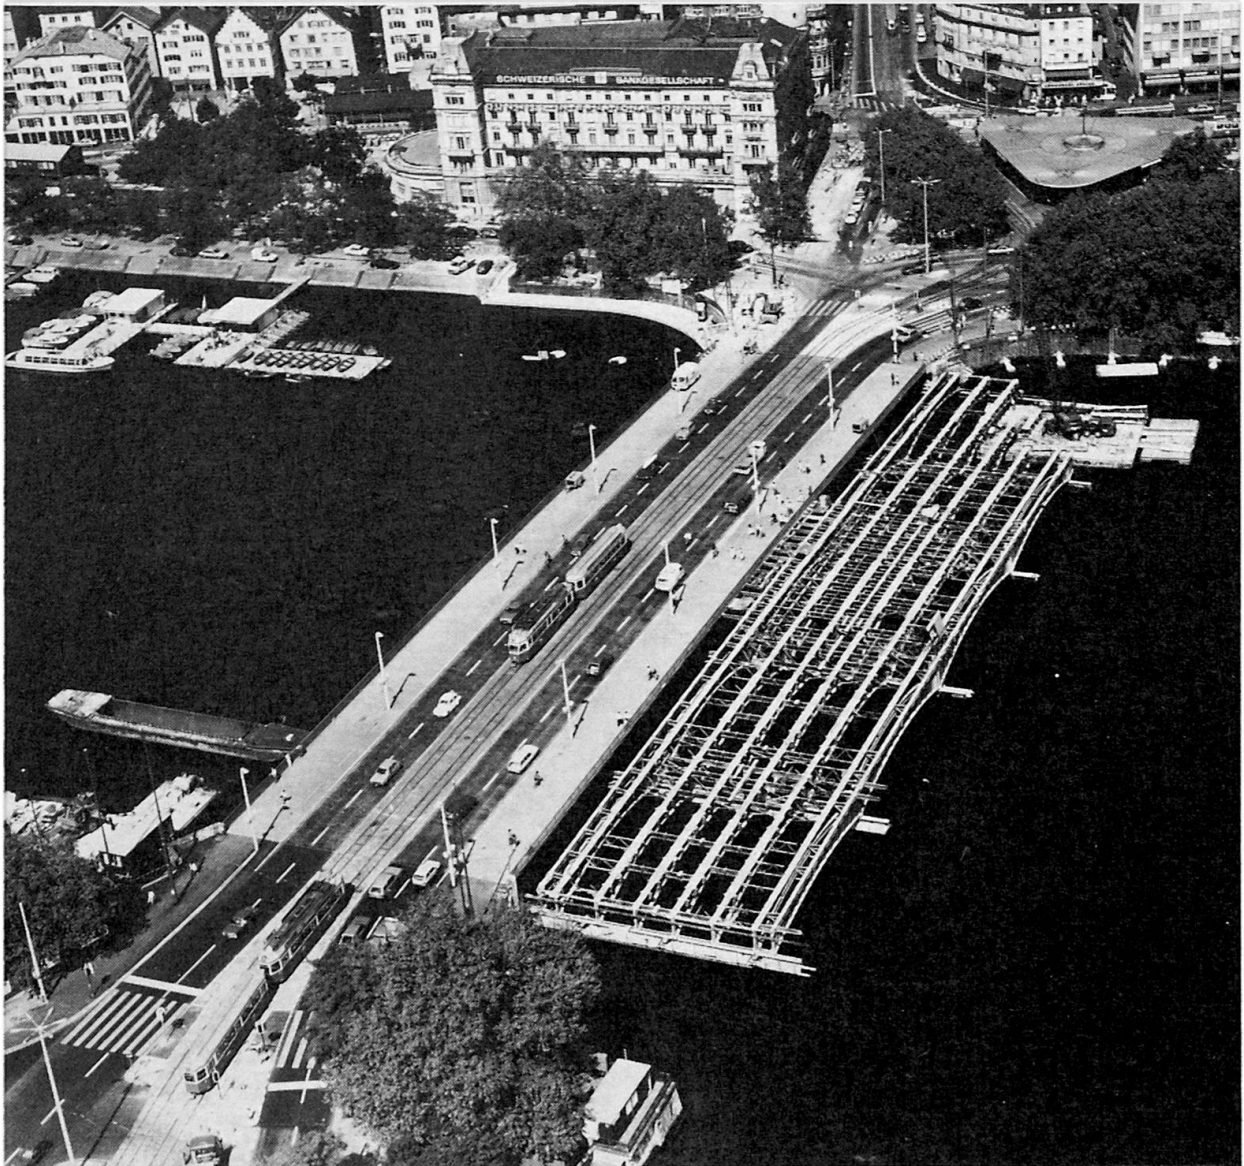
Photo 3: Demolition work on the old bridge (right) after the displacement
