Conserving and Strengthening Prestressed Concrete Structures

Dieter JUNGWIRTH

Dr.-Ing., Dir.
Dyckerhoff & Widmann AG
Munich, Fed. Rep. of Germany

Using the Gänstor prestressed concrete bridge in Ulm as an example for strengthening, the tasks involved are explained and further typical applications are illustrated.

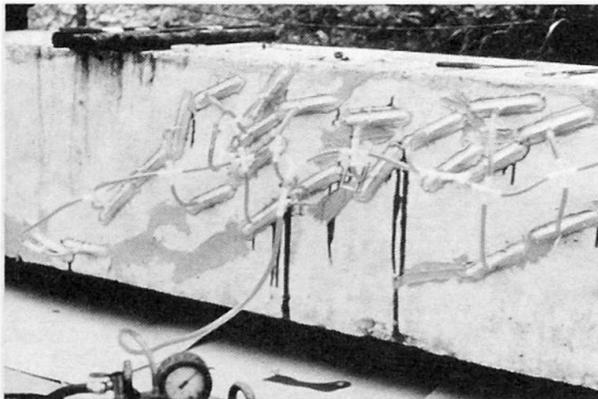
Fig. 18 Example of Crack Grouting

- . sealing, coatings to fill out cracks
- . crack grouting (Fig. 18); particular requirements must be observed when grouting coupling joints
- . repairing corrosion locations
- . vacuum grouting, using specially formulated resins, if need be (Table 2) in wet ducts (high specific weight, water displacing, high consolidation etc.).
