Artikel: Surfacing on an experimental deck panel in a highway

Autor: Price, W.I.J.

SURFACINGS ON AN EXPERIMENTAL DECK PANEL IN A HIGHWAY

W.I.J. PRICE
Head of Bridges Section
Road Research Laboratory

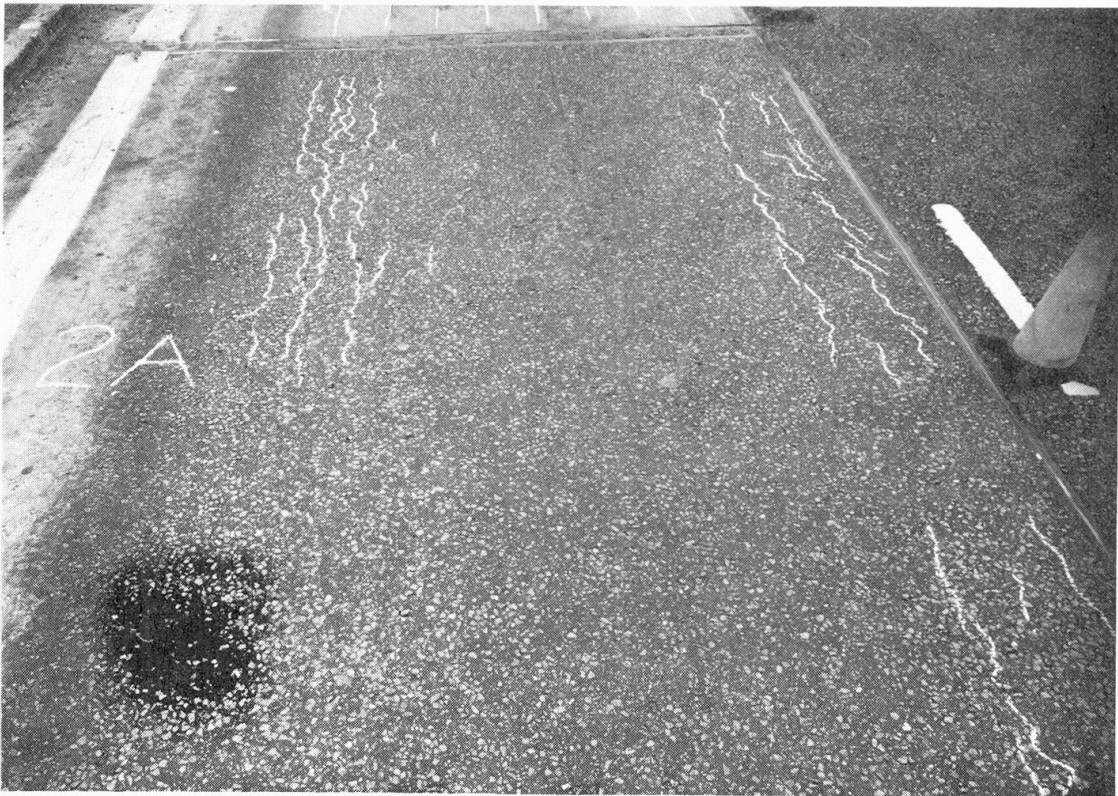
FIG. 4 CRACKING ON ROLLED ASPHALT OVER GRITTED EPOXY RESIN, NOVEMBER, 1967

A very fine crack, a few inches long, appeared during the Spring of 1964 in the nearside wheel track. It remained largely unchanged until the Winter of 1964/5 when the crack lengthened to extend almost over the length of the section by the Spring of 1965. By that time two intermittent cracks had developed in the outer wheel tracks, near the edge of the panel. During 1966, parallel cracks developed in the near side wheel track over the webs of the underlying stiffener, that is 6 in. (15 mm) on either side of the existing crack. By November, 1967, when the photograph in Fig. 4 was taken, a crazed pattern of cracks was established over a 12 in (300 mm) wide strip, with short crack appearing over the line of the next stiffener towards the centre of the panel. When last observed in July, 1968 (Fig. 5) a depression about $\frac{1}{4}$ in (6 mm) deep had formed in the centre of the strip. Cracks along the off-side wheel tracks had become more continuous, but these are not such good indicators of performance, because of the proximity of the edge of the panel. It is significant that cracks have not run over the transverse diaphragm of the deck panel, but have terminated some 9 in (225 mm) from it.

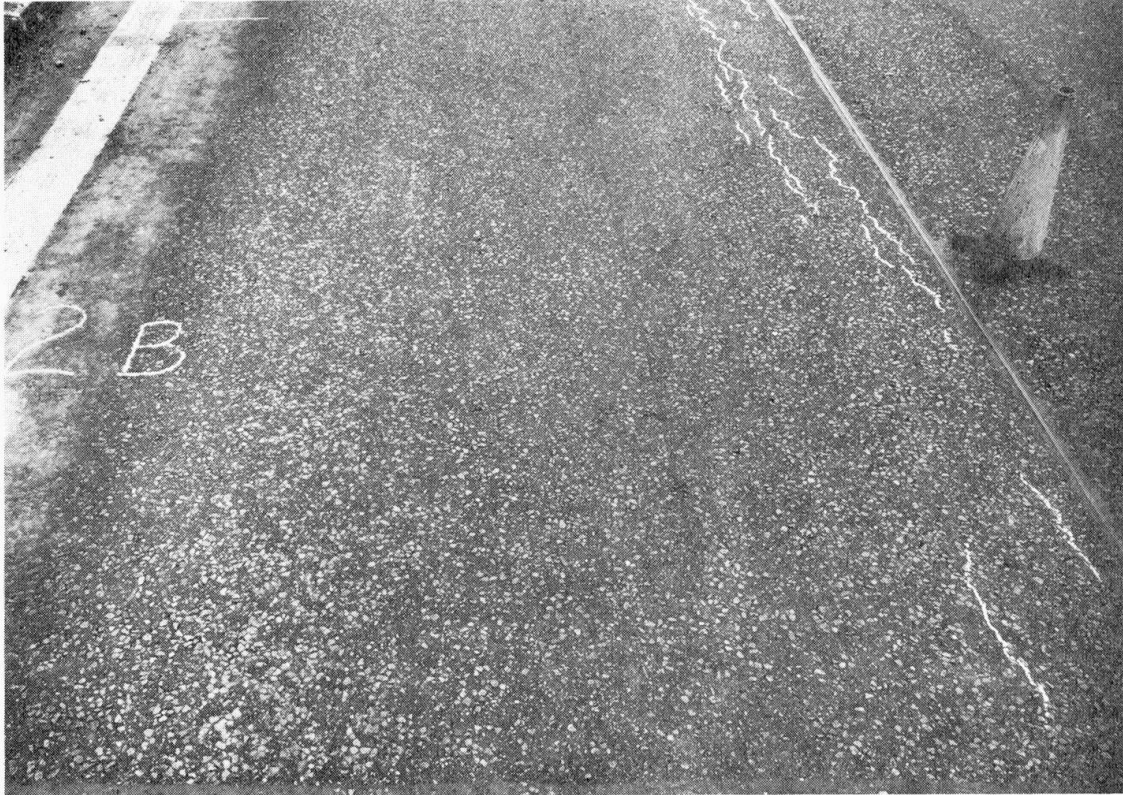
FIG. 6 CRACKING IN ROLLED ASPHALT ON FILLED RUBBER BITUMEN, NOVEMBER, 1967

In February, 1965, short intermittent cracks were noticed in the off-side wheel tracks near the edge of the panel. These cracks occur mid-way between lines of stiffeners. They have continued to develop, until in November, 1967 there were two fairly definite lines of cracks about 12 in. (300 mm) apart with some interconnecting cracks (Fig. 6). Again the cracks disappear within about 9 in (225 mm) of the position of the transverse stiffener.

In terms of freedom from cracking and deformation, this trial confirms that mastic asphalt gives a better performance than rolled asphalt or resin-based systems. The cracking in Section 2B (rolled asphalt on an insulating layer of filled rubber bitumen) could be attributed to proximity to the edge of the panel and so is not to be taken as typical of such a surfacing on orthotropic decks in general. However, the mastic asphalt was subjected to similar conditions of stress and deformation and it has withstood them successfully hitherto.

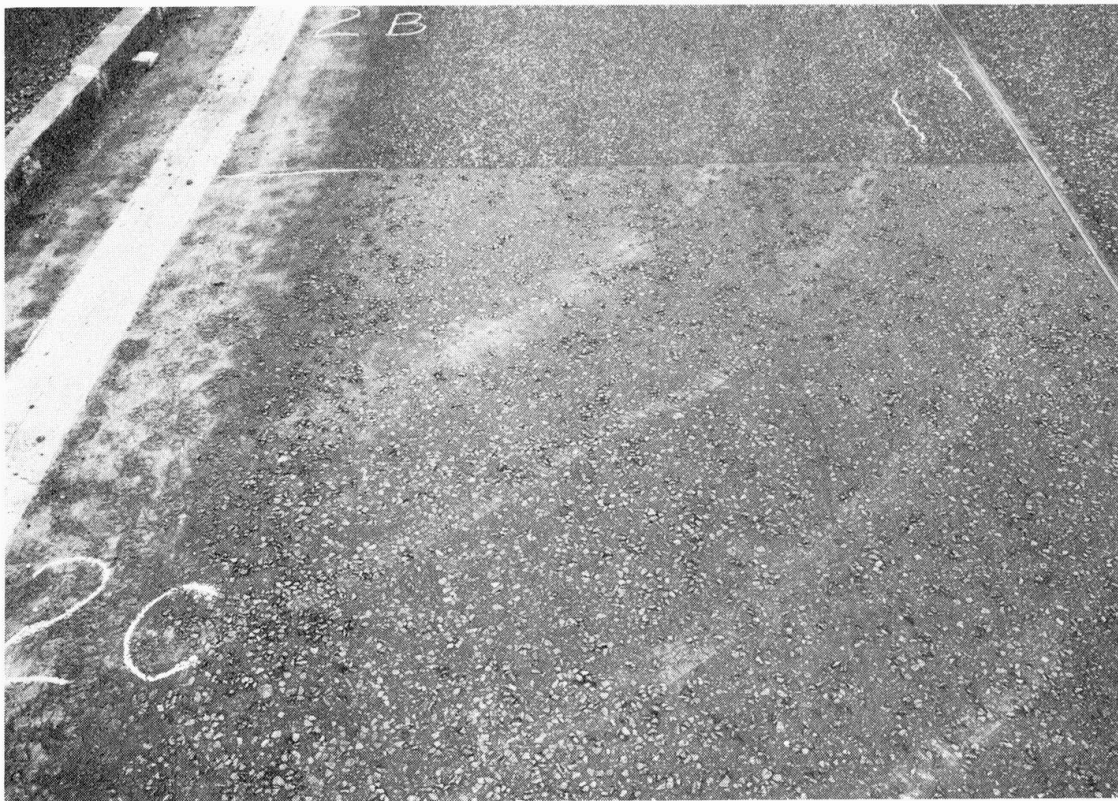
FIG. 7 MASTIC ASPHALT ON FILLED RUBBER BITUMEN, NOVEMBER, 1967

No cracking has so far occurred in this section. In the Spring of 1964, however, a blister about 9 in. to 12 in (225 to 300 mm) dia. appeared near the centre of the section, When it was cut out and repaired

in September, 1964, it was observed that separation had occurred between the layer of filled rubber bitumen and the mastic asphalt wearing course (Fig. 7).

One blister formed in the mastic asphalt on Section 2C, about 6 months after laying. Blister formation is sometimes an unfortunate feature of mastic asphalt surfacing and it seems to be associated with one or several of the following factors: the presence of water or of a volatile liquid, or of trapped air, relatively high temperatures and high temperature gradients. Blisters have not been widespread on steel decks in Britain hitherto, but where they have occurred, they have been satisfactorily treated either by puncturing at the time of formation, resealing the puncture with sealing compound, or by cutting out and replacing the surfacing system.
