**Zeitschrift:** IABSE reports of the working commissions = Rapports des commissions de travail AIPC = IVBH Berichte der Arbeitskommissionen

**Rubrik:** Theme III: Thin wearing surfaces

## INTRODUCTORY REPORT

LABORATORY AND FIELD EVALUATIONS OF THIN WEARING SURFACES  
FOR ORTHOTROPIC STEEL DECK BRIDGES

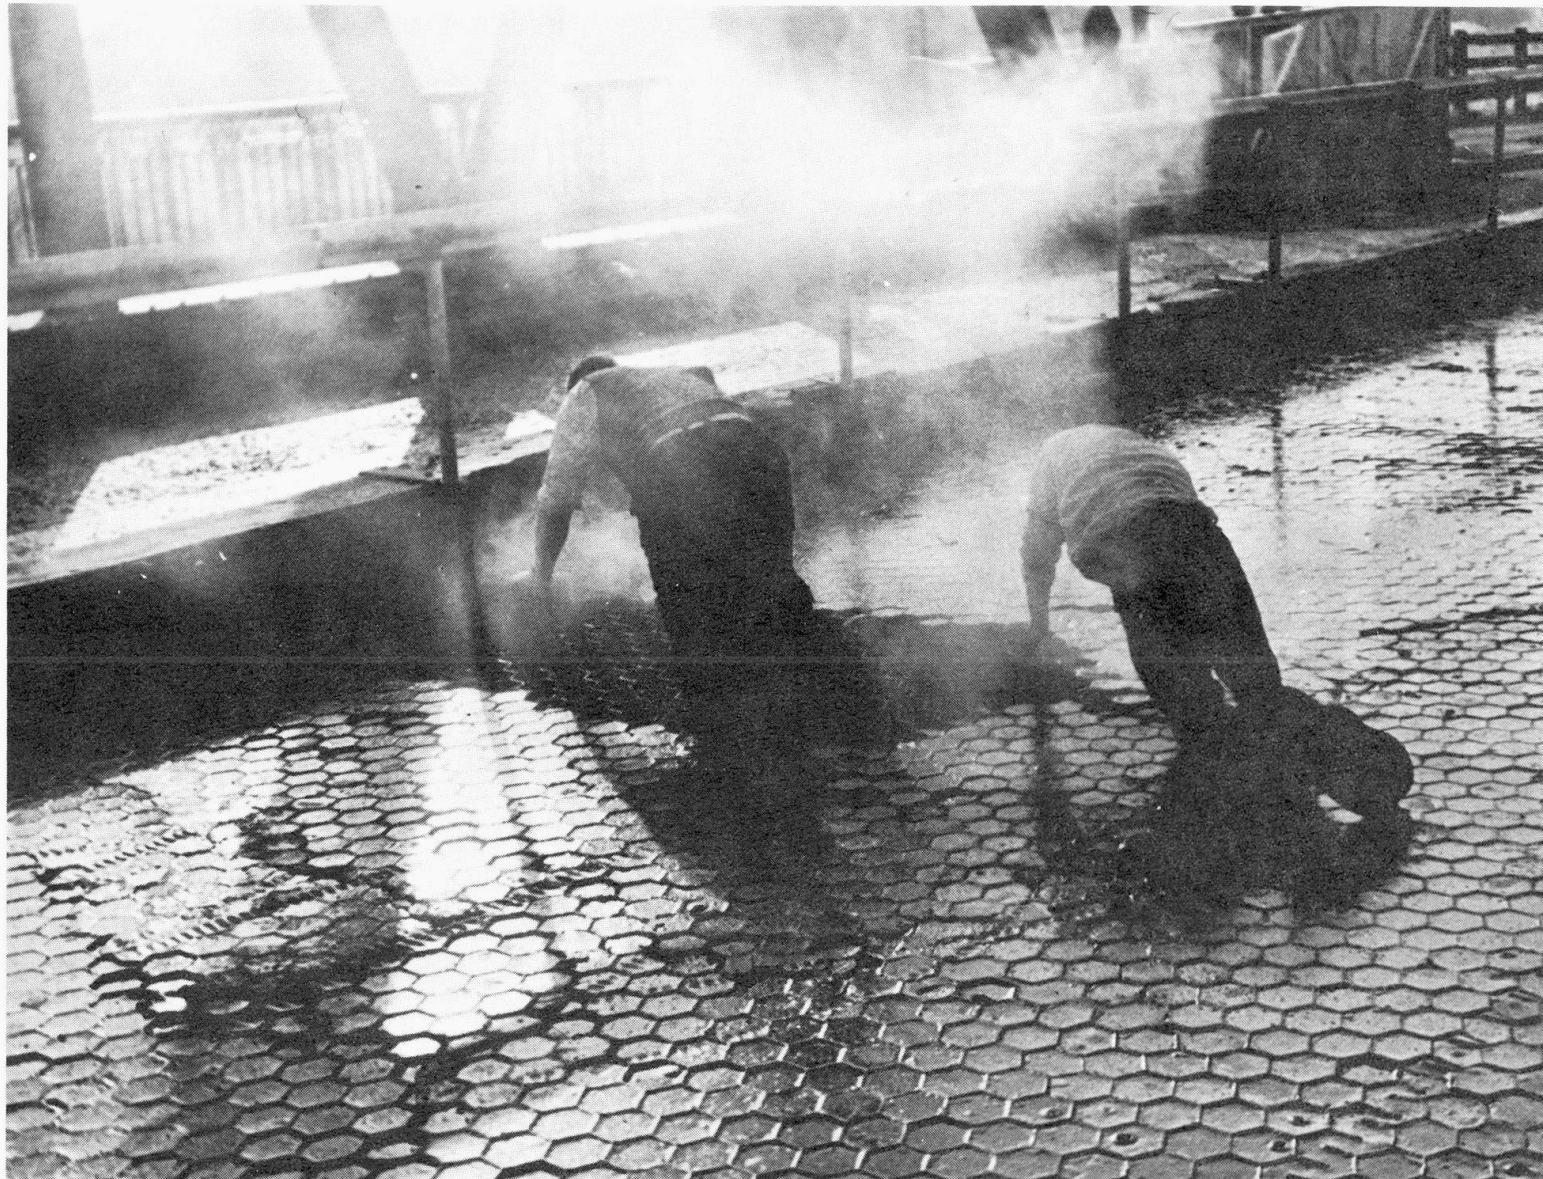
FIG. 1 HEXAGONAL GRID 1 in (25 mm) DEEP, ON AN ALUMINIUM DECK OF A BASCULE BRIDGE IN HULL.
