Zeitschrift: IABSE reports of the working commissions = Rapports des commissions de travail AIPC = IVBH Berichte der Arbeitskommissionen

POST EARTHQUAKE CONSTRUCTION OF GEDİZ

STRUCTURAL REPAIR OF MONUMENTAL MASONRY BUILDINGS

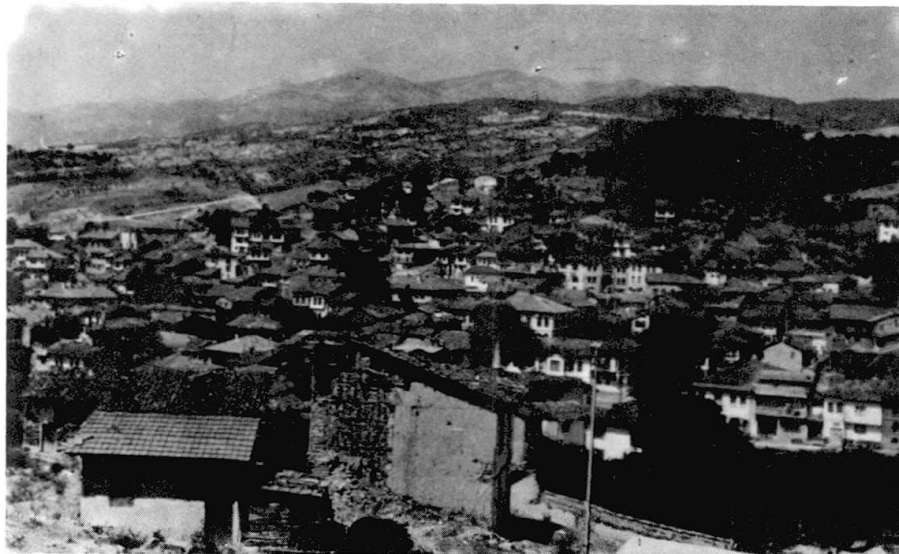
Figure 1. General View of Gediz

The town is located in the valley of a river of the same name, (Figure 1). In the center of the town a peculiar basaltic formation underlying rubble dominates the scenery, (Figures 2 and 3). The river runs through this formation leaving a strip of narrow flat land on each side for suitable habitation. However, this land was densely populated before the earthquake. Although not as densely as this part; the 'castle' (as the basaltic formation is locally called) also provided habitable land to a considerable population.

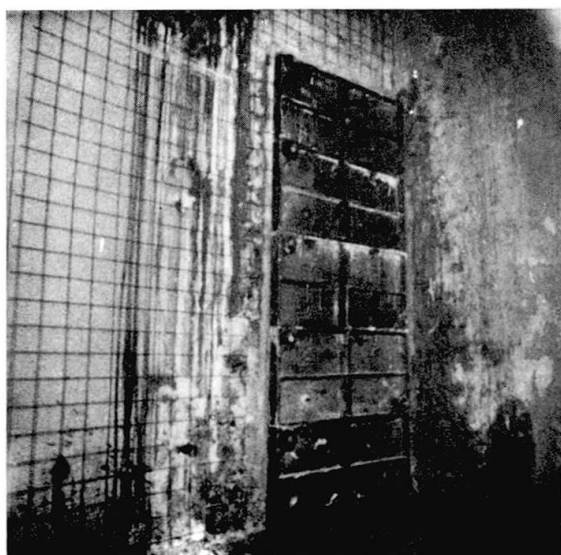
FIG. 1 A

(1) With reinforced concrete plates laid on the two sides of the wall and sewed together by transversal steel passing through the wall. These plates are usually more than 5 cm. thick, it turns out that the original walls become considerably bigger and heavier.
