Artikel: Behaviour of large panel building during the Romania earthquake of March 4, 1977

BEHAVIOUR OF LARGE PANEL BUILDING DURING
THE ROMANIA EARTHQUAKE OF MARCH 4,1977

Miodrag Velkov *

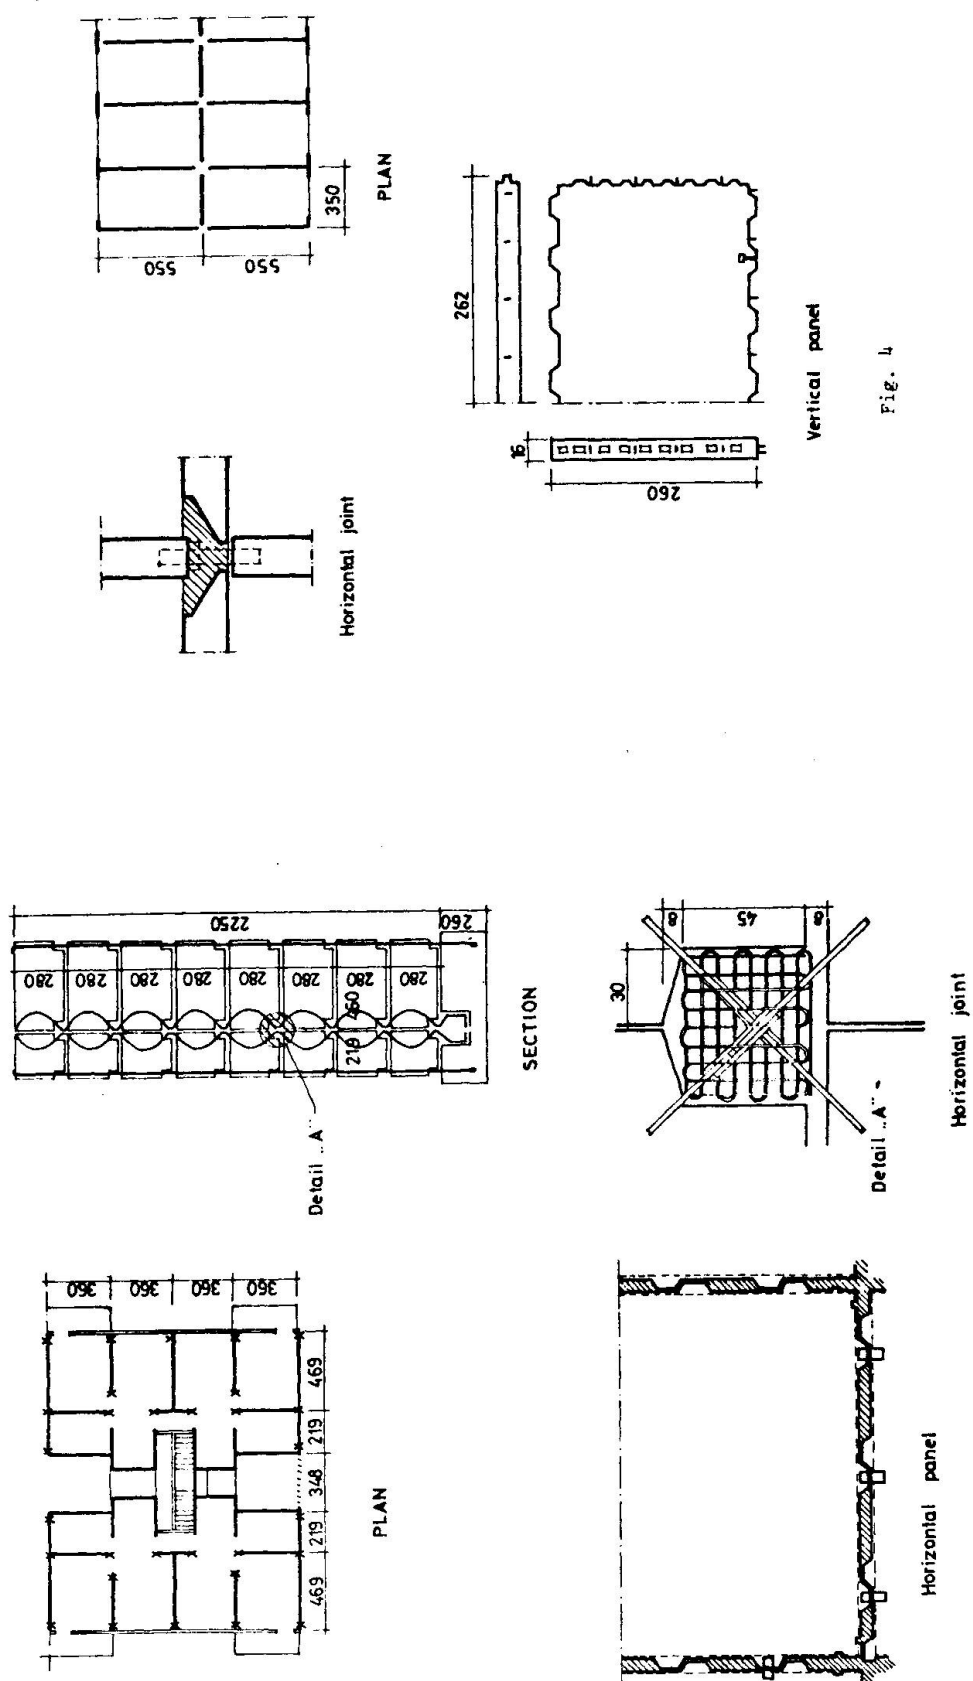
1. Two way system of eight storeys and nonbearing facade panels. These structures have no basement and the prefabricated system is placed on monolith foundations. It was constructed in series some 15 years ago in Bucharest. It is solved with monolythic horizontal and vertical joints, welded reinforcement of vertical panels and monolith slabs above the last precast structure. Fig. 3

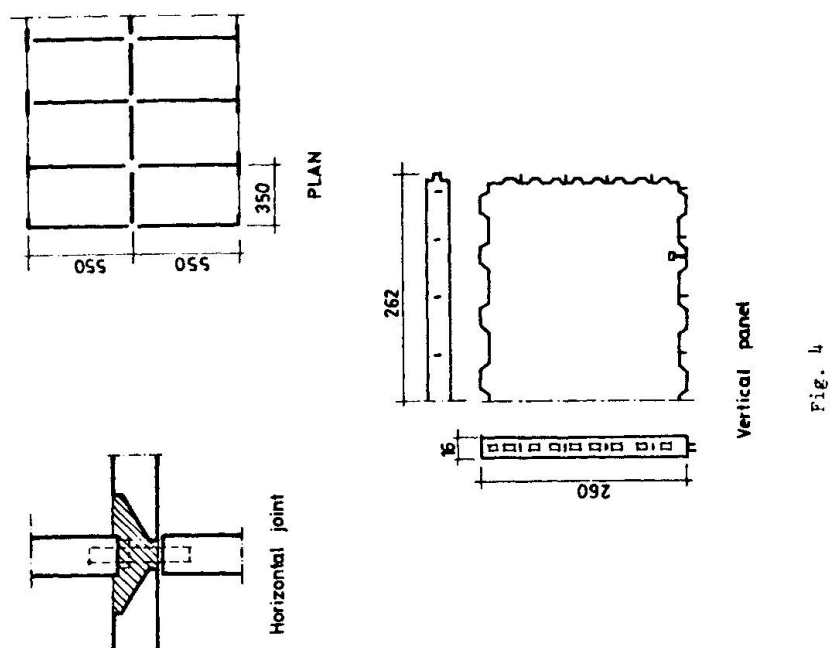
2. Two way system of ten storeys with basement. It is a precast basement structure on monolythic foundations. The system is constructed in series in Bucharest and its use will continue in future, no matter of the recent earthquake event. Fig. 4
