Fatigue Strength of Welded Butt Joints of Multiple Plate Flanges of Beams

K.P. BOLSHAKOV

I.M. SHAFERMAN

SUMMARY

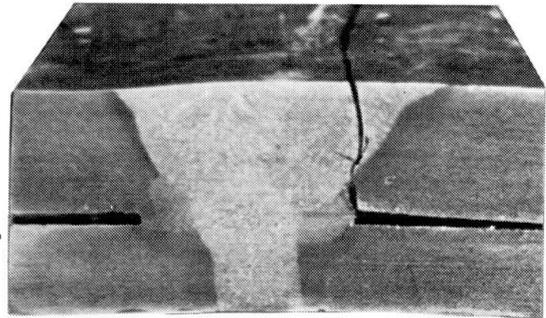
fig.1. Fatigue fracture of double plate beam flange joint

At our Institute attention has been paid for the first time to reliability of such joints during fatigue test of I-beams with double plate flanges. Beam flanges were welded with single - V (butt) joint according to the technology [1-3]. Tests were supposed to be conducted under variable load of 2 million cycles, however fatigue fracture of joints was found to initiate before specified time. In all cases fatigue crack occurred at the point of joint intersection with gap between plates (fig. 1).

Tests have demonstrated that regardless of the technology applied all specimens fracture (in beams as well - fig. 1) occurred at the point of joint intersection with gap between plates. Fatigue strength limit in series 2 and 4 (fig. 2,d) appeared to be the lowest and approximately the same at $\rho = 0,40$; fatigue strength limit in series 3 is slightly higher comparing with series 2 and 4, but lower in comparison with base metal (series 1). Tests conducted at $\rho = 0,125$ support the conclusions relative to series 2 and 3 (fig. 2c). The value of fatigue strength limit given in

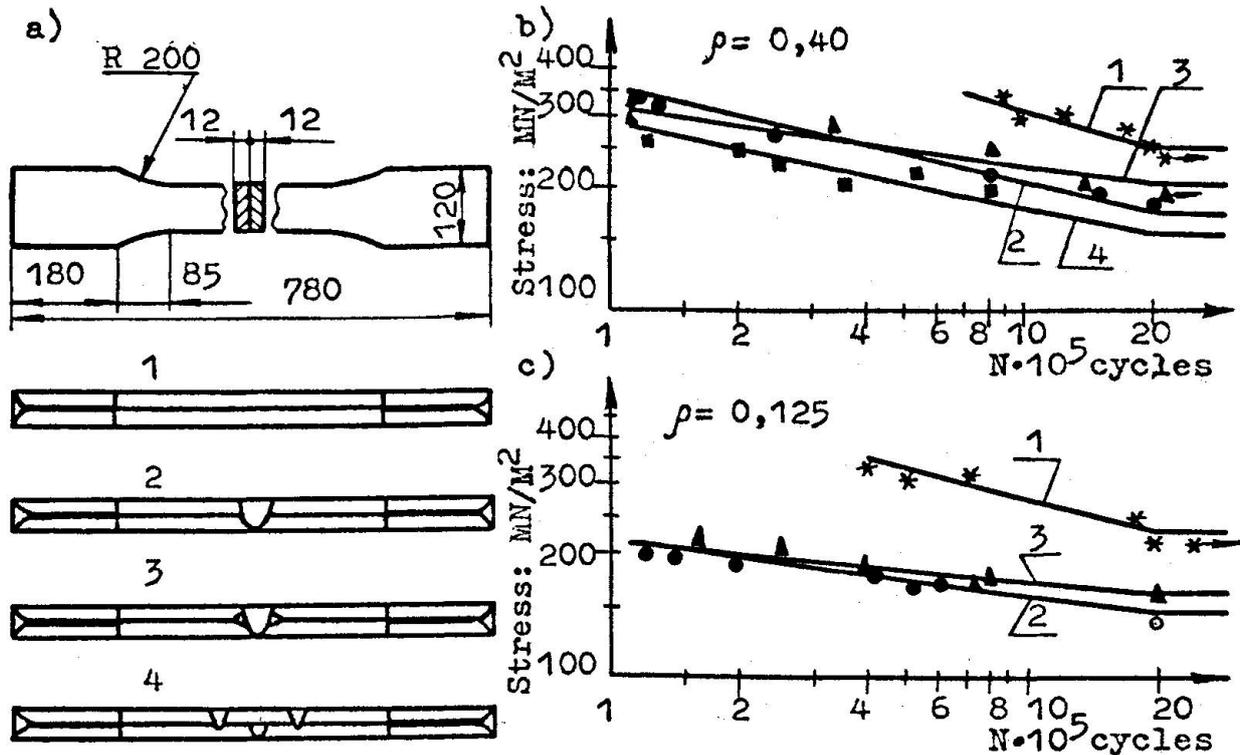
fig. 2. The curves of specimens fatigue strength (O - data from ref [2])

To estimate technologies applied we have conducted four series tests of double plate specimens on fatigue strength limit at variable tension (fig.2a); series 1 - specimens of base metal; series 2 - specimens with single - V (butt) joints done according to the technology applied for one plate flanges; series 3 - specimens with single - V (butt joint) done according to the technology [1-3]; series 4 - specimens with insertion in one of plates and three separate single - V (butt) joints done according to the technology [4]. In all specimens the gap between plates was welded along end block contours to provide coincidence of deformation of pack plates. After welding single - V (butt) joints were trimmed flush with base metal surface.

Series 1-3 were tested at two values of cycles asymmetry: $\rho = 0,125$ and $\rho = 0,40$; while series 4 - at $\rho = 0,40$. Crack being detected at one of the plates, tests were stopped. Obtained results were processed by the method of mathematical statistics. The fatigue strength curves were plotted in logarithmic coordinates (fig.2b,c).

reference [2] for double V butt joint is shown here too. Fatigue strength limit of such joint obtained from "weak regime" tests ($\rho = 0,18$) appeared to be similar to fatigue strength limit at $\rho = 0,125$ in series 2. Therefore recommendations [2] haven't provided significant advantages.

Higher fatigue strength of series 3 (fig. 2) may be explained as follows. Joint circumjacent zone includes five sections of thermic influence zone (fig. 6). The sections hardness decreases as it is moved away from joint axis at HRB = 86 (in the first section) up to HRB = 68 (in the fifth section) These zones plasticity varies inversely with hardness. In series 2 concentrator is located in the zone of high hardness, but less elasticity (fig. 6a). In series 3 - in the zone of less hardness, but higher elasticity (fig. 6b). These factors determine the difference in connections behaviour under fatigue loading.

ge building results in fusion of butt joints metal with lower pack plate. Stress concentrators in connections of this series just as in series 2 are located in the zone of high hardness. As a result developed fatigue strength curves for this series appeared to be close one (fig. 2b) to another.

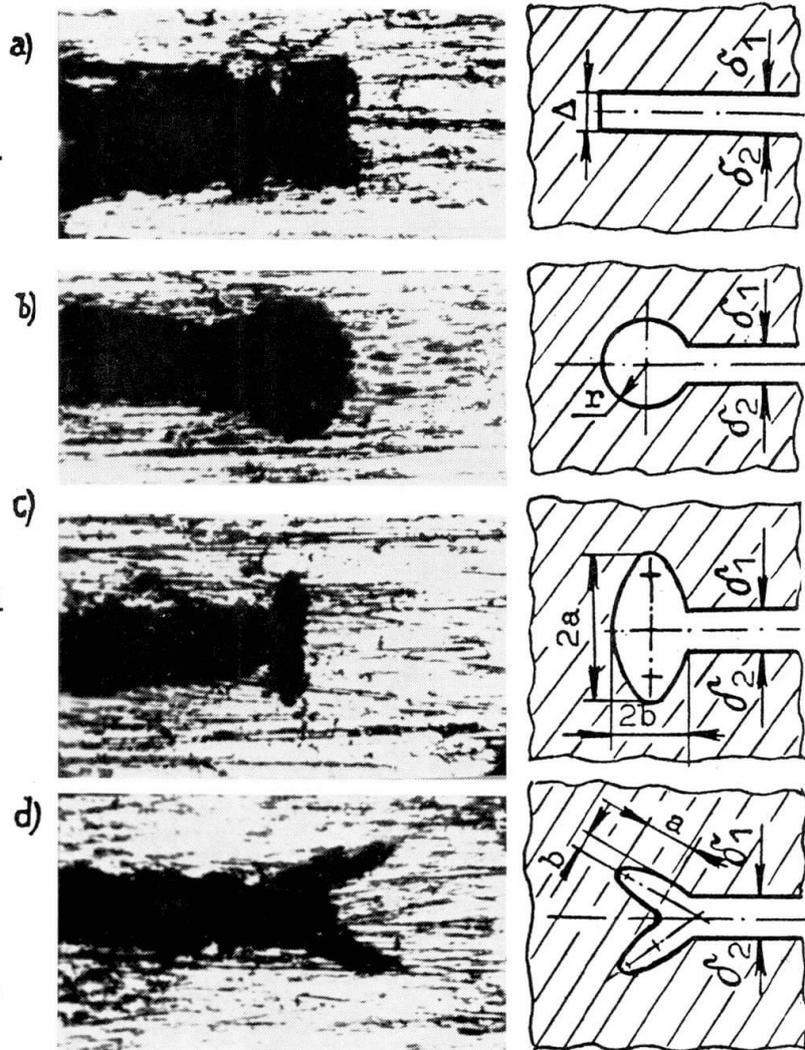
fig. 3. Zones of joint intersection with the gap

To find out the conditions of stress concentration occurrence the contours of points of joint intersection with gap between plates were investigated by means of microscope. It has been determined that in most cases the contours are close to rectangular (fig. 3a). However in a number of cases distortions (defects) were observed such as spherical expansion with radius r at $\Delta < r \ll \delta_1, \delta_2$ (fig. 3b); sharp cross expansion of a specific size - $2a_1 > 2b$, $b \approx \Delta < 2a \ll \delta_1, \delta_2$ and section form similar to elliptical (fig. 3c); branching from intersection point, section shape being close to elliptical with similar sizes ratio (fig. 3d). The mentioned defects have been induced by slag inclusions along the line of joint - gap intersection.

After geometrical approximation of points of joint intersection with gap (fig.3) it has been decided that mathematical problem of elasticity theory on extension of plane with various apertures is equivalent to the problem of elongation of welded butt joints of multiple plate packs.

Rectangular aperture of $a/\Delta = 2+2,5$ (sides ratio, fig 4a) was considered for fig.3a. In such aperture mutual influence of cross sides might be neglected within 3-4% [7]. It was found out that the value of theoretical coefficient of concentration K_t depends on radius r of aperture angle rounding off and is approximately identical for all long apertures, when ratio r/Δ is the same. In chart 1 it is obvious that value $K_t = 2,15$ even for the case when $r/\Delta = 0,5$. Such concentration coefficient will be evidently minimum for real connections.

The case of fig. 3 is interpolated as extension of plane with round aperture (fig. 4b) when $K_t = 3$ [6].

of ellipse large axis to extension direction [6] Maximum meaning of K_t will be at the ends of large axis when $\alpha = \pi/2$ and corresponds to defects shown in fig. 3b. Such defects existing, coefficient of concentration [8] might be very high (fig. 4c). In all considered cases, where defects resulted from slag inclusions (fig. 3, b, c, d), the gap should not affect concentration level as it is situated in the zone of least stresses.

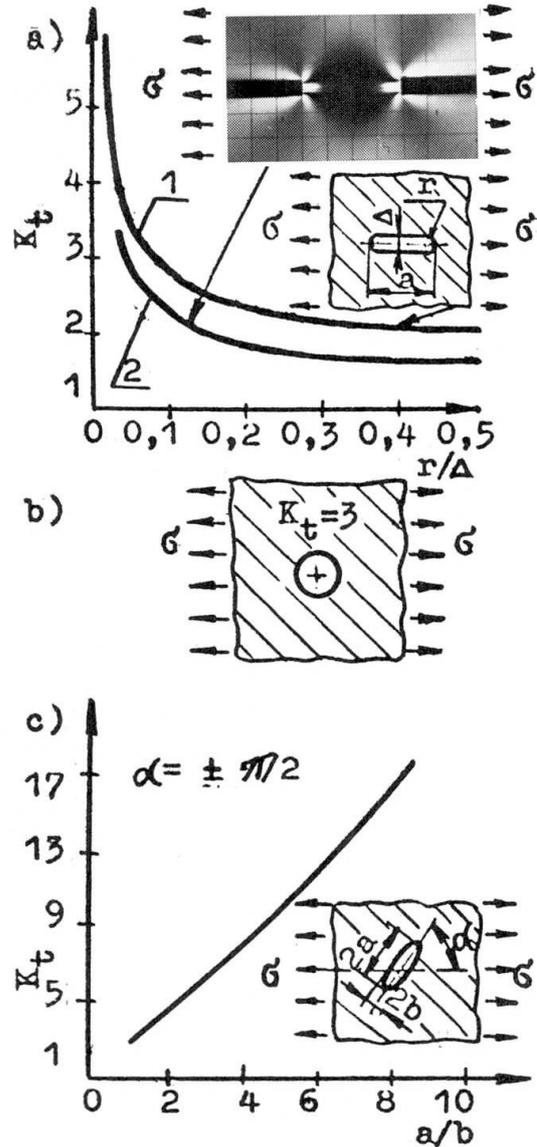
fig. 4. Theoretical concentration coefficients

The results of analytical solution are qualitatively confirmed by investigations conducted by photoelasticity method (chart 2). In practice there appears to be more cases when $r/\Delta < 0,5$. Charts 1 and 2 show that with r/Δ decrease the coefficient of concentration sharply increases.

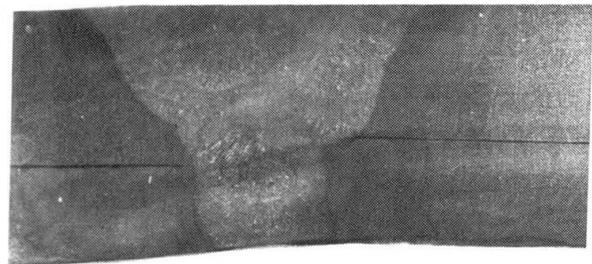
fig. 5. Fatigue fracture with displacement of plates in joint

Displacement of jointing pack plates is likely to take place when assembling butt joints and in the process of welding (fig. 5). In this case eccentricity of load occurs this being the cause of additional bending stress resulting in increase of total stress level. Thus displacement of 15% and 32% increases stress level by 1,34 and 1,84 [9]. Similar increase of total stress level occurs where there is residual angle deformations of connected plates [2]. Accordingly stress concentrators influence becomes larger.

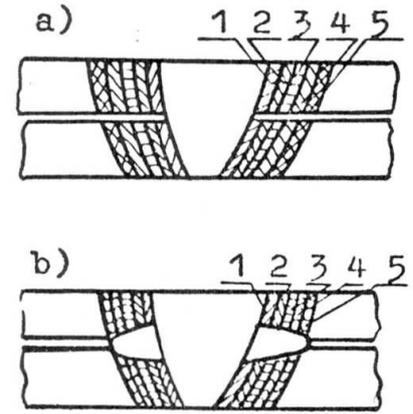
fig. 6. Concentrators location in joint circumjacent zone

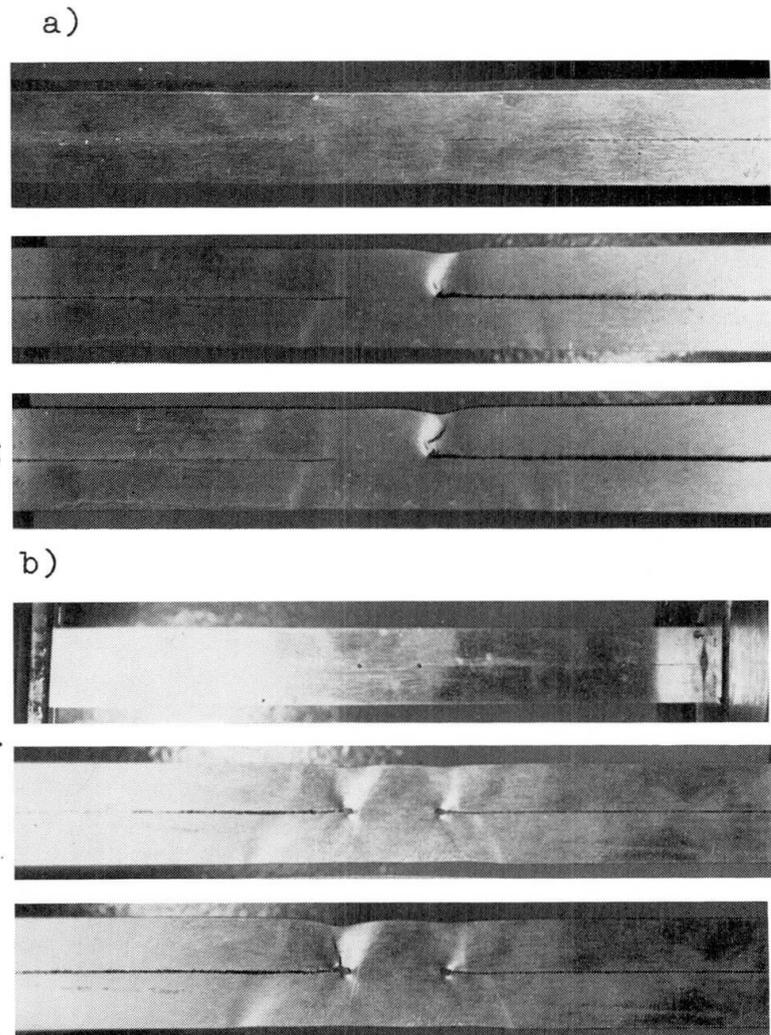
fig. 7. Static tension fracture

To determine the fracture mechanism of welded butt joint of multiple plate pack tests have been carried out on static tension of specimens possessing higher efficient coefficient of concentration B and specimens with artificial defects - apertures of 1,5 mm diameter simulating defect shown in fig. 3b. In both cases fracture initiated from the point of joint intersection with the gap (fig.7).
