Zeitschrift: IABSE reports = Rapports AIPC = IVBH Berichte
Band: 37 (1982)

Artikel: Fatigue of nodal joints and box-section members in a bridge truss
Autor: Tajima, Jiro / Miki, Chitashi / Asama, Tatsuo
DOI: <https://doi.org/10.5169/seals-28929>

Fatigue of Nodal Joints and Box-Section Members in a Bridge Truss

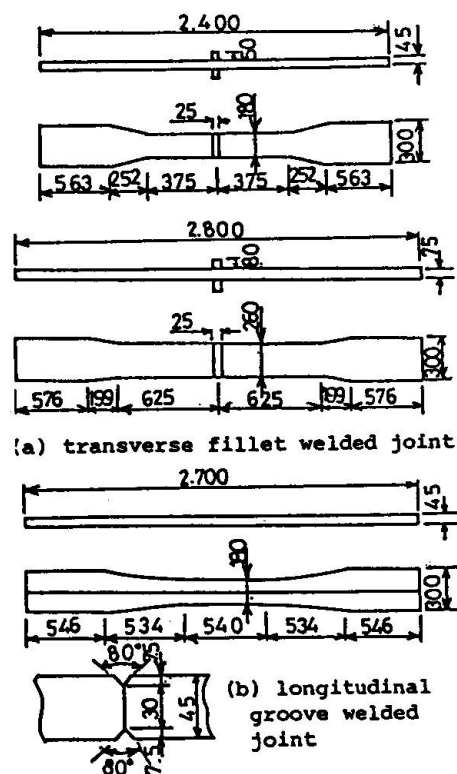
Fig. 1 Joint Specimen

The mechanical properties of the steels used for joint specimens are shown in Table 1. Fig. 1 shows the configurations and dimensions of the specimens. The non-loadcarrying cruciform fillet welded joint (a) simulates the stress condition at the joint of a diaphragm attached to a chord member of a truss. Welding was done manually using an electrode exclusively for fillet welds

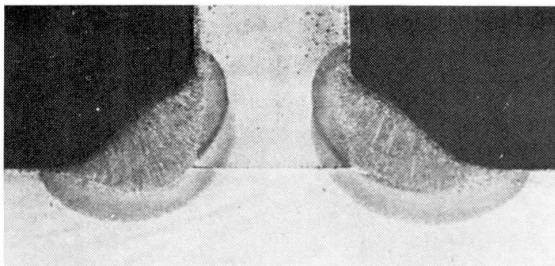
Fig. 2 Shapes of Fillet Welds

said to produce a regular bead shape as shown in Fig. 2. Leg length of fillet welds for 45mm thickness specimens and 75mm thickness specimens are 10mm (two paths) and 13mm (three paths) respectively. Partially penetrated longitudinal groove weld joint simulate for corner welds of truss members with box section. Welding was done using the submerged arc process.

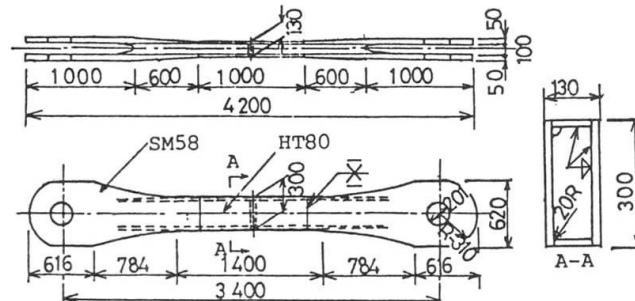
Fig. 3 Box Section Specimen

The mechanical properties of the steels used for specimens of box section are shown in Table 1. Fig. 3 shows the configurations and dimensions of the specimens. Type BA has a diaphragm used SM41 steel at the center of the specimen, and other types have no diaphragm. Welding of the diaphragm was done manually using the same electrode used for joint specimens mentioned above. Corner Welding of these specimens were conducted with automatic welding. Kinds of welding are shown in Table 2. Three types, BB, BD, BF, were with partially penetrated groove welds and one type, BF, was with fillet welds.

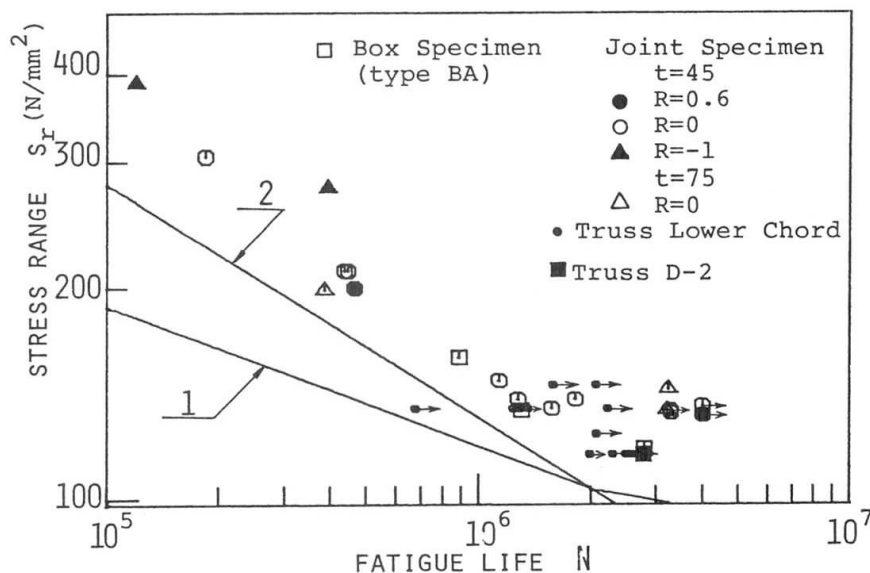
Fig. 6 Results of Fatigue Tests on Transverse Fillet Welds

Fig. 6 shows the results of fatigue tests on cruciform joint specimens, box-section specimens with diaphragm and panel point structures concerning about transverse fillet welds. Twelve cruciform joint specimens of $t = 45\text{mm}$ and three cruciform joint specimens of $t = 75\text{mm}$

In Fig. 6, results of tests on panel point structures are also plotted. In these tests only one fatigue crack was occurred at the toe of fillet welds of diaphragms arranged in the chord members of D type specimen. Line 1 in Fig. 6 shows the former design allowable stress [3] for this type of joint under pulsating stress for the Honshu-Shikoku bridges. All of the test results satisfy the requirement of this criterion. However, the slope of line 1 is too gentle in comparison with the test results. Line 2 in Fig. 6 shows the current design allowable stress for this type of joint. This curve is revised based on the fatigue test results and the analysis of fatigue life by fracture mechanics concept.

Three specimens of box-section with diaphragm (Type BA) were tested. In Fig. 6 the results of these tests are plotted. Fig. 8 shows fracture surface of BA-1 specimen. With these three specimens, beach mark tests were performed. Fatigue cracks initiated at the corner of fillet welds of diaphragms at the early period in the life.

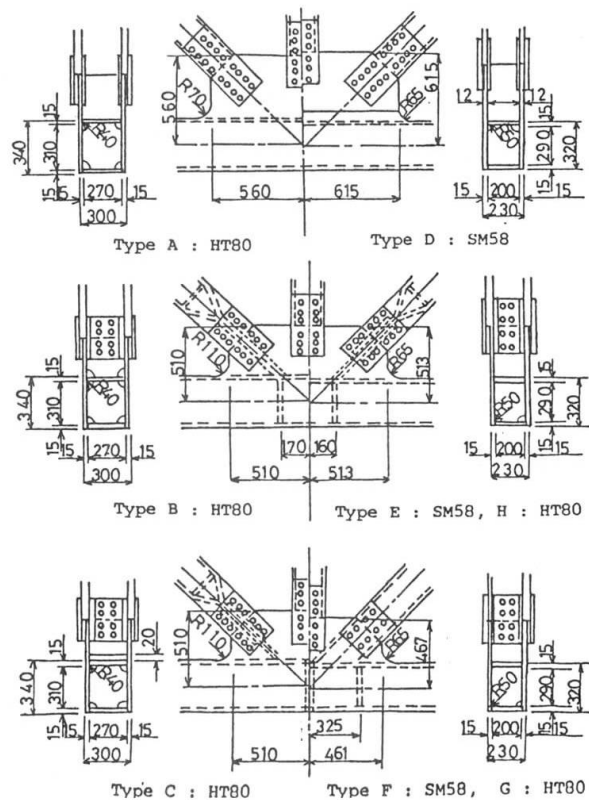
Fig. 5 Truss Panel Point Structures

The mechanical Properties of the steels used for truss panel point structures are shown in Table 1. Fatigue tests were performed using the loading apparatus shown in Fig. 4. The hatched portion in the figure represents a specimen. Fig. 5 gives details of the vicinities of panel points of eight varieties of test specimens. The major points of difference between the each types lie in the methods of connecting the diagonal members, the numbers of diaphragms and fillet radii of gusset plates. Corner welds of chord members were made by manual welding for the specimens A, B and C and by the submerged-arc welding for D, E, F, and G. Kinds of Corner welds are single bevel groove welds, and bevel angle is 45°, depth is 7.5mm for type A, B and C, 8mm for type D-G.

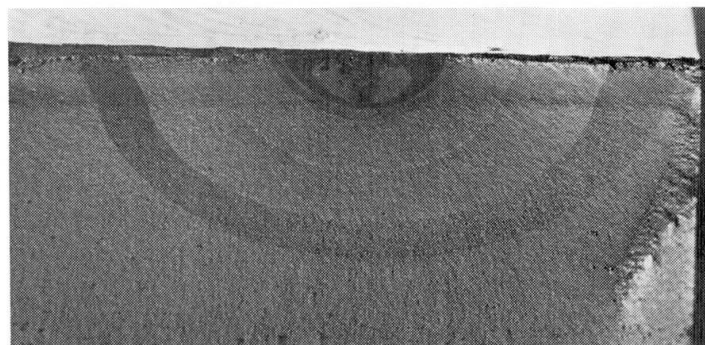
Fig. 7 Fracture Surface of Cruciform Joints

With one joint specimen of $t = 45\text{mm}$, two stage multi-stress amplitude test was performed to form the beach marks on the fracture surface (Beach mark test). Fig. 7 shows the result of beach mark test. In this figure, five beach marks can be counted, and numbers of loading block for this specimen are also five. So it was found that the fatigue crack had initiated at the first stress block (prior to 0.18 N with N_f being failure life) from the concave part at the toe of fillet weld.

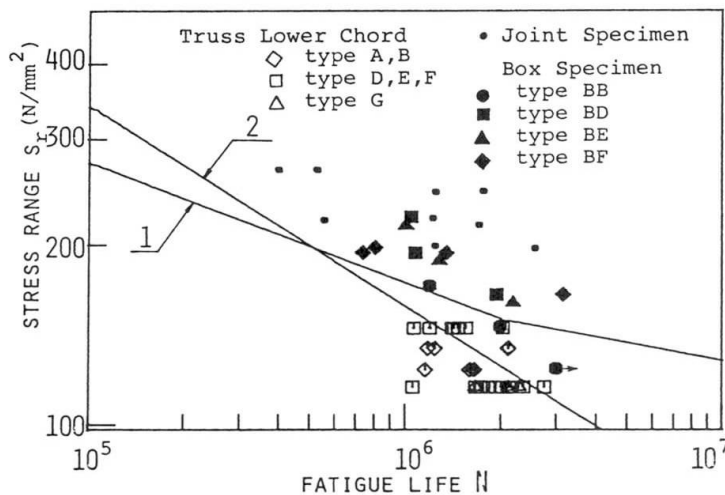
Fig. 9 Results of Fatigue Tests on Longitudinal Welds

Fig. 9 indicates the results of fatigue tests on longitudinal weld joints, box section specimens and panel point structures concerning about longitudinal welds. With longitudinal weld joints, initiation points of fatigue cracks in six out of the entire nine test specimens were blowholes or pores existing at roots of welds, the size being 0.6 to 1.2mm in diameter. Other initiation points were a small pit at bead surface, grinder scratch at surface of base metal and defect at part of base metal repaired by welding. Residual tensile stresses of approximately 340 N/mm² and 250 N/mm² were measured at joints of an unloaded specimen and an after fatigue test specimen, respectively.

In Fig. 9, line 1 shows the former design allowable stress and line 2 shows the current design allowable stress for this type of joints under pulsating stress. Most of experimental values of panel point structure specimens are below the former design allowable stress. Furthermore, about half of experimental values of panel point structure specimens are below the current design allowable stress. The current design allowable stress is established based on the fatigue test results of box section specimens and the analysis using fracture mechanics concept. From that analysis, weld defects as blowholes exceeding 1.5mm in diameter of inscribed circle must be avoided to remain therein.

With box section specimens, each three test specimens of type BB, BD and BE, and four of type BF were tested. Results of fatigue tests on these specimens are shown in Fig. 9. The locations of fatigue crack initiation in each type of specimens are as follows.

All specimens except C-1 and C-2, fatigue tests were terminated by growth of fatigue cracks initiated at corner welds of bottom chord members. The relation between nominal stress range and number of cycles of stressing the fatigue crack was discovered at a bottom chord is shown in Fig. 9. In the type A and B specimens fatigue cracks at corner welds were initiated from irregularities at the roots of welds due to nonfusion or lack of penetration. The number of fatigue cracks initiated in the four specimens of type A and B was 13, with surface length from 9mm to 310mm. In the type D, E, F, and G specimens most of fatigue cracks were initiated from blowholes existing at the roots of welds. Fig. 13 shows one example of fracture surface of corner welds. In E-2 and G-1 each one crack occurred at the corner of butt joint of lower chord member, where some small pits existed near the surfaces of plates. The number of fatigue cracks initiated in the eight specimens of type D, E, F and G was 30, with

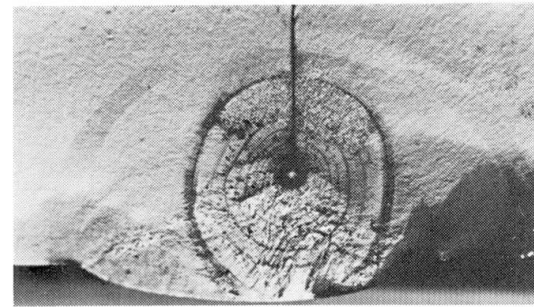
Fig. 10 Fracture Surface of Longitudinal Weld Joint

Beach mark tests were performed with three joints specimens. Fig. 10 shows the fracture surface with beach marks. Fatigue crack had been initiated from the wall of a blowhole at the root of weld. In this fracture surface, thirty beach marks can be counted and numbers of loading block are thirty four so the fatigue crack of this specimen had started growing before 0.12 N_f cycles of loading.

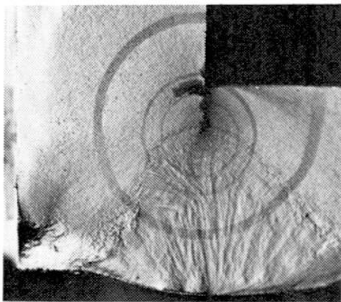
Fig. 11 Fracture Surface of BB-1 Specimen

- BB type : blowhole (2.5 x 1.8, 4.1 x 3.4mm) at the root of welds.
- BD type : bead surface, blowhole (3.9 x 3.6mm) at the root of welds and imperfection of weld metal.
- BE type : weld root (no blowhole) and blowhole (1.1 x 0.5, 1.4 x 0.7mm) at the root of welds.
- BF type : slag inclusions at the end of butt joint (2 specimens) and slag inclusions at the toe of fillet weld and root.

Fig. 11 and 12 shows the fracture surface of BB-1 and BE-2 specimens.
