Fatigue of Nodal Joints and Box-Section Members in a Bridge Truss

JIRO TAJIMA

This paper describes tests to verify the fatigue strength of welded joints in quenched and tempered high strength steel. Typical welded joints from a bridge truss were tested in a 400 t maximum capacity fatigue testing machine.

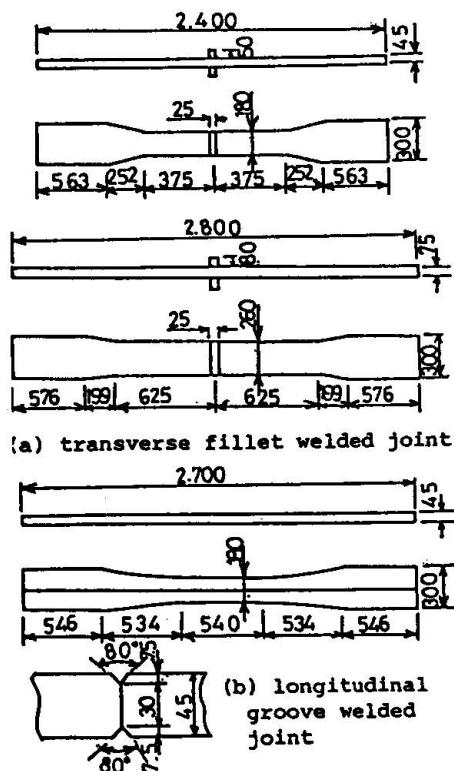
Fig. 1 Joint Specimen

The mechanical properties of the steels used for joint specimens are shown in Table 1. Fig. 1 shows the configurations and dimensions of the specimens. The non-loadcarrying cruciform fillet welded joint (a) simulates the stress condition at the joint of a diaphragm attached to a chord member of a truss. Welding was done manually using an electrode exclusively for fillet welds

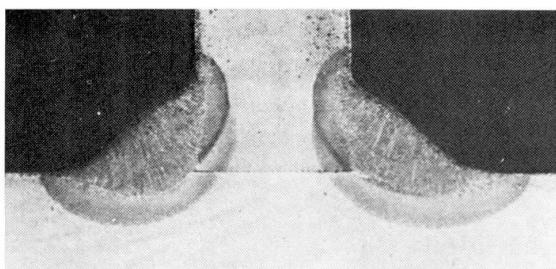
Fig. 2 Shapes of Fillet Welds

said to produce a regular bead shape as shown in Fig. 2. Leg length of fillet welds for 45mm thickness specimens and 75mm thickness specimens are 10mm (two paths) and 13mm (three paths) respectively. Partially penetrated longitudinal groove weld joint simulate for corner welds of truss members with box section. Welding was done using the submerged arc process.

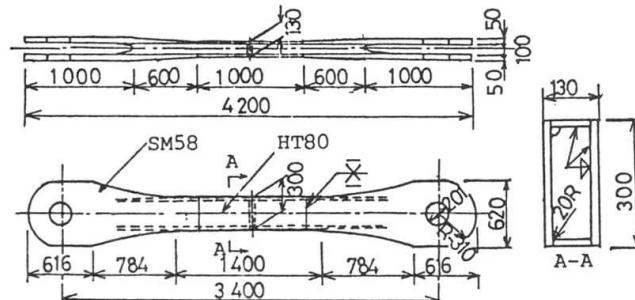
Fig. 3 Box Section Specimen

The mechanical properties of the steels used for specimens of box section are shown in Table 1. Fig. 3 shows the configurations and dimensions of the specimens. Type BA has a diaphragm used SM41 steel at the center of the specimen, and other types have no diaphragm. Welding of the diaphragm was done manually using the same electrode used for joint specimens mentioned above. Corner Welding of these specimens were conducted with automatic welding. Kinds of welding are shown in Table 2. Three types, BB, BD, BE, were with partially penetrated groove welds and one type, BF, was with fillet welds.

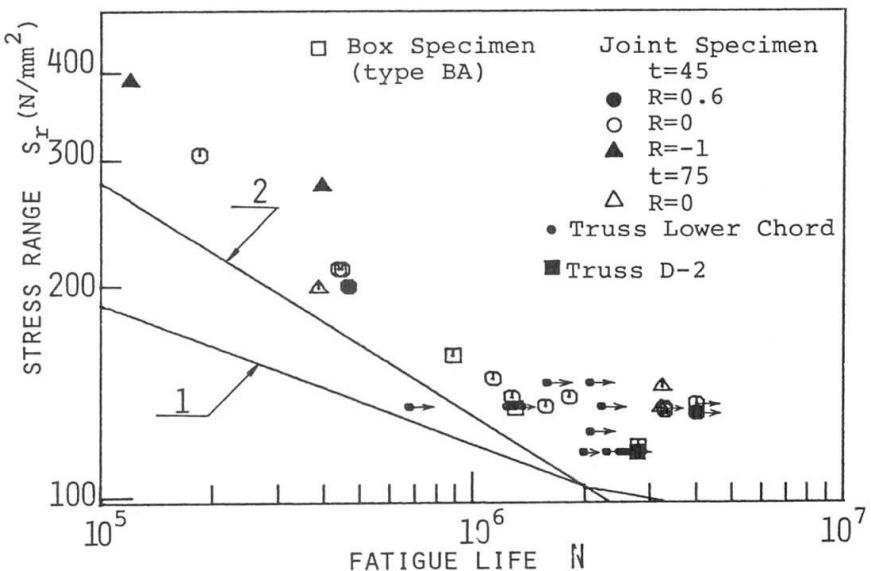
Fig. 6 Results of Fatigue Tests on Transverse Fillet Welds

Fig. 6 shows the results of fatigue tests on cruciform joint specimens, box-section specimens with diaphragm and panel point structures concerning about transverse fillet welds. Twelve cruciform joint specimens of $t = 45\text{mm}$ and three cruciform joint specimens of $t = 75\text{mm}$

were tested. With joint specimens of $t = 45\text{mm}$, fatigue tests were performed with stress ratios (R) at 0.6, 0 and -1. The influences of differences of mean stress on fatigue strength are not very prominent. Differences in fatigue strengths depending on differences in plate thickness of base metals were also small. Fatigue cracks were initiated at the toe of first path fillet welds in most specimens, but in some specimens cracks were initiated at the toe of second path welds.

Three specimens of box-section with diaphragm (Type BA) were tested. In Fig. 6 the results of these tests are plotted. Fig. 8 shows fracture surface of BA-1 specimen. With these three specimens, beach mark tests were performed. Fatigue cracks initiated at the corner of fillet welds of diaphragms at the early period in the life.

In Fig. 6, results of tests on panel point structures are also plotted. In these tests only one fatigue crack was occurred at the toe of fillet welds of diaphragms arranged in the chord members of D type specimen. Line 1 in Fig. 6 shows the former design allowable stress [3] for this type of joint under pulsating stress for the Honshu-Shikoku bridges. All of the test results satisfy the requirement of this criterion. However, the slope of line 1 is too gentle in comparison with the test results. Line 2 in Fig. 6 shows the current design allowable stress for this type of joint. This curve is revised based on the fatigue test results and the analysis of fatigue life by fracture mechanics concept.

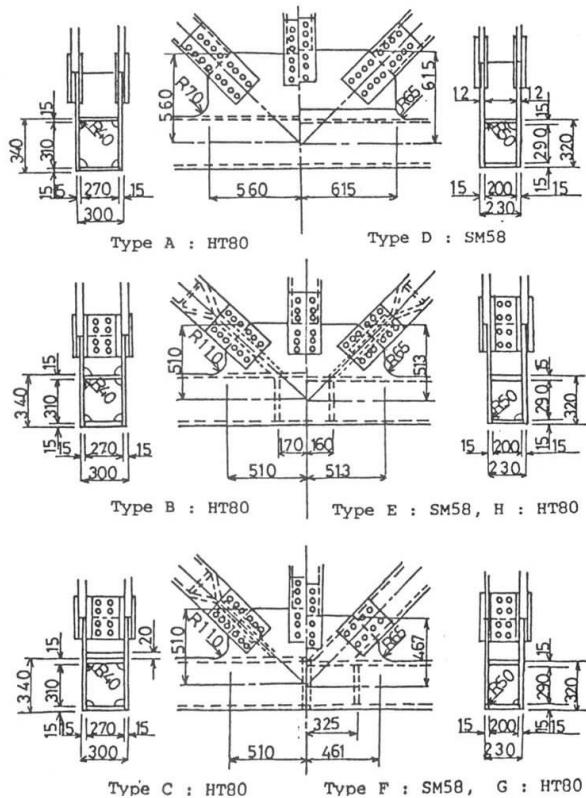
Fig. 5 Truss Panel Point Structures Fig. 8 Fracture Surface of Box Section Specimen

The mechanical Properties of the steels used for truss panel point structures are shown in Table 1. Fatigue tests were performed using the loading apparatus shown in Fig. 4. The hatched portion in the figure represents a specimen. Fig. 5 gives details of the vicinities of panel points of eight varieties of test specimens. The major points of difference between the each types lie in the methods of connecting the diagonal members, the numbers of diaphragms and fillet radii of gusset plates. Corner welds of chord members were made by manual welding for the specimens A, B and C and by the submerged-arc welding for D, E, F, and G. Kinds of Corner welds are single bevel groove welds, and bevel angle is 45° , depth is 7.5mm for type A, B and C, 8mm for type D-G.

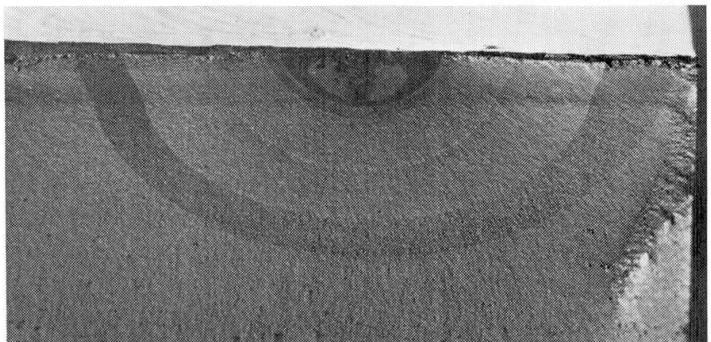
Fig. 7 Fracture Surface of Cruciform Joints

With one joint specimen of $t = 45\text{mm}$, two stage multi-stress amplitude test was performed to form the beach marks on the fracture surface (Beach mark test). Fig. 7 shows the result of beach mark test. In this figure, five beach marks can be counted, and numbers of loading block for this specimen are also five. So it was found that the fatigue crack had initiated at the first stress block (prior to 0.18 N with N_f being failure life) from the concave part at the toe of fillet weld.

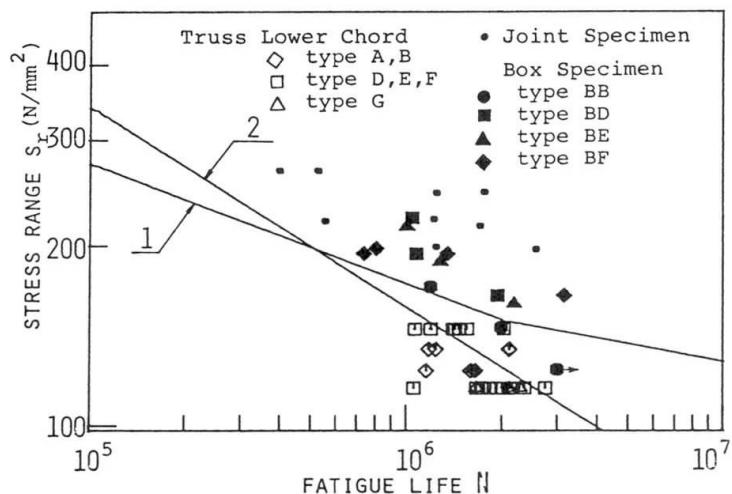
Fig. 9 Results of Fatigue Tests on Longitudinal Welds

Fig. 9 indicates the results of fatigue tests on longitudinal weld joints, box section specimens and panel point structures concerning about longitudinal welds. With longitudinal weld joints, initiation points of fatigue cracks in six out of the entire nine test specimens were blowholes or pores existing at roots of welds, the size being 0.6 to 1.2mm in diameter. Other initiation points were a small pit at bead surface, grinder scratch at surface of base metal and defect at part of base metal reparation by welding. Residual tensile stresses of approximately 340 N/mm^2 and 250 N/mm^2 were measured at joints of an unloaded specimen and an after fatigue test specimen, respectively.

With box section specimens, each three test specimens of type BB, BD and BE, and four of type BF were tested. Results of fatigue tests on these specimens are shown in Fig. 9. The locations of fatigue crack initiation in each type of specimens are as follows.

All specimens except C-1 and C-2, fatigue tests were terminated by growth of fatigue cracks initiated at corner welds of bottom chord members. The relation between nominal stress range and number of cycles of stressing the fatigue crack was discovered at a bottom chord is shown in Fig. 9. In the type A and B specimens fatigue cracks at corner welds were initiated from irregularities at the roots of welds due to nonfusion or lack of penetration. The number of fatigue cracks initiated in the four specimens of type A and B was 13, with surface length from 9mm to 310mm. In the type D, E, F, and G specimens most of fatigue cracks were initiated from blowholes existing at the roots of welds. Fig. 13 shows one example of fracture surface of corner welds. In E-2 and G-1 each one crack occurred at the corner of butt joint of lower chord member, where some small pits existed near the surfaces of plates. The number of fatigue cracks initiated in the eight specimens of type D, E, F and G was 30, with

In Fig. 9, line 1 shows the former design allowable stress and line 2 shows the current design allowable stress for this type of joints under pulsating stress. Most of experimental values of panel point structure specimens are below the former design allowable stress. Furthermore, about half of experimental values of panel point structure specimens are below the current design allowable stress. The current design allowable stress is established based on the fatigue test results of box section specimens and the analysis using fracture mechanics concept. From that analysis, weld defects as blowholes exceeding 1.5mm in diameter of inscribed circle must be avoided to remain therein.

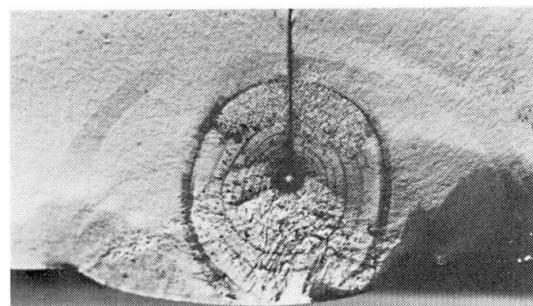
Fig. 10 Fracture Surface of Longitudinal Weld Joint

Beach mark tests were performed with three joints specimens. Fig. 10 shows the fracture surface with beach marks. Fatigue crack had been initiated from the wall of a blowhole at the root of weld. In this fracture surface, thirty beach marks can be counted and numbers of loading block are thirty four so the fatigue crack of this specimen had started growing before 0.12 N_f cycles of loading.

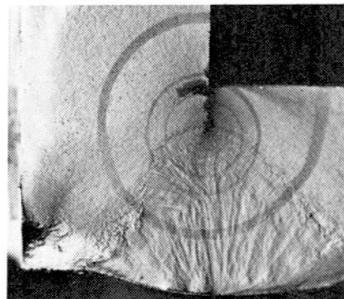
Fig. 11 Fracture Surface of BB-1 Specimen

- BB type : blowhole (2.5×1.8 , $4.1 \times 3.4\text{mm}$) at the root of welds.
- BD type : bead surface, blowhole ($3.9 \times 3.6\text{mm}$) at the root of welds and imperfection of weld metal.
- BE type : weld root (no blowhole) and blowhole (1.1×0.5 , $1.4 \times 0.7\text{mm}$) at the root of welds.
- BF type : slag inclusions at the end of butt joint (2 specimens) and slag inclusions at the toe of fillet weld and root.

Fig. 11 and 12 shows the fracture surface of BB-1 and BE-2 specimens.
