Artikel: Fatigue of nodal joints and box-section members in a bridge truss
Autor: Tajima, Jiro / Miki, Chitashi / Asama, Tatsuo
DOI: <https://doi.org/10.5169/seals-28929>

Fatigue of Nodal Joints and Box-Section Members in a Bridge Truss

This paper describes tests to verify the fatigue strength of welded joints in quenched and tempered high strength steel. Typical welded joints from a bridge truss were tested in a 400 t maximum capacity fatigue testing machine.

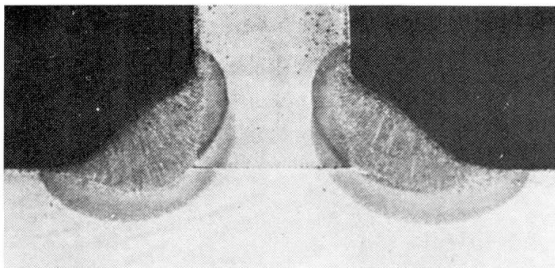
Fig. 2 Shapes of Fillet Welds

said to produce a regular bead shape as shown in Fig. 2. Leg length of fillet welds for 45mm thickness specimens and 75mm thickness specimens are 10mm (two paths) and 13mm (three paths) respectively. Partially penetrated longitudinal groove weld joint simulate for corner welds of truss members with box section. Welding was done using the submerged arc process.

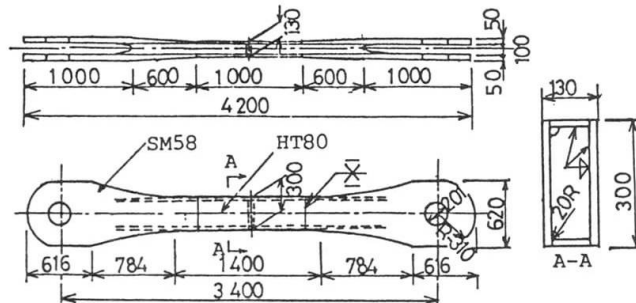
Fig. 3 Box Section Specimen

The mechanical properties of the steels used for specimens of box section are shown in Table 1. Fig. 3 shows the configurations and dimensions of the specimens. Type BA has a diaphragm used SM41 steel at the center of the specimen, and other types have no diaphragm. Welding of the diaphragm was done manually using the same electrode used for joint specimens mentioned above. Corner Welding of these specimens were conducted with automatic welding. Kinds of welding are shown in Table 2. Three types, BB, BD, BF, were with partially penetrated groove welds and one type, BF, was with fillet welds.

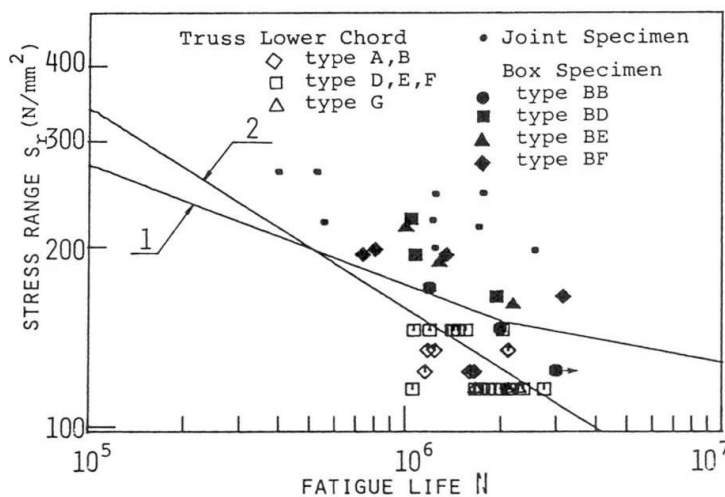
Fig. 9 Results of Fatigue Tests on Longitudinal Welds

Fig. 9 indicates the results of fatigue tests on longitudinal weld joints, box section specimens and panel point structures concerning about longitudinal welds. With longitudinal weld joints, initiation points of fatigue cracks in six out of the entire nine test specimens were blowholes or pores existing at roots of welds, the size being 0.6 to 1.2mm in diameter. Other initiation points were a small pit at bead surface, grinder scratch at surface of base metal and defect at part of base metal repaired by welding. Residual tensile stresses of approximately 340 N/mm² and 250 N/mm² were measured at joints of an unloaded specimen and an after fatigue test specimen, respectively.

With box section specimens, each three test specimens of type BB, BD and BE, and four of type BF were tested. Results of fatigue tests on these specimens are shown in Fig. 9. The locations of fatigue crack initiation in each type of specimens are as follows.

All specimens except C-1 and C-2, fatigue tests were terminated by growth of fatigue cracks initiated at corner welds of bottom chord members. The relation between nominal stress range and number of cycles of stressing the fatigue crack was discovered at a bottom chord is shown in Fig. 9. In the type A and B specimens fatigue cracks at corner welds were initiated from irregularities at the roots of welds due to nonfusion or lack of penetration. The number of fatigue cracks initiated in the four specimens of type A and B was 13, with surface length from 9mm to 310mm. In the type D, E, F, and G specimens most of fatigue cracks were initiated from blowholes existing at the roots of welds. Fig. 13 shows one example of fracture surface of corner welds. In E-2 and G-1 each one crack occurred at the corner of butt joint of lower chord member, where some small pits existed near the surfaces of plates. The number of fatigue cracks initiated in the eight specimens of type D, E, F and G was 30, with

In Fig. 9, line 1 shows the former design allowable stress and line 2 shows the current design allowable stress for this type of joints under pulsating stress. Most of experimental values of panel point structure specimens are below the former design allowable stress. Furthermore, about half of experimental values of panel point structure specimens are below the current design allowable stress. The current design allowable stress is established based on the fatigue test results of box section specimens and the analysis using fracture mechanics concept. From that analysis, weld defects as blowholes exceeding 1.5mm in diameter of inscribed circle must be avoided to remain therein.

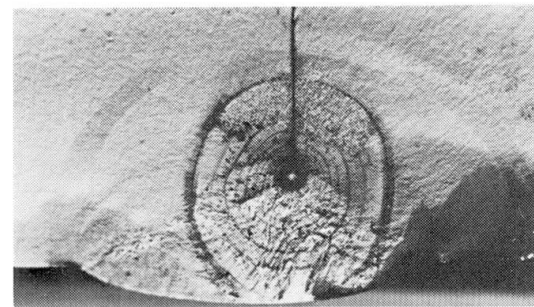
Fig. 10 Fracture Surface of Longitudinal Weld Joint

Beach mark tests were performed with three joints specimens. Fig. 10 shows the fracture surface with beach marks. Fatigue crack had been initiated from the wall of a blowhole at the root of weld. In this fracture surface, thirty beach marks can be counted and numbers of loading block are thirty four so the fatigue crack of this specimen had started growing before 0.12 N_f cycles of loading.

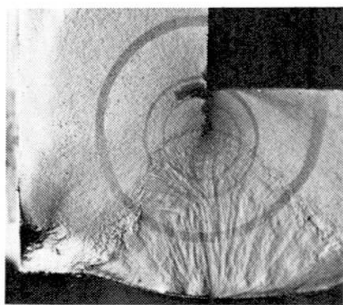
Fig. 11 Fracture Surface of BB-1 Specimen

- BB type : blowhole (2.5 x 1.8, 4.1 x 3.4mm) at the root of welds.
- BD type : bead surface, blowhole (3.9 x 3.6mm) at the root of welds and imperfection of weld metal.
- BE type : weld root (no blowhole) and blowhole (1.1 x 0.5, 1.4 x 0.7mm) at the root of welds.
- BF type : slag inclusions at the end of butt joint (2 specimens) and slag inclusions at the toe of fillet weld and root.

Fig. 11 and 12 shows the fracture surface of BB-1 and BE-2 specimens.
