Zeitschrift: IABSE reports = Rapports AIPC = IVBH Berichte

Artikel: Survey of structures by using acoustic emission monitoring

Autor: Robert, Jean Louis / Brachet-Rolland, Marcelle

Survey of Structures by Using Acoustic Emission Monitoring

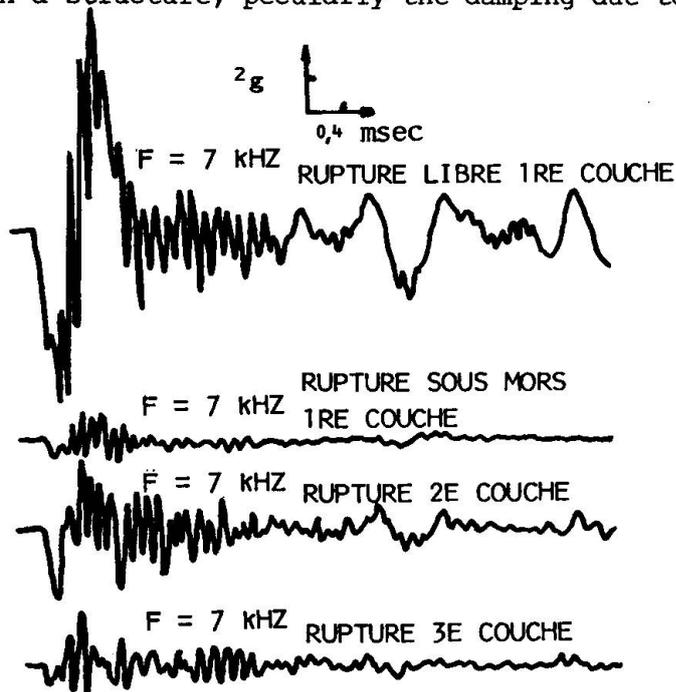
FIGURE N° 1 - Recording of the first wave in various cases of individual wire fracture in a cable, at 21 m far from the breaking point

The experimental method consisted in inducing, at a given point, the individual fracture of internal and external wires in tensioned cables and in recording the produced waves (fig. 1) at various distances of the breaking point, by using accelerometers in order to determine the properties (frequency, amplitude, damping versus distance). In a parallel way, we searched a simple mean for producing similar waves in a cable, so that we could study the propagation conditions in a structure, pecularly the damping due to suspenders and suspender catches.

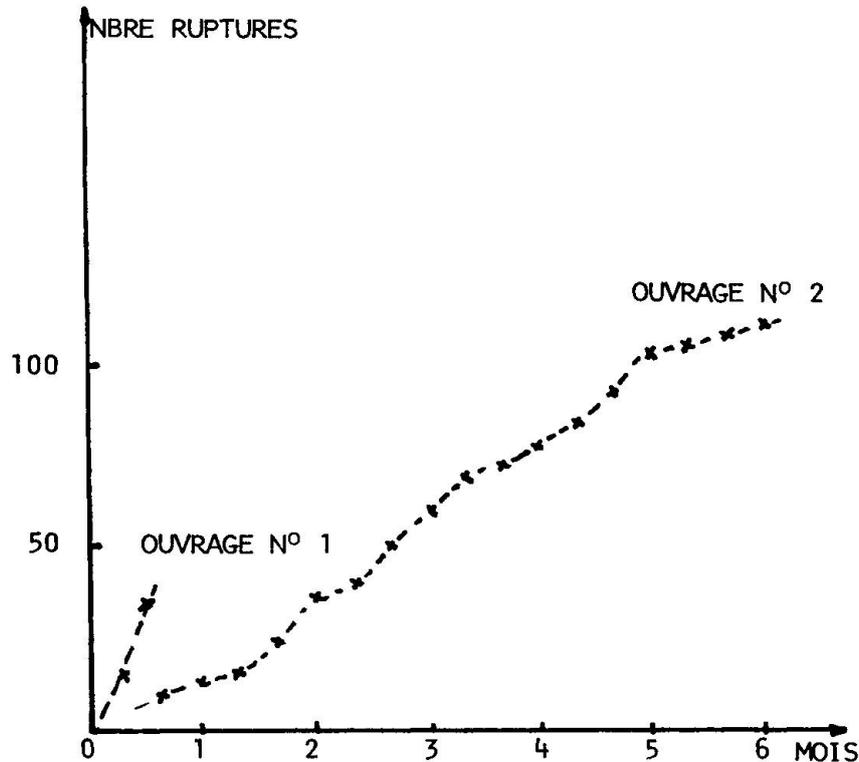
FIGURE N° 2 - Number of fractures monitored by acoustic survey of cables in two suspension bridges (on service)

It deals with a bridge having a 82 m long span, and having in each bundle four cables (66 mm diameter) continuous from one anchorage to the other one. Only the center span is suspended. After a total failure of the holding cable on the right side upstream, the acoustic survey was settled on the other cables, seeming to be intact, on the right side bank upstream and downstream. No new wire fracture was detected downstream but on the contrary, upstream two fractures for a day were, as a mean value, observed on the three remaining cables, on a length of 23 m and during 15 days (fig. 2), this time deviation was necessary for the immediate settling of a provisional suspension in order to prevent the total failure of the structure.

continuous from one anchorage to the other one. In one of the downstream cables, about 20 wire fractures were observed in the second layer, and the acoustic survey was immediately settled on the 4 cables of the downstream bundle, on a length of 60 m which was evaluated to be the most critical for the whole structure.

In this area, the number of fractures monitored with the acoustic survey was 1 for a day, as a mean value, from July to December. Then the phenomenon seemed to be stabilized, starting from December.

After the cable removal, a 5 m long piece, where the acoustic emission had monitored 10 fractures, was examined : 63 fractures were observed in the internal layers (the external layer being perfectly safe). This result enabled us to verify the validity of the acoustic survey of the suspension bridge cables, which makes it possible to monitor the individual fracture of elementary wires at the time when it occurs, with a location precision in the order of 0,10 m.

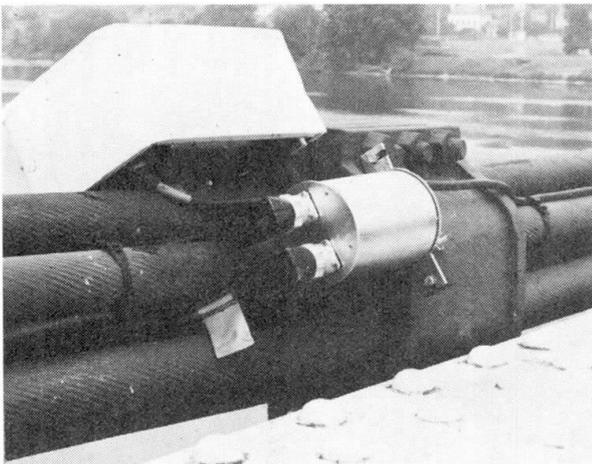
FIGURE N° 3

A - Sensor on a structure

- a set of sensors connected in a series and fixed on the cable at ranges of 10 to 20 m, depending on the wave clamping proper to each structure. Every sensor has a monitoring element composed of an accelerometer and electronic circuits necessary for the transmission to a box centralizing the carried out measurements ;

In a second step, the high density of sensors in the area with active cracks enabled us to localize 2 preferential areas of acoustic emission, of about 1 m^2 (fig. 3). The basic data on the properties of the waves emitted by concretes and on their propagation conditions were not sufficient for the identification of the source of the received waves : opening or growth of cracks. But we are allowed to assess that these waves indicated the activity of these cracks because they were off since additional prestressing cables were tensioned (before cracks were injected).

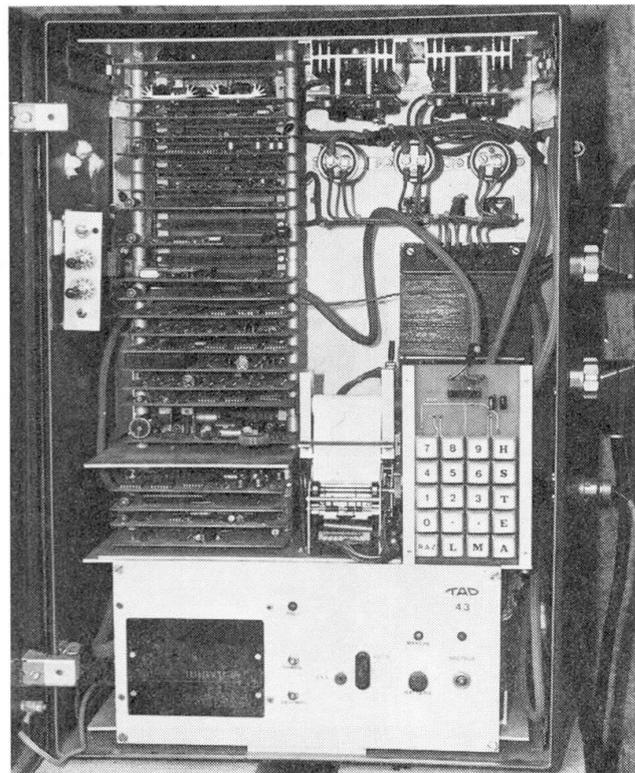
FIGURE N° 3

B - Central box

- a box centralizing the data and processing, using a microprocessor, the signals given by every sensor (maximum number 100 sensors) and making it possible their recording with a printing machine (local result processing) or on a mini-cassette tape recorder (further study with a computer). The obtained information is as follows :
