Fatigue Life of Australian Railroad Bridges

Paul GRUNDY

Assoc. Prof of Civil Eng.
Monash University
Clayton, Vic, Australia

A series of Australian railroad bridges with identical welded coverplate details are reviewed for expected fatigue life. A method of determining complete sample stress histories from traffic records is developed, with the key factors of influence line and impact being confirmed by field measurements to give a reliable estimate of fatigue loading. Difficulties are encountered in identifying the fatigue category of the detail. Laboratory tests are used to give guidance on crack growth characteristics. Although confident estimates are made of expected life, the risk of premature failure of any one detail in such a large number remains difficult to estimate.

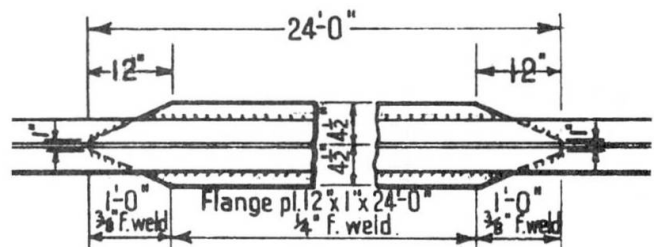
Fig. 2 Detail of Coverplate (from the original drawing).

In 1962 a new rail track was opened between Melbourne and Albury in the State of Victoria, completing the standard gauge link between Sydney and Melbourne shown in Fig. 1. Nearly all the bridges were of three standard spans of approximately 7m, 10m and 13m, consisting of stringers and open decking. The designs use 24" x 7.5" x 95 lb/ft. taper flange girders, which were the largest available, with cover plates. As was fashionable, the coverplates were terminated where they were no longer required to keep stresses within allowable limits. A typical coverplate termination detail is shown in Fig. 2, and a photograph of one ready for fatigue testing is shown in Fig. 3.

Although coverplate ends have been extensively studied [5,6,13], it is evident from Figs. 2 and 3 that this series does not readily compare with those tested by others. The overlapping thick coverplate leads to a choice of USA fatigue category E' [6], proposed to allow both for overlapping coverplate and for size effect. In this case the manual fillet weld is continuous through the

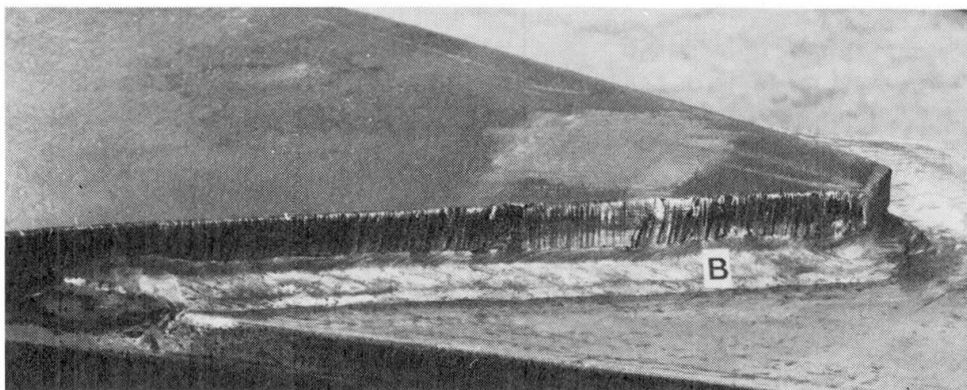
Fig. 3 View of Coverplate terminations

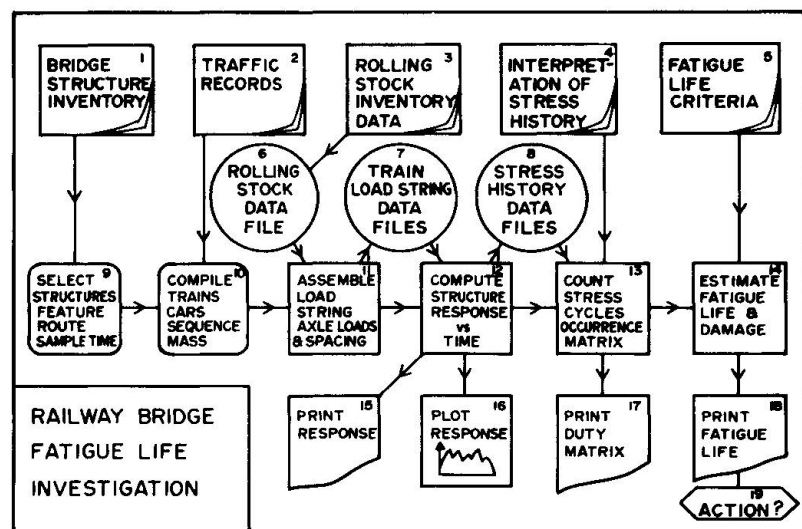
Fig. 4 Bridge Fatigue Life Flow Chart.

summarised in Fig. 4, where items 1-5 are documentary sources, items 6-8 are computer data files, items 9-10 are user inputs, items 11-14 are computer programs processing the data, and items 15-18 are outputs. Items 14 and 18 require an input on fatigue resistance. Apart from these, the entire program develops a general damage index for the structures on the chosen route.

For the bridges under review there exists remarkably complete documentation of all trains to the extent that the entire history of axle loads, spacing and sequence can be reconstructed for the whole life of the bridge. In practice sample days are chosen to represent typical traffic to give a daily damage rate. The annual gross tonnage is compared with the sample day to confirm the representativeness of the sample. The procedure, detailed elsewhere [7-11], is

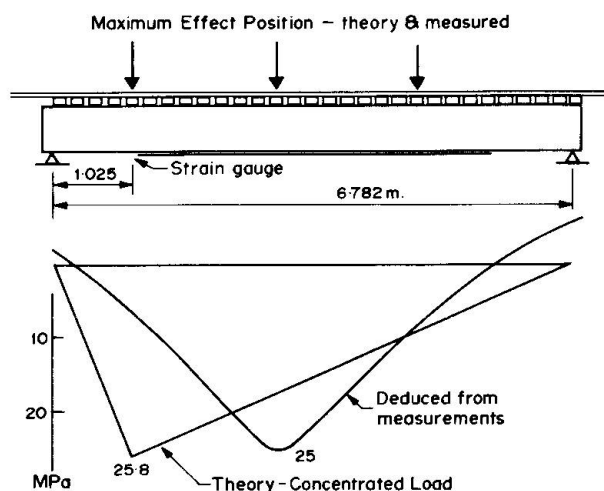
Fig. 5 Influence Lines for Stress 1.025m from support for 115.7kN wheel load.

For the given load history, item 7, the corresponding stress history is computed for a given span (influence length) and shape of influence line. The influence line is readily determined for these statically determinate structures. However, the effects of continuity of track and the dispersion of load from the top of the rail to the bottom of the girder where the critical details were located needed to be taken into account. The influence line was deduced from strain measurements with a locomotive stationed on the bridge (Fig. 5).

Although the measured peak value almost agreed with the computed one, the positive influence length is shorter and there are adjacent negative influence regions as a consequence of the structural continuity of the track. For the span shown in Fig. 5, the measured maximum static stress for the locomotive was only 79% of the computed value. If the computed stress amplitudes on this simple statically determinate structure were used without calibration by field measurement the damage index would have been overestimated by nearly 100%.

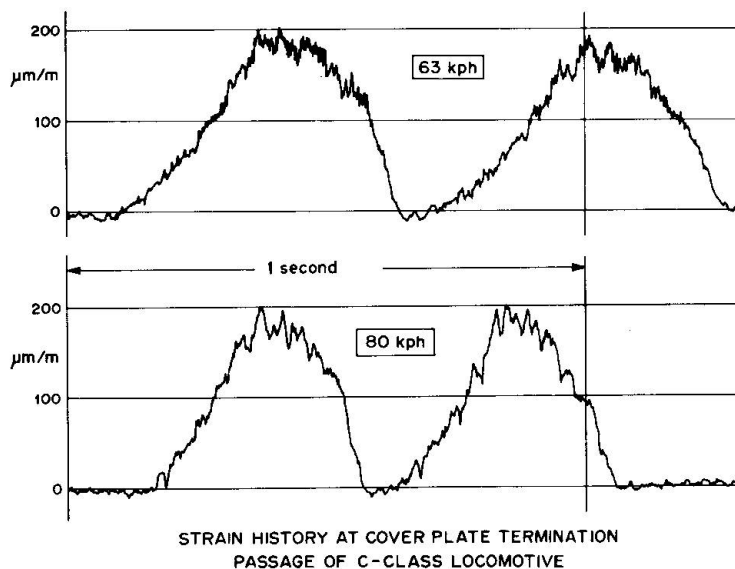
Fig. 6 Measured Response to Locomotive.

Two methods of measurement were employed in this study. In the first, dynamic traces of the of the strain at the ends of the coverplates were made for the locomotive previously used in static calibrations traversing the bridge at various speeds. Two such traces are shown in Fig. 6. Superimposed on the quasistatic response, which is not amplified, is a vibration associated with the suspension of the locomotive. This vibration adds on about

8% to the maximum static stress amplitude, and it creates a significant number of minor stress cycles not previously present. If the latter are disregarded, the dynamic effect can be included by amplifying the static stress amplitudes uniformly 8%. The method is imprecise, but vastly superior to using the impact factor specified in the relevant Code, which is 1.58.

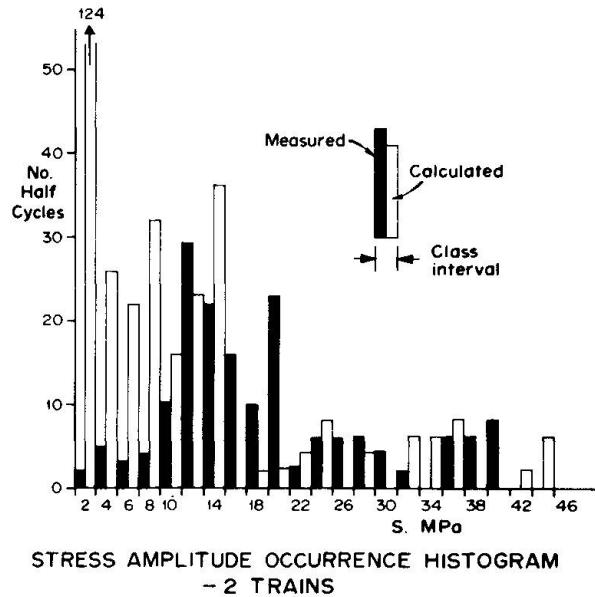
Fig. 7 Stress Amplitudes by Rainflow Method.

The second method integrates the dynamic effect for a whole train in terms of fatigue damage. The strain history was recorded for two trains and then subjected to analysis by the Rainflow method [3]. For all stress cycles, the sum $\Sigma(\Delta\sigma)^3$ was formed as a measure of damage, D_{meas} . The procedures of Fig. 4 were then followed for the same two trains to generate the corresponding stress history, and the measure of damage, D_{calc} was formed in the same way, without using the 0.93 static calibration factor derived from field measurements. The expression $\sqrt[3]{D_{meas}/D_{calc}}$

When applied to the 7m span under review, the second method yields a nett impact factor of 1.01. If the calibration factor remains at 0.79 for all axle configurations, the real average impact factor becomes 1.27 - much higher than the value from the first method. One reason for the difference is that the vibrations noted create more stress cycles at lower amplitudes, and the amplification factor is greater for stress cycles of lesser amplitude. Histograms of the measured and calculated occurrences of stress half-cycles are shown in Fig. 7. The number of major stress cycles corresponded between theory and measurement, with the measured maximum being 0.91 of calculated maximum. This is consistent with the lower impact factors measured with the locomotive. Low amplitude cycles were filtered out of the field measurements, but in the middle range many more cycles were measured than calculated.

It is noted that 90% of damage is done by stress cycles exceeding 16 MPa. This confirms the observation that the small cycles are not significant, and that fatigue damage estimates are not sensitive to the shape of the S-N curve at low stresses under variable amplitude.

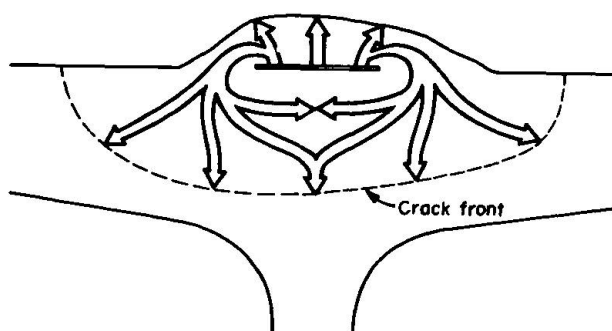
Fig. 9 Key to Crack Growth of Fig. 8.

So far one test has run out and two have failed in the same way, by a crack propagating outwards from the root of the fillet weld (Fig. 8). The crack surfaces almost simultaneously across the full width of the coverplate end and then turns down through the side fillet welds into the top flange (Fig. 9). The two specimens which failed had virtually identical crack growth rate and form, but very different times to the initial visible crack. There appears to be insufficient data to support a change from E' classification to E, but the stable crack growth gives confidence in implementing a program of visual inspection, since the cracks are large and easily seen over a long period of the fatigue life.
