**Zeitschrift:** IABSE reports = Rapports AIPC = IVBH Berichte  
**Band:** 39 (1982)

**Artikel:** Fatigue life of Australian railroad bridges  
**Autor:** Grundy, Paul  
**DOI:** <https://doi.org/10.5169/seals-30172>

## Fatigue Life of Australian Railroad Bridges

### Paul GRUNDY

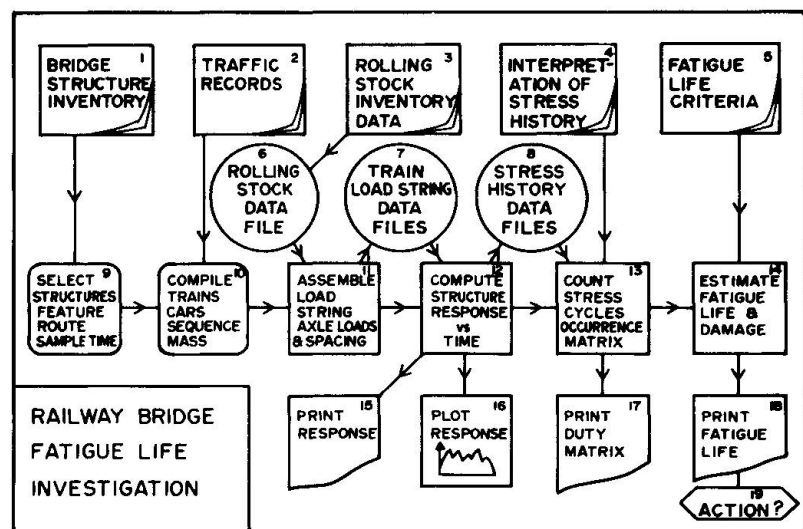
Fig. 4 Bridge Fatigue Life Flow Chart.

summarised in Fig. 4, where items 1-5 are documentary sources, items 6-8 are computer data files, items 9-10 are user inputs, items 11-14 are computer programs processing the data, and items 15-18 are outputs. Items 14 and 18 require an input on fatigue resistance. Apart from these, the entire program develops a general damage index for the structures on the chosen route.

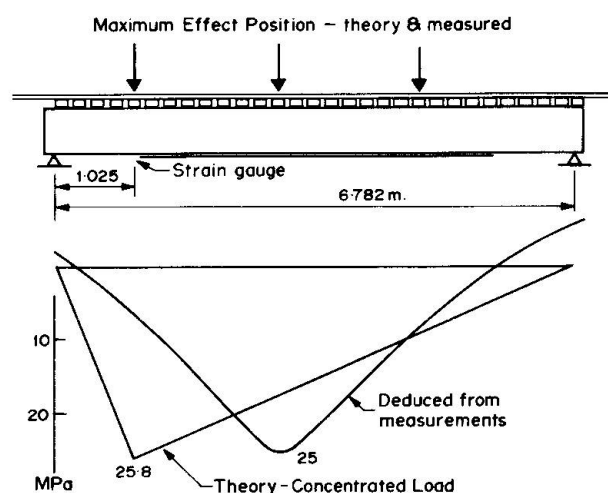
Fig. 5 Influence Lines for Stress 1.025m from support for 115.7kN wheel load.

For the given load history, item 7, the corresponding stress history is computed for a given span (influence length) and shape of influence line. The influence line is readily determined for these statically determinate structures. However, the effects of continuity of track and the dispersion of load from the top of the rail to the bottom of the girder where the critical details were located needed to be taken into account. The influence line was deduced from strain measurements with a locomotive stationed on the bridge (Fig. 5).

Although the measured peak value almost agreed with the computed one, the positive influence length is shorter and there are adjacent negative influence regions as a consequence of the structural continuity of the track. For the span shown in Fig. 5, the measured maximum static stress for the locomotive was only 79% of the computed value. If the computed stress amplitudes on this simple statically determinate structure were used without calibration by field measurement the damage index would have been overestimated by nearly 100%.

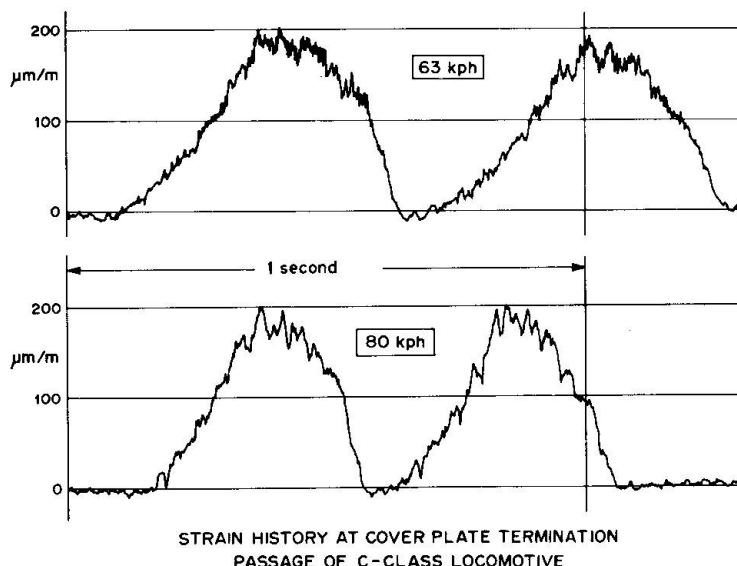
Fig. 6 Measured Response to Locomotive.

Two methods of measurement were employed in this study. In the first, dynamic traces of the strain at the ends of the coverplates were made for the locomotive previously used in static calibrations traversing the bridge at various speeds. Two such traces are shown in Fig. 6. Superimposed on the quasistatic response, which is not amplified, is a vibration associated with the suspension of the locomotive. This vibration adds on about

8% to the maximum static stress amplitude, and it creates a significant number of minor stress cycles not previously present. If the latter are disregarded, the dynamic effect can be included by amplifying the static stress amplitudes uniformly 8%. The method is imprecise, but vastly superior to using the impact factor specified in the relevant Code, which is 1.58.

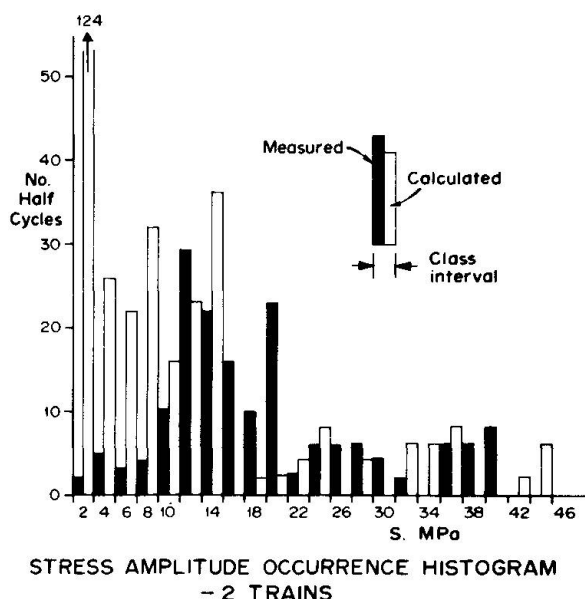
Fig. 7 Stress Amplitudes by Rainflow Method.

The second method integrates the dynamic effect for a whole train in terms of fatigue damage. The strain history was recorded for two trains and then subjected to analysis by the Rainflow method [3]. For all stress cycles, the sum  $\sum(\Delta\sigma)^3$  was formed as a measure of damage,  $D_{meas}$ . The procedures of Fig. 4 were then followed for the same two trains to generate the corresponding stress history, and the measure of damage,  $D_{calc}$  was formed in the same way, without using the 0.93 static calibration factor derived from field measurements. The expression  $\sqrt[3]{D_{meas}/D_{calc}}$

When applied to the 7m span under review, the second method yields a nett impact factor of 1.01. If the calibration factor remains at 0.79 for all axle configurations, the real average impact factor becomes 1.27 - much higher than the value from the first method. One reason for the difference is that the vibrations noted create more stress cycles at lower amplitudes, and the amplification factor is greater for stress cycles of lesser amplitude. Histograms of the measured and calculated occurrences of stress half-cycles are shown in Fig. 7. The number of major stress cycles corresponded between theory and measurement, with the measured maximum being 0.91 of calculated maximum. This is consistent with the lower impact factors measured with the locomotive. Low amplitude cycles were filtered out of the field measurements, but in the middle range many more cycles were measured than calculated.

It is noted that 90% of damage is done by stress cycles exceeding 16 MPa. This confirms the observation that the small cycles are not significant, and that fatigue damage estimates are not sensitive to the shape of the S-N curve at low stresses under variable amplitude.
