Fatigue Life of Australian Railroad Bridges

Paul GRUNDY

Assoc. Prof of Civil Eng.
Monash University
Clayton, Vic, Australia

A series of Australian railroad bridges with identical welded coverplate details are reviewed for expected fatigue life. A method of determining complete sample stress histories from traffic records is developed, with the key factors of influence line and impact being confirmed by field measurements to give a reliable estimate of fatigue loading. Difficulties are encountered in identifying the fatigue category of the detail. Laboratory tests are used to give guidance on crack growth characteristics. Although confident estimates are made of expected life, the risk of premature failure of any one detail in such a large number remains difficult to estimate.

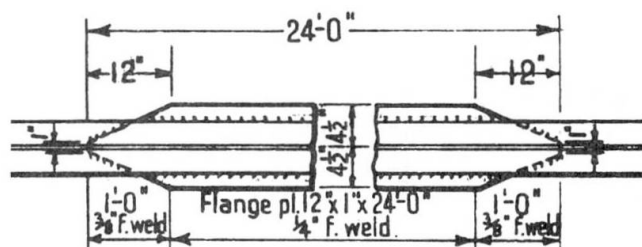
Fig. 2 Detail of Coverplate (from the original drawing).

In 1962 a new rail track was opened between Melbourne and Albury in the State of Victoria, completing the standard gauge link between Sydney and Melbourne shown in Fig. 1. Nearly all the bridges were of three standard spans of approximately 7m, 10m and 13m, consisting of stringers and open decking. The designs use 24" x 7.5" x 95 lb/ft. taper flange girders, which were the largest available, with cover plates. As was fashionable, the coverplates were terminated where they were no longer required to keep stresses within allowable limits. A typical coverplate termination detail is shown in Fig. 2, and a photograph of one ready for fatigue testing is shown in Fig. 3.

Although coverplate ends have been extensively studied [5,6,13], it is evident from Figs. 2 and 3 that this series does not readily compare with those tested by others. The overlapping thick coverplate leads to a choice of USA fatigue category E' [6], proposed to allow both for overlapping coverplate and for size effect. In this case the manual fillet weld is continuous through the

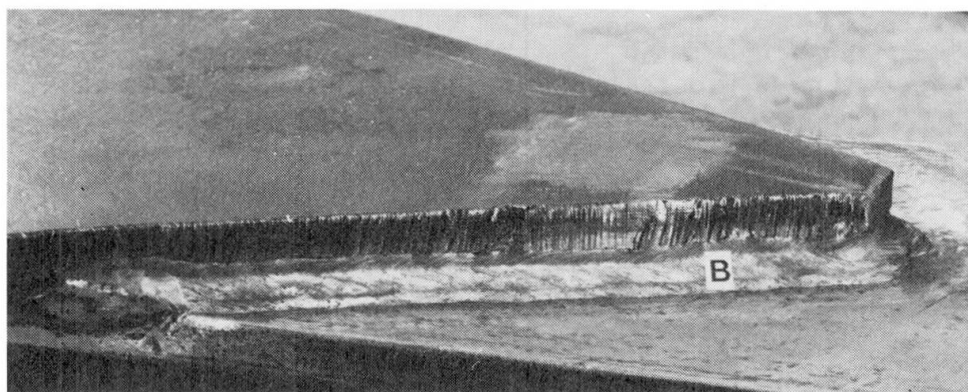
Fig. 3 View of Coverplate terminations

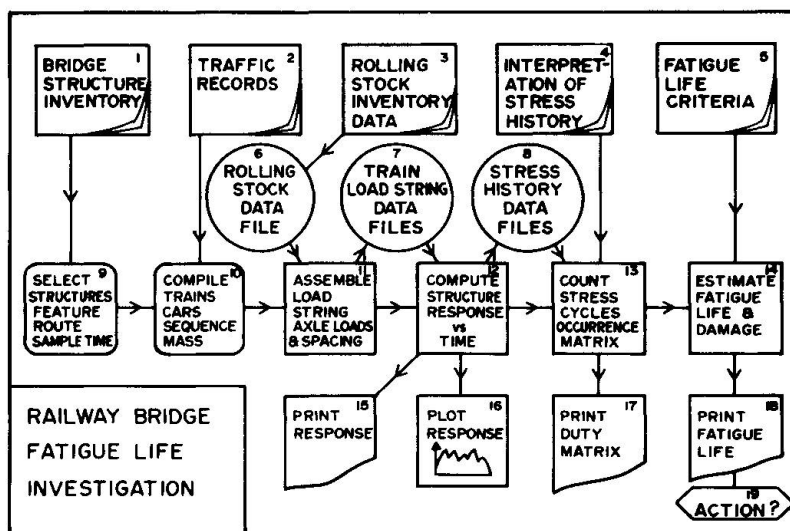
Fig. 4 Bridge Fatigue Life Flow Chart.

summarised in Fig. 4, where items 1-5 are documentary sources, items 6-8 are computer data files, items 9-10 are user inputs, items 11-14 are computer programs processing the data, and items 15-18 are outputs. Items 14 and 18 require an input on fatigue resistance. Apart from these, the entire program develops a general damage index for the structures on the chosen route.
