## Maintenance of Reinforced and Prestressed Concrete Bridges in the Federal Republic of Germany

### Heribert THUL

Dr.-Ing.  
Bundesverkehrsministerium  
Bonn, BRD

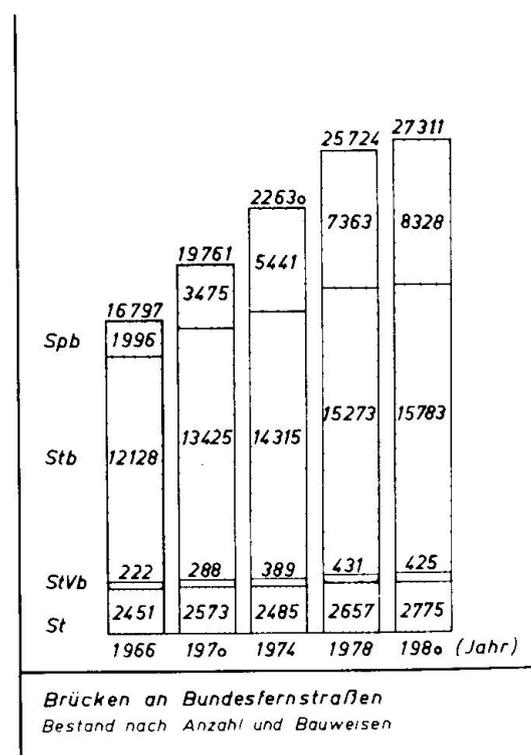
Fig. 1 Bridge statistics/number of bridges

The development of the federal trunk road network and of the bridge stock during the past 15 years is shown in Fig. 1.

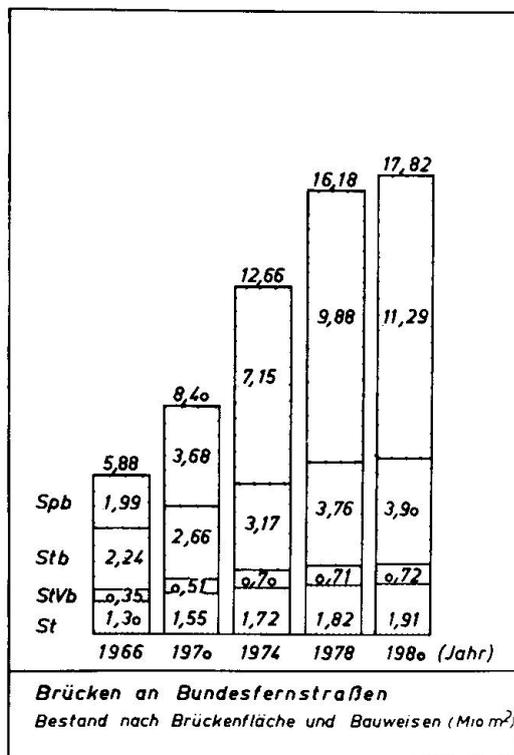
Fig. 2 Bridge statistics / bridge deck area

Approximately 11,500 bridges with a deck area of almost 12.4 million m<sup>2</sup> were built on federal trunk roads between 1965 and 1980. Thus, by 1980, the number of bridges carrying or spanning federal trunk roads increased to about 27,000, with their deck area amounting to 18 million m<sup>2</sup> (Fig. 2).

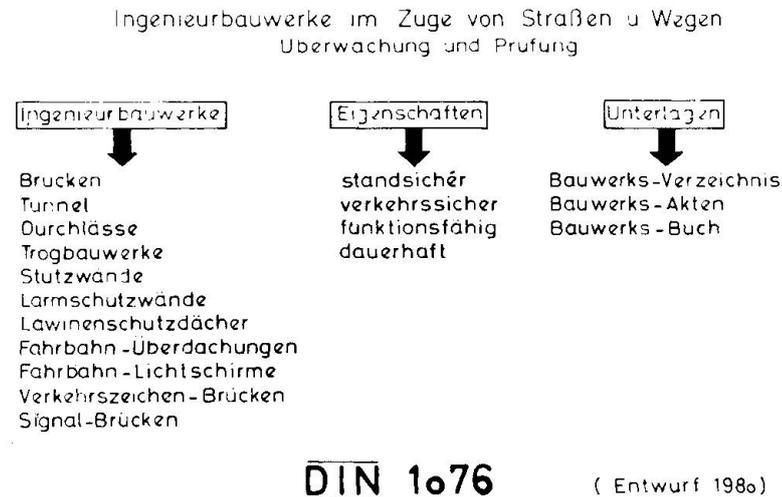
**Fig. 3** DIN 1076;  
inspection structures/properties/  
documents

Fig. 3 contains the most important engineering structures which are inspected in conformance with this standard. Above all, noise barriers and trough constructions have increased considerably during the past years. The properties of the structures to be preserved are listed in the middle of the figure and on the right those documents that are needed for the inspection of the structures.

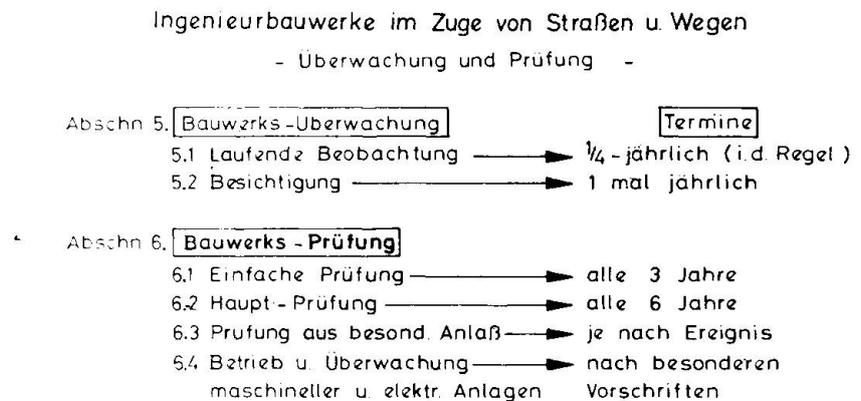
**Fig. 4** DIN 1076;  
inspection intervals

The next figure (Fig. 4) shows the types of inspection and the times and intervals at which these should take place. The most important inspection is the so-called main inspection, which is carried out every six years, during which the structure is put to the "acid test".

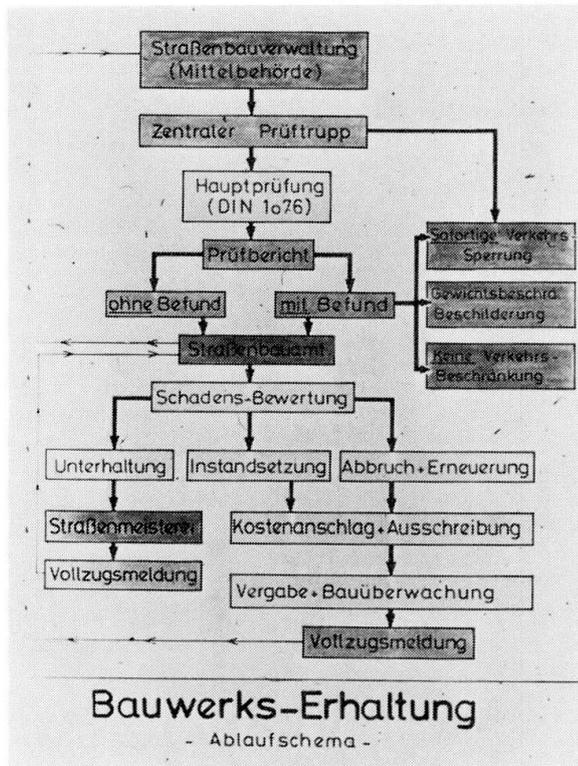
Fig. 9 Preservation of the structure - organization scheme

Fig. 9 shows how the supervision of structures is organized within our highway administration, taking the main inspection as an example. The main inspection is generally carried out by special inspection parties. Depending on the kind and the significance of the defects detected, the test results will set off different activities, which range from minor maintenance measures by the responsible road or motorway maintenance depot to the immediate closure of the bridge.

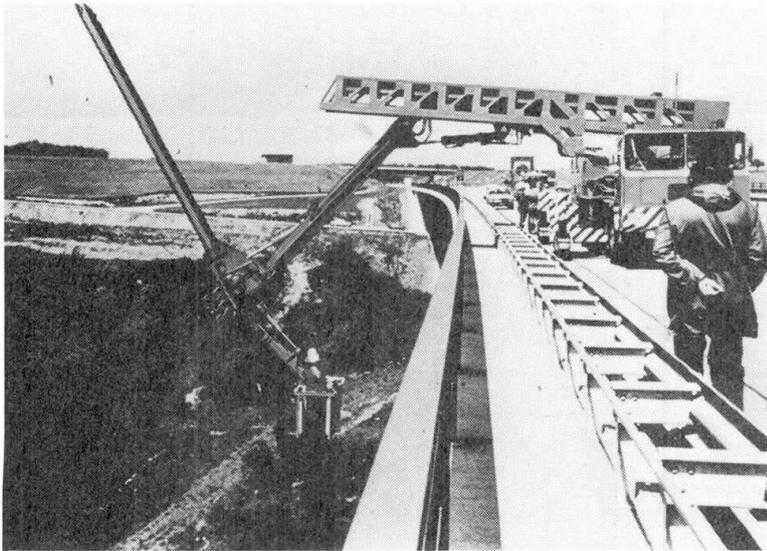
- Figure 10 shows a double telescope with elevator and three joints with a working and inspection bucket for two men. The extension under the bridge is 9.10 m, the lifting height 28 m. Such equipment is particularly suitable for the local inspection of bearings, drainage installations, etc.
- For wide motorway bridges, inspection equipment with working platforms of up to 16 m extension under the bridge are necessary. Figure 11 shows such equipment in action. There can be no doubt that such platforms give much better access to underbridge areas and make it possible to do minor repair work.
- Other equipment, such as inspection trains from the German Federal Railways or an inspection ship from the Waterways and Shipping Administration, can be used for the necessary inspection of road bridges over electrified railway lines and across canals.

Fig. 10 Bridge inspection equipment Ruthmann double telescope with elevator and three joints US 260

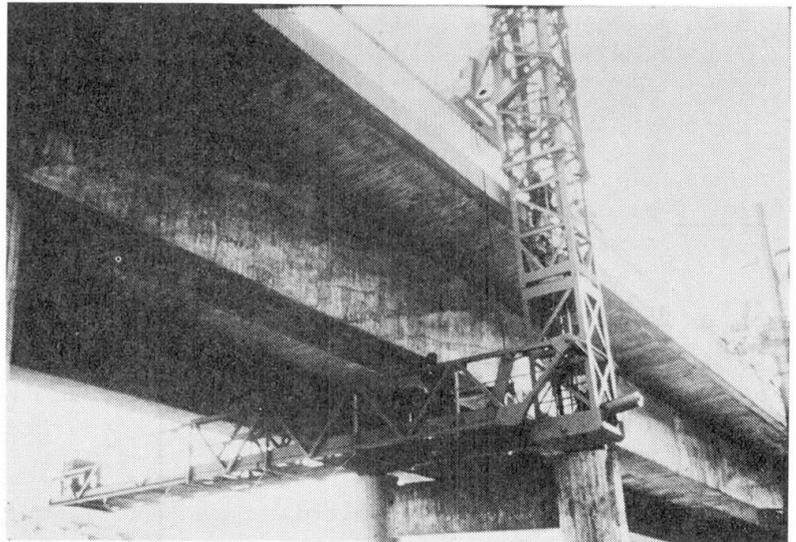
Fig. 11 Bridge inspection equipment Passarella

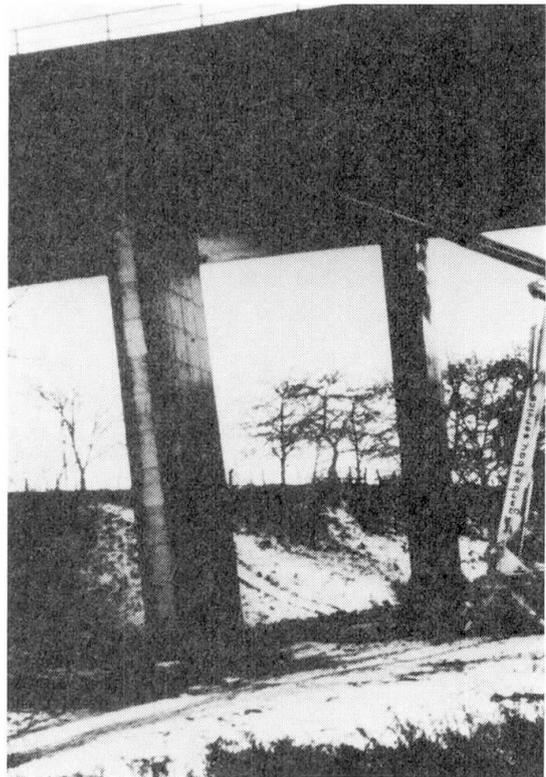
There, extremely low temperatures led to the roller bearings rolling off. The expansion movements were calculated in accordance with the code valid at the time the design was made. However they did not contain any calculational or constructional safety in view of the probable deformation values.

Fig. 19 Damage to the pier due to  
rolled off bearing (valley  
bridge Blockheide)

Owing to the failure of a roller bearing the superstructure sagged by 27 cm which caused an eccentric load on the pier and entailed heavy damage to the super- and substructures (Figure 19).
