Zeitschrift: IABSE reports = Rapports AIPC = IVBH Berichte
Band: 39 (1982)

Rubrik: Session 4: a) Joints, bearings and other details; b) Financial and planning considerations

Bridge Deck Expansion Joint Transition Areas

Fatigue Tests on Couplings of Tendons under Service Conditions

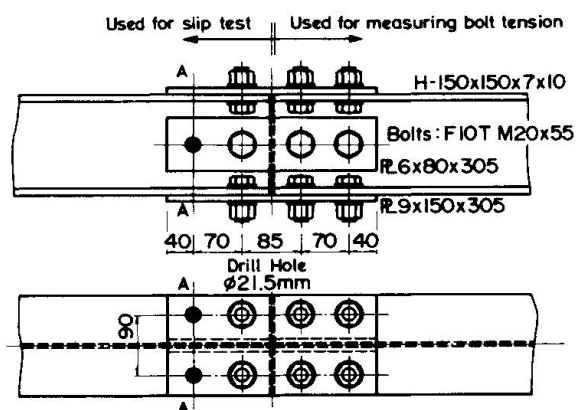
Fig. 1 Tested Joint for Series C

Note: A half number of bolts (5 bolts) in A-A were loosened before slip tests.

Slip tests were conducted for series C, D and E. The joint slip was determined by relative displacements measured with clip gages set between the main plate and the splice plate of the joint.

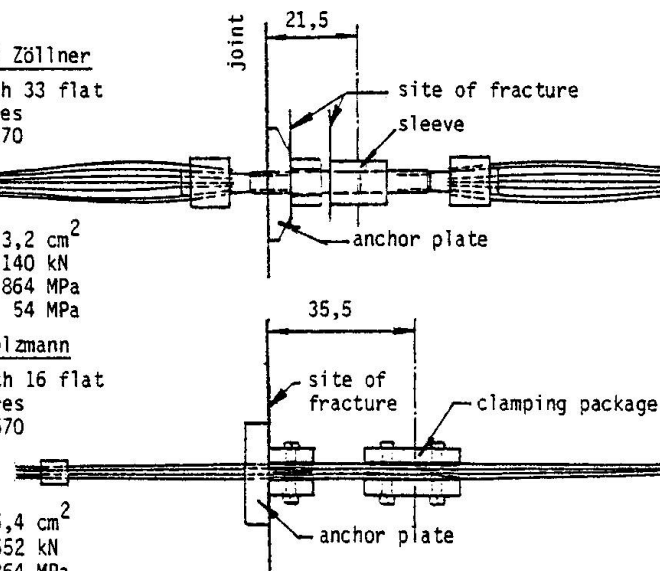
Fig.2 Characteristics of the tendons and their couplings

bundle with 16 flat
ribbed wires
St 1420/1570

tot $A = 6,4 \text{ cm}^2$
adm $F = 552 \text{ kN}$
adm $\sigma = 864 \text{ MPa}$
adm $\Delta\sigma = 68 \text{ MPa}$

- prestressing system DYWIDAG with a short coupling by means of a screwed sleeve,
- prestressing system POLENSKY + ZÖLLNER with a long coupling by means of a stiff coupling bar with thread and
- prestressing system PHILIPP HOLZMANN with a a so-called clamping package.

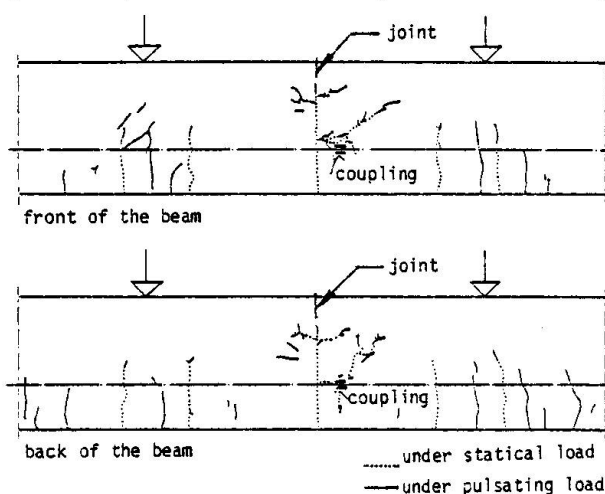
Fig.4 Typical cracks (beam no.10)

Fig.4 shows a typical crack pattern. Exceeding the decompression load, the joint opened immediately because an appreciable tensile strength did not exist.

When reaching the maximum load, the height of the crack corresponded to the height of the calculated tensile zone. Near the neutral axis horizontal cracks formed, as they are also typical for elements with unbonded tendons. Only in that part of the beam, where the coupling was installed, some diagonal cracks formed near the coupling. Flexural bending cracks starting from the bottom formed at some distance from the joint. During the fatigue loading, some cracks elongated and new cracks were initiated. The change of the crack width difference ΔW in the joint is presented in Fig.5. It increases at first, then remains constant for a long period and increases once again shortly before failure.

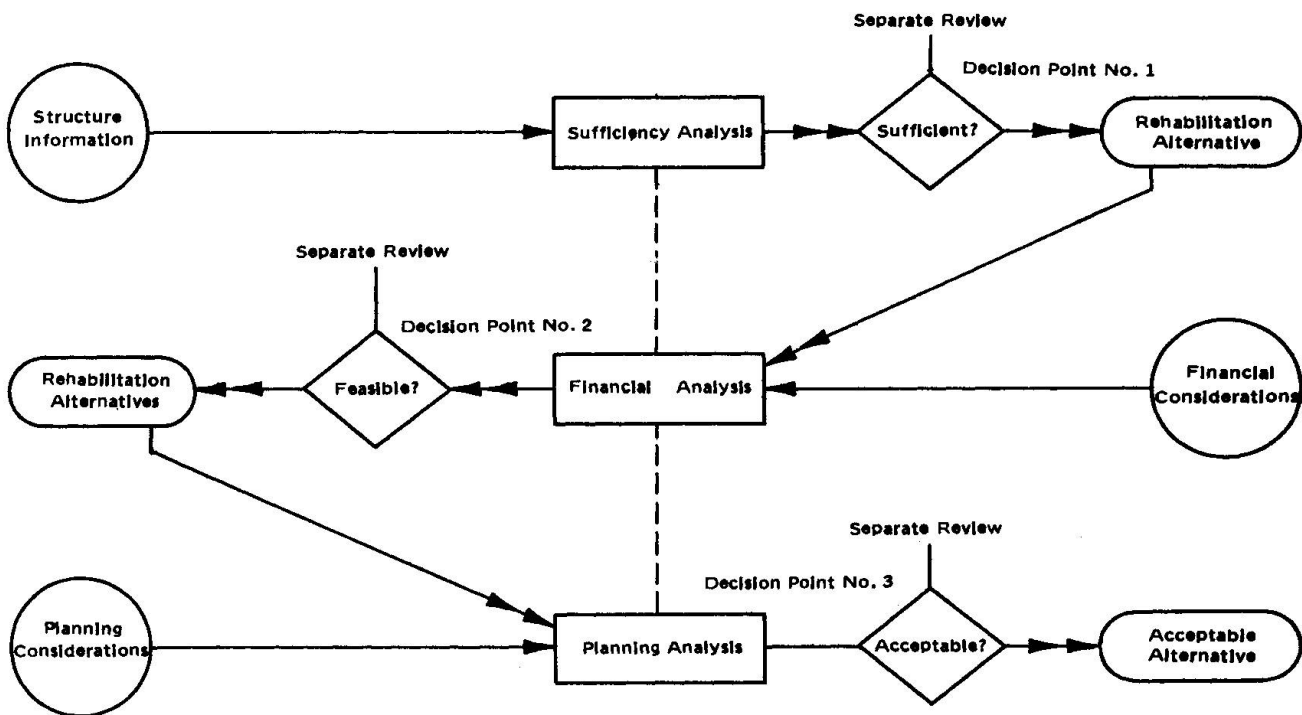
FLOW CHART OF REHABILITATION DECISION MAKING

4.1 A step by step procedure as outlined in this paper is shown in the above flow chart.
