Ship Collisions with Bridges in Sweden

Werner von OLNHAUSEN
Head, bridge section,
Swedish Natl. Road Adm.
Borlänge, Sweden

The article gives some facts about five ship collisions with bridges, which have happened in Sweden since 1965. The road administration has developed design rules, which have been applied for new bridges since 1967. After the Tjörn bridge disaster in 1980 a complete survey was made of the collision risk at all Swedish bridges.

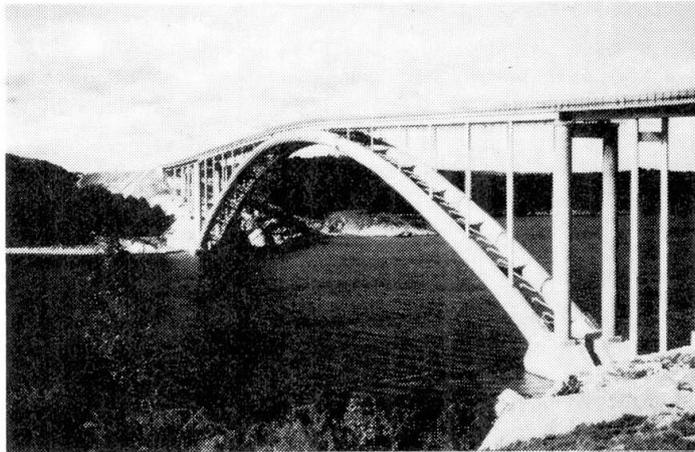
Fig 1. The former Tjörnbridge

The former Tjörnbridge was a 278 m steel-arch bridge, built about 1960, fig 1. The arch consisted of two 3,8 m circular tubes with 14-22 mm plate thickness ("tube-tandem"). The navigation channel under the arch had a height of 41 m on 50 m width.- On the 18th of Januari 1980 at 1.30 a.m. in bad weather the arch was struck by a 27.000 dwt ship and collapsed totally. 8 people lost their lives, driving in their motorcars into the water over the edges of the remaining viaducts, before the road traffic could be stopped. The arch fell partly upon the ship without causing any injuries, fig 2. For further details, see /1/.

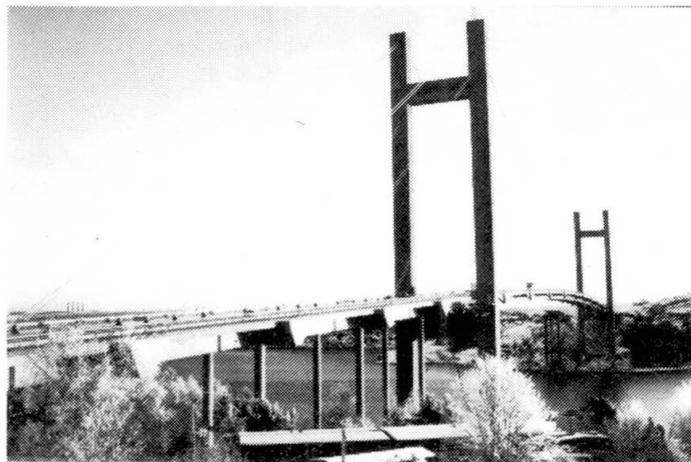
Fig 3. The new Tjörnbridge

About 16 month after the order - certainly a remarkable record in construction time - two lanes of the new bridge could be taken into use on Nov. 9th 1981, fig 3. The total cost for the new bridge and the temporary ferries was about 210 M SEK.

The collapse of the bridge interrupted a very important communication for the people on the islands of Orust and Tjörn, prolonging the roadway distance to Gothenburg by about 80 km. A provisional ferry-lane was therefore established immediately after the disaster, giving a capacity of about 2000 vehicles/day. At the same time a new bridge was planned and - after an international competition - the order for its construction was given in medio July 1980 to a Swedish-German consortium. The new bridge was built on the same place, but as a cable-stayed steel boxbeam of 366 m theoretical span. The about 100 m high pylons and the approaches were made in reinforced concrete. In order to make sure that the new bridge not could be hit by a ship, the pylons were placed on the rocks about 25 m on land. The free height was chosen to 45,3 m on 110 m width.-

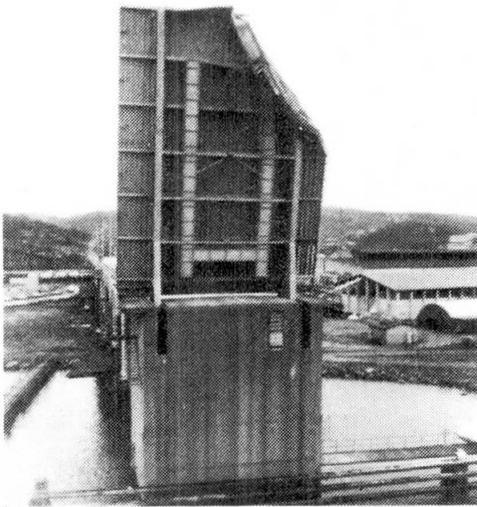
Fig 4. Damage on the Jordfallet bascule-bridge

There are about 20 m long bascule-piers of reinforced concrete on each side and then approaching bridges of about 240 respectively 362 m length. - On 30th April 1979 a 3.000 dwt ship hit the superstructure of one bascule, which could not be opened because of an electrical failure on the bridge. The ship, which had a breadth of only 12 m, could have passed in the remaining channel of 21,0 m, but she touched the bascule with her deckhouse. - A triangular bit of the bascules' ortotropic deck, with the bending points about 9 resp. 9 m from the corner, was bent downward at an angle of about 70° , fig 4. In spite of the very strong impact, the machinery and the counter-weight-arm of the bascule were undamaged. - The repair consisted of replacing of the damaged parts of the bridge deck and the main girder. Repair-cost about 1,5 M SEK.

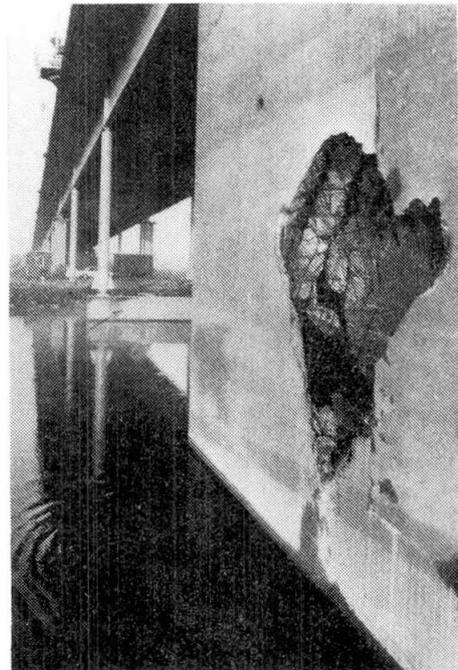
Fig 5. Damage on a bascule-pier at the Jordfallet-bridge

The same bridge was hit again on 28th Okt 1981 by a 480 dwt ship, which missed the channel and struck into the bascule-piers concrete wall about 8 m behind the guard-railing. The vessel went at about 3 knt speed upstream. The shipsbow passed through the 0,45 m thick wall, reinforced by $\phi 12$ c 300 on both sides, leaving a triangular hole of about $3 \times 3,5$ m just above the water level, fig 5. A concrete stiffener with $0,3 \times 1,00$ m cross-section was also destroyed. The bow never reached the backarm of the bascule. - The repair consisted of rebuilding of the concrete wall. Cost about 0,2 M SEK.

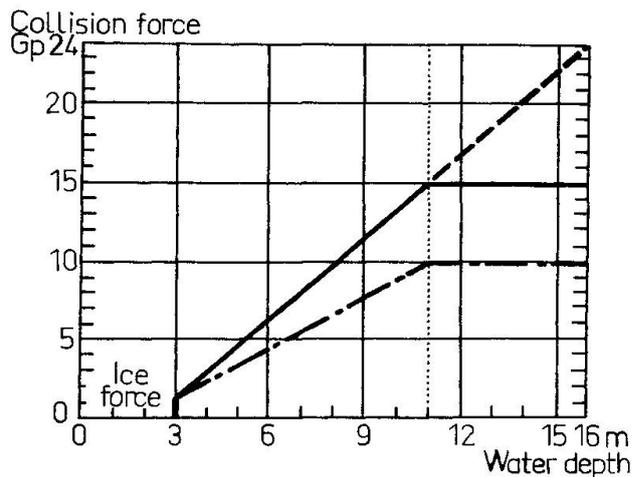
Fig 6. Design-forces due to ship-collisions for planned Öresundsbridge

The proposed design forces for the piers of the Öresundbridge are given in fig 6. They have a maximum of 150 MN and are based on the assumption of a full speed collision (16 knt) of an ordinary 40.000 dwt tanker. It was even stated, that a 100.000 dwt tanker gives forces of about 240 MN (dotted extrapolation of the main line to a draught of about 16 m).

- that piling foundations - if possible - should be avoided,
- that the pier shafts should be made of reinforced concrete with at least 2 m walls, surface reinforcement $\phi 25 \neq c 200$,
- that the cross section of the pier should be given a form which would be capable to break through the shipshull,
- that the pier shafts should be made in one piece, if minor than 10 m wide,
- that the bearings should be properly fixed on the top of the pier,
- that the collision forces may be regarded as ultimate loads, safety factor 1,0.

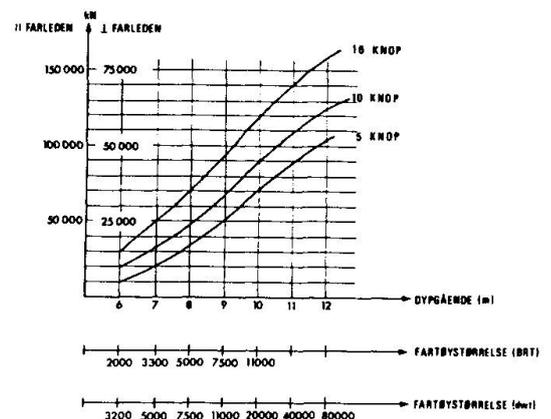
Fig 7. Shipcollision forces according to Nordic Recommendations

The recommended design forces are shown in fig 7. They are applied as statical loads in the water level on the piers on each side of the navigation channel, perpendicular to the bridge's axis (parallel to the channel). In the direction of the bridge's axis and on other piers, far away from the channel, minor forces (e.g. 50 %) can be chosen as design loads. The characteristic ship size, when using the diagram fig 7, is that size of ships, which can be expected to pass the channel a certain number of passages a year, depending on the nautical difficulties in the channel, e.g. 100 passages/year in a easy navigated channel.

The Nordic Recommendations /3/ have been developed from the Swedish rules. The proposed collision forces are based on the same study /2/, using Minorskys energy-formula. But there are made some justifications in order to take account of the risk that big ships can sail in shallow water when unloaded. Moreover the risk of side-way collisions at low speed has been observed. Last not least some extrapolation has been made into the low energy area, which not can be handled according Minorskys formula, but which is of great importance for small bridges passed by minor ships.

The general detailing rules, as mentioned in 2.2 above are valid also according to the Nordic Recommendations. The pier-dimensions may be changed in relation to the various impact forces. The large forces might be handled as surface loadings of about 2000 kN/m^2 , which corresponds to the strength of the hull of large ships. For minor impact about 500 kN/m^2 is adequate.
