Ship Collisions with Bridges in Sweden

Werner von OLNHAUSEN
Head, bridge section,
Swedish Natl. Road Adm.
Borlänge, Sweden

The article gives some facts about five ship collisions with bridges, which have happened in Sweden since 1965. The road administration has developed design rules, which have been applied for new bridges since 1967. After the Tjörn bridge disaster in 1980 a complete survey was made of the collision risk at all Swedish bridges.

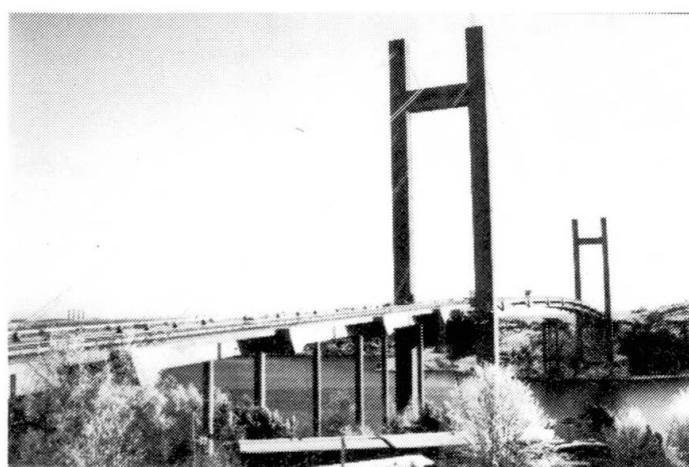
About 16 month after the order - certainly a remarkable record in construction time - two lanes of the new bridge could be taken into use on Nov. 9th 1981, fig 3. The total cost for the new bridge and the temporary ferries was about 210 M SEK.

Fig 3. The new Tjörnbridge

The collaps of the bridge interrupted a very important communication for the people on the islands of Orust and Tjörn, prolonging the roadway distance to Gothenburg by about 80 km. A provisional ferry-lane was therefore established immediately after the disaster, giving a capacity of about 2000 vehicles/day. At the same time a new bridge was planned and - after an international competition - the order for its construction was given in medio July 1980 to a Swedish-German consortium. The new bridge was built on the same place, but as a cable-stayed steel boxbeam of 366 m theoretical span. The about 100 m high pylons and the approaches were made in reinforced concrete. In order to make sure that the new bridge not could be hit by a ship, the pylons were placed on the rocks about 25 m on land. The free height was chosen to 45,3 m on 110 m width.-
