**Artikel:** Analysis of a Brunelleschi-type dome including thermal loads  
**Autor:** Chiarugi, A. / Fanelli, M. / Giuseppetti, G.  
**DOI:** <https://doi.org/10.5169/seals-35847>

## Analysis of a Brunelleschi-Type Dome Including Thermal Loads

This paper deals with an important historical monument: the Florence Cathedral dome. A Brunelleschi-type octagonal double-shell dome structure, was studied using a finite element model which reproduced its general geometry and various cases of load and restraint. The material was assumed to be linear-elastic, however, non-linear geometry was introduced by analysing gradual crack development as indicated by the present situation. Besides static loads with various assumed restraints, thermal loads were also considered in accordance with yearly periodic variations. The superposition of these effects gives some hints on the origin of the present cracks and the static performance of the cracked structure.

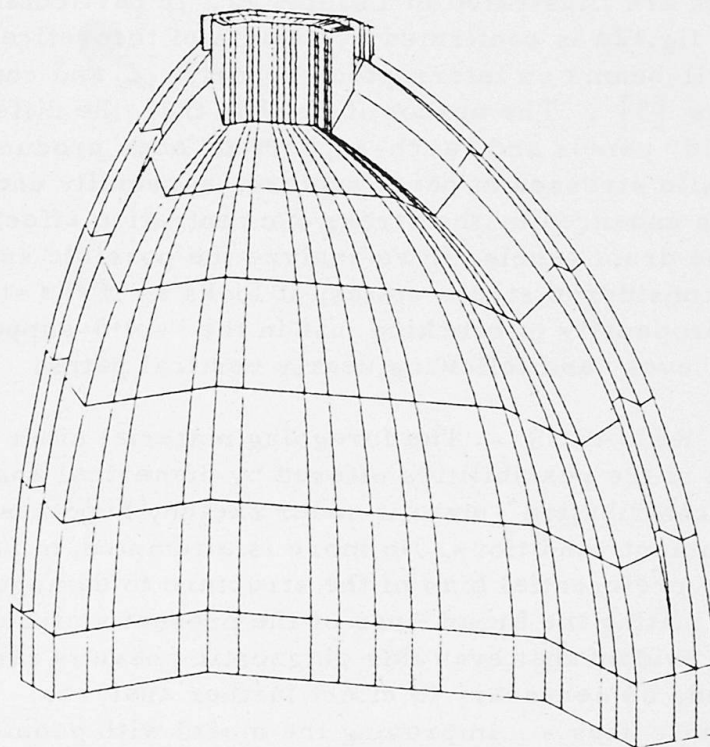
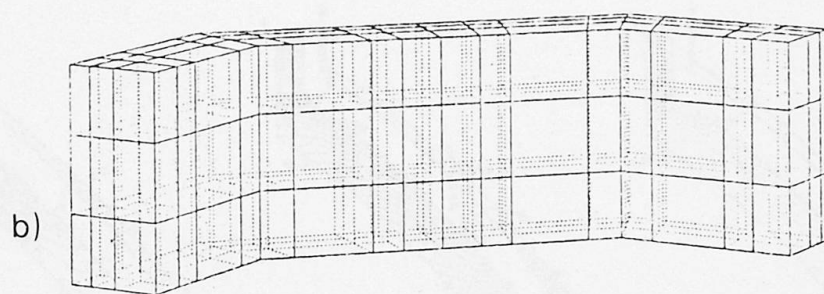
Fig. 1 a)

Fig. 1 - a) F.E. mesh of a quarter of the dome ; b) F.E. mesh of the drum underlying the dome

RESULTS - In order to achieve the abovesaid aims we defined at first the geometry of an ideal octogonal, regular, double-shell symmetric dome, the vertical profiles at corners being circular. The two shells are connected not only by the corner ribs, but also by two equally spaced ribs for every panel. To this model we attributed ideal mechanical characteristics of an elastic, homogeneous, isotropic solid (Young modulus  $E = 50,000 \text{ kg cm}^{-2}$ ; Poisson ratio 0.2; thermal dilatation coefficient  $\alpha = .8 \cdot 10^{-5} (\text{°C})^{-1}$ ; thermal diffusivity  $a = 16 \text{ cm}^2 \text{ h}^{-1}$ ). We intended to assess on such a structure -in this preliminary phase- only the effects of deadweight and of yearly sinusoidal thermal variations. To this end a F.E. mesh was built up for one quarter of the dome, cut by two orthogonal vertical symmetry planes (fig. 1 a). In order to better define the constraint conditions at the dome basis a quarter of the underlying drum, as schematized by the F.E. mesh of fig. 1 b, was later joined to the dome quarter of fig. 1 a. In this "dome plus drum" mesh there are 428 elements (2nd order, isoparametric ones with 20 or 15 nodes) and 2667 nodes. Some first-approach computations concerned only the dome, under different constraint hypotheses at the basis, assuming different degrees of participation for the outer shell, and also applying stiffness and deadweight either in one stage or in 7 successive stages broadly simulating the construction process. Passing over these first approaches, we intend here to illustrate the main results obtained by analysing the "dome plus drum" structure with complete constraints at the drum basis, under deadweight (including that of the skylight, acting on the upper rim of dome) and yearly periodic temperature variations. All these conditions were applied both to the intact and the cracked structure (see fig. 2, [1]). The position of cracks was defined by schematizing the actual cracking pattern, i.e. following vertical planes symmetrically intersecting four out of the eight dome panels (those at  $45^\circ$  from the plan cross axes). As concerns the extension in height of the cracks, an iterative computation was performed by raising in steps the upper tip of the cracks, until the tensile stresses that tended to

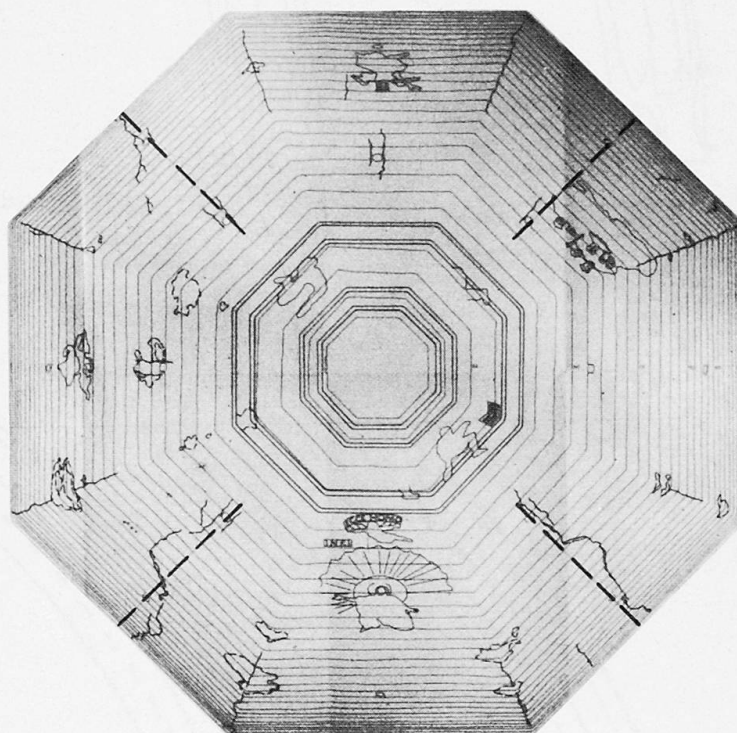
Fig. 2 - Nadiral view of crack pattern in Florence Cathedral dome  
(-----) assumed cracks

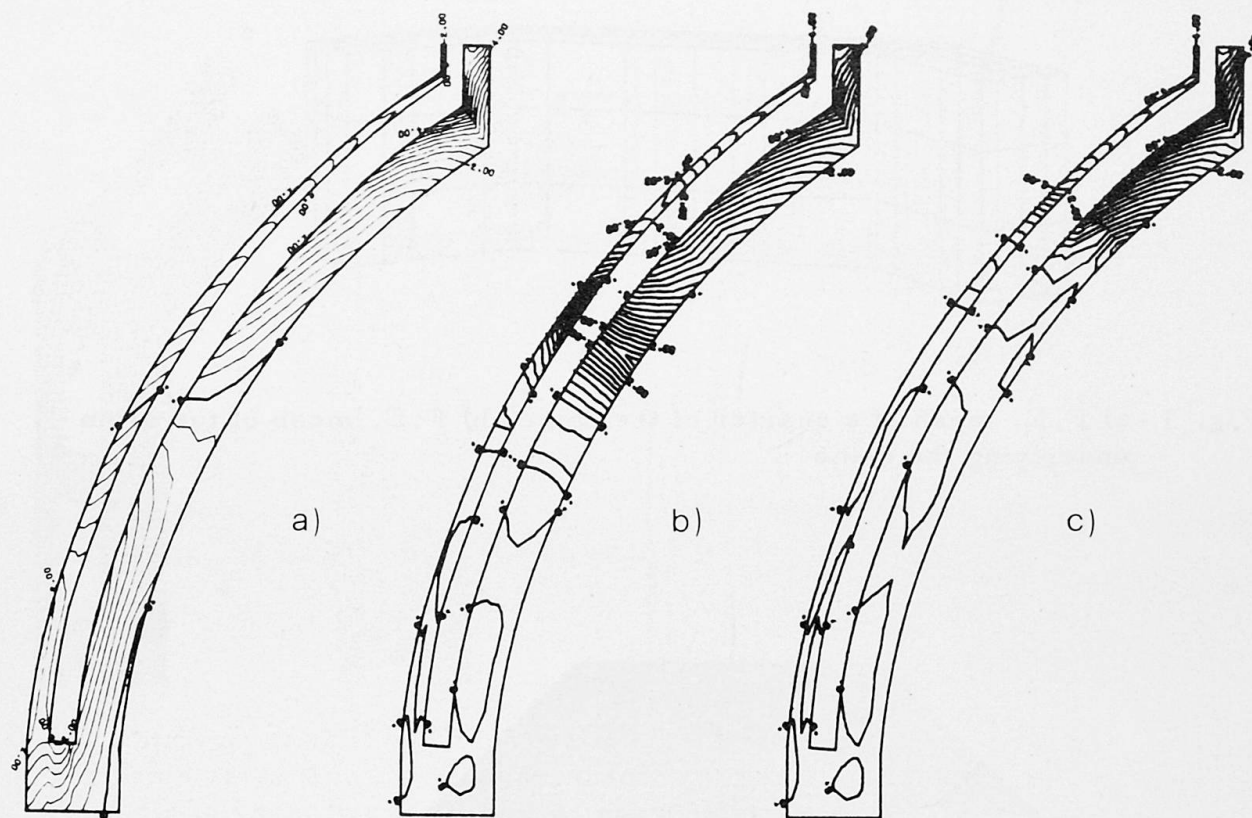
Fig. 3 - Contour lines of  $\sigma_x$  in the cross-section at mid-panel (load = dead-weight) ; a) uncracked structure; b) crack up to one-half height; c) crack up to two-third height

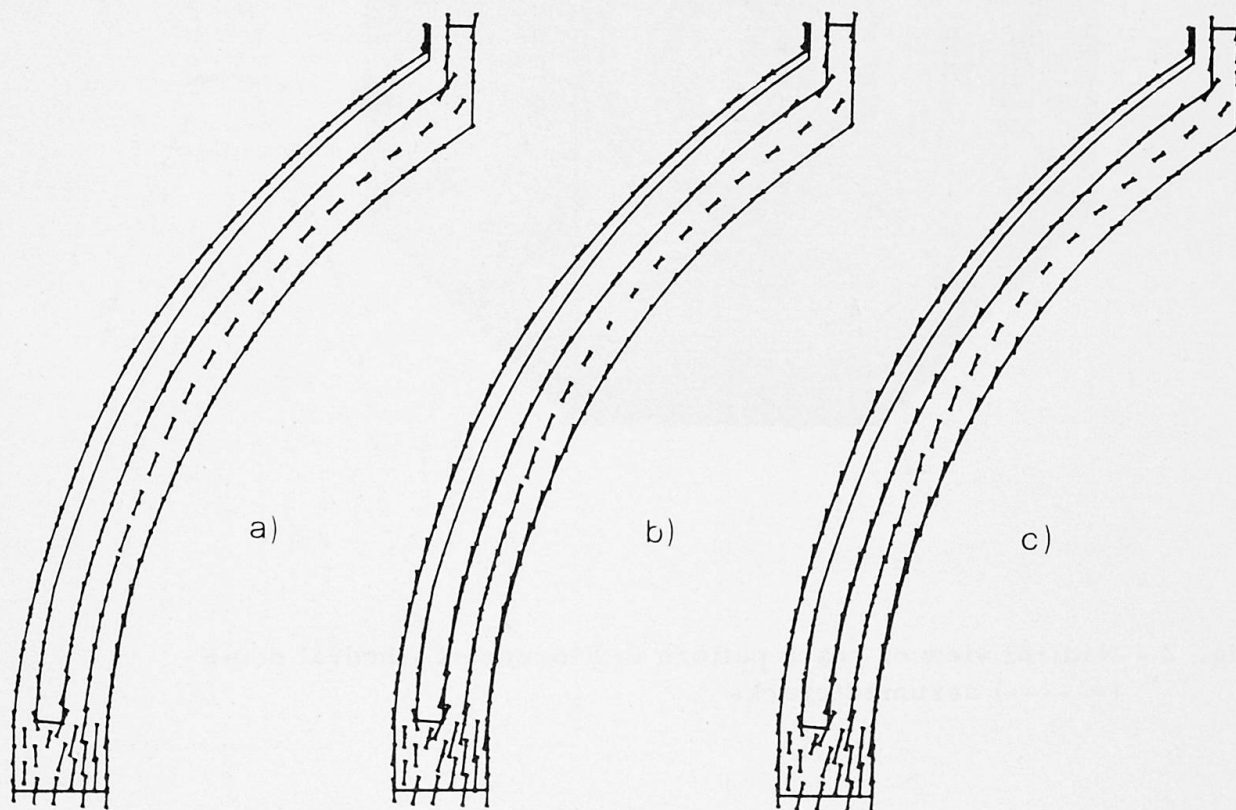
Fig. 4 - Principal stresses in cross-section at mid-panel: a) b) c) as in fig. 3 (load=deadweight)

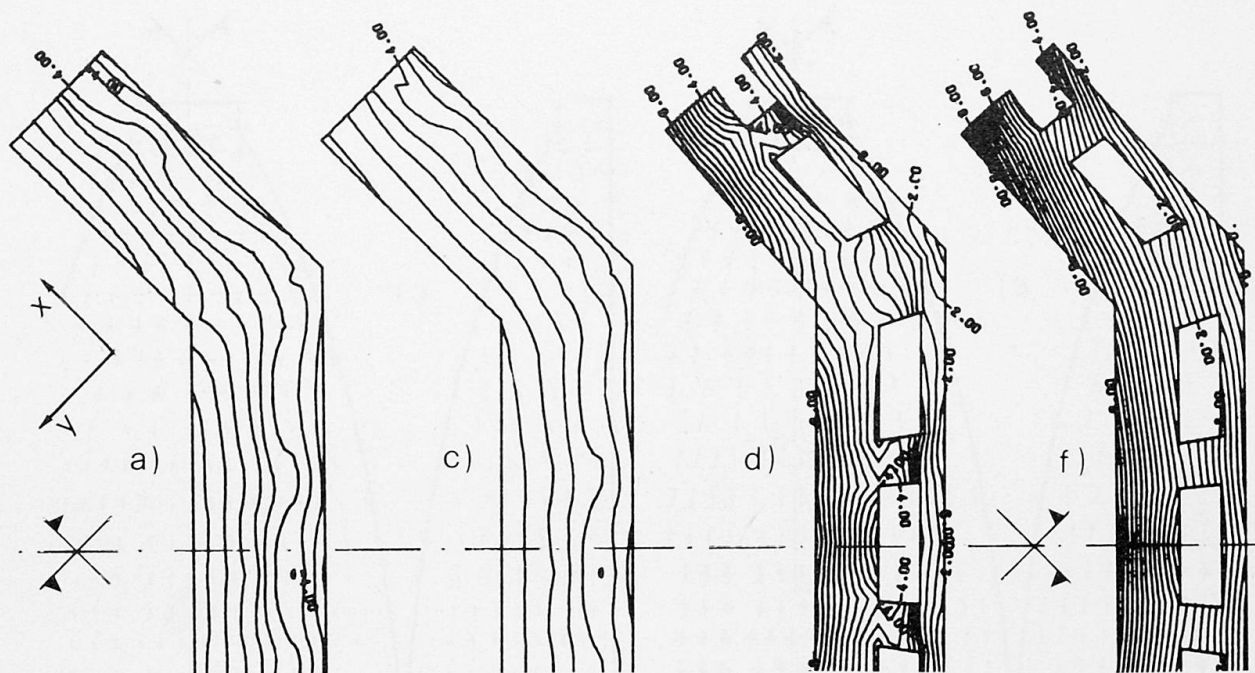
Fig. 5 - Contour lines of  $\sigma_z$  in horizontal sections: a) c) as in fig. 3 for hor. sect. at level of first gallery (load=deadweight); d) f) same as a) c) but for hor. sect. at level between second and third layer of elements in fig. 1 a)

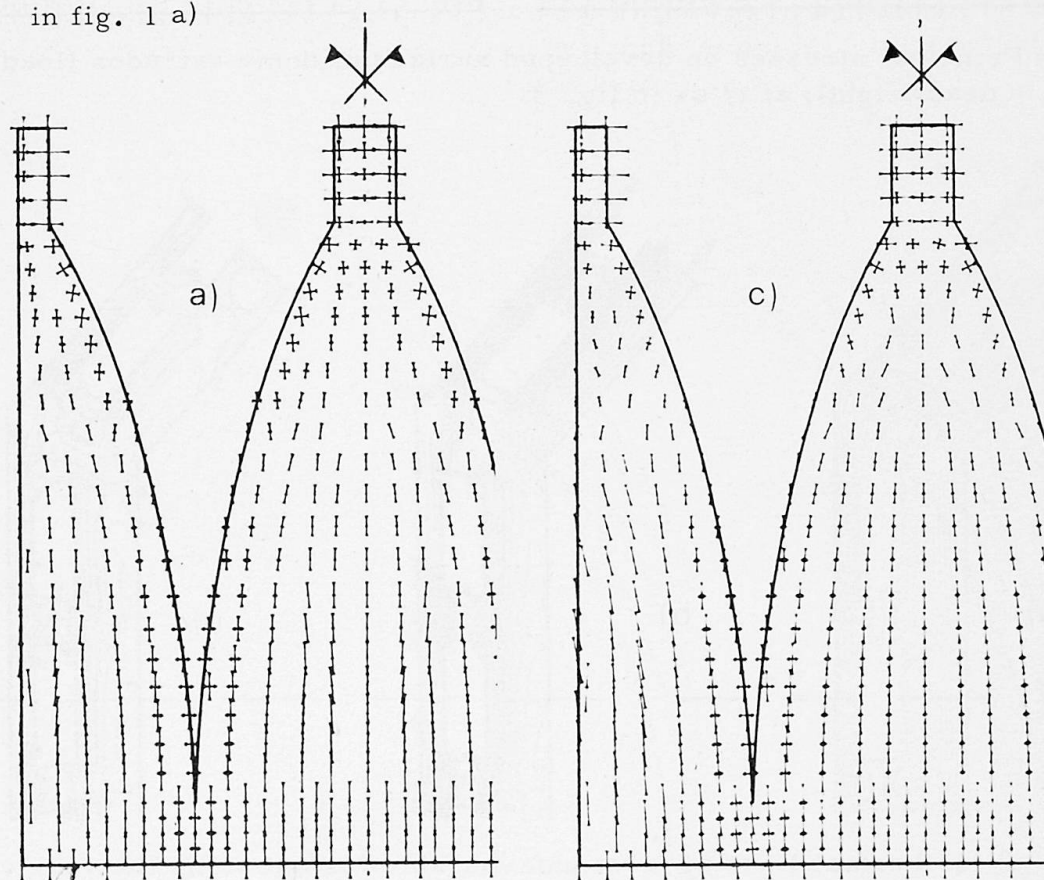
Fig. 6 - Principal stresses on developed surface of dome intrados (load = deadweight); a) c) as in fig. 3

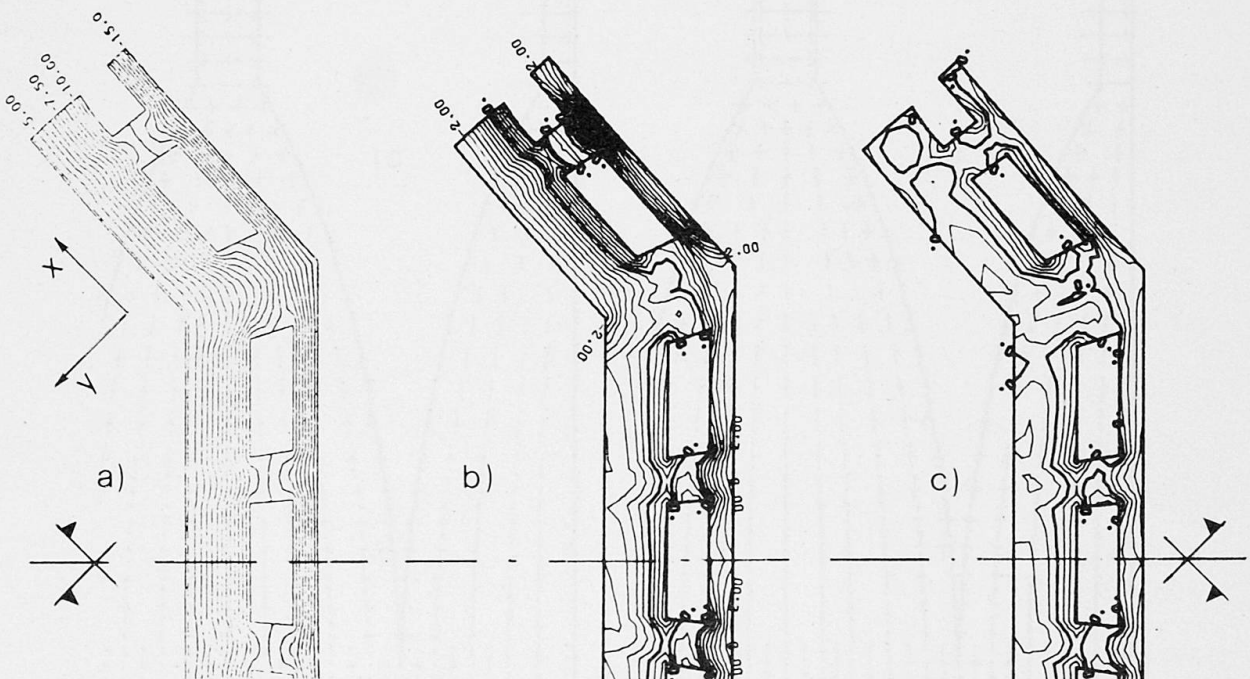
Fig. 8 - a) Isothermal lines at most unfavourable instant along the yearly cycle (Jan.) at hor. sect. between second and third layer of elements in fig. 1 a); b) Horiz. sect. between second and third layer of elements in fig. 1 a): contour lines for  $\sigma_x$ , uncracked structure, thermal load at Jan.; c) as b), but for cracked structure, maximum extension of cracks

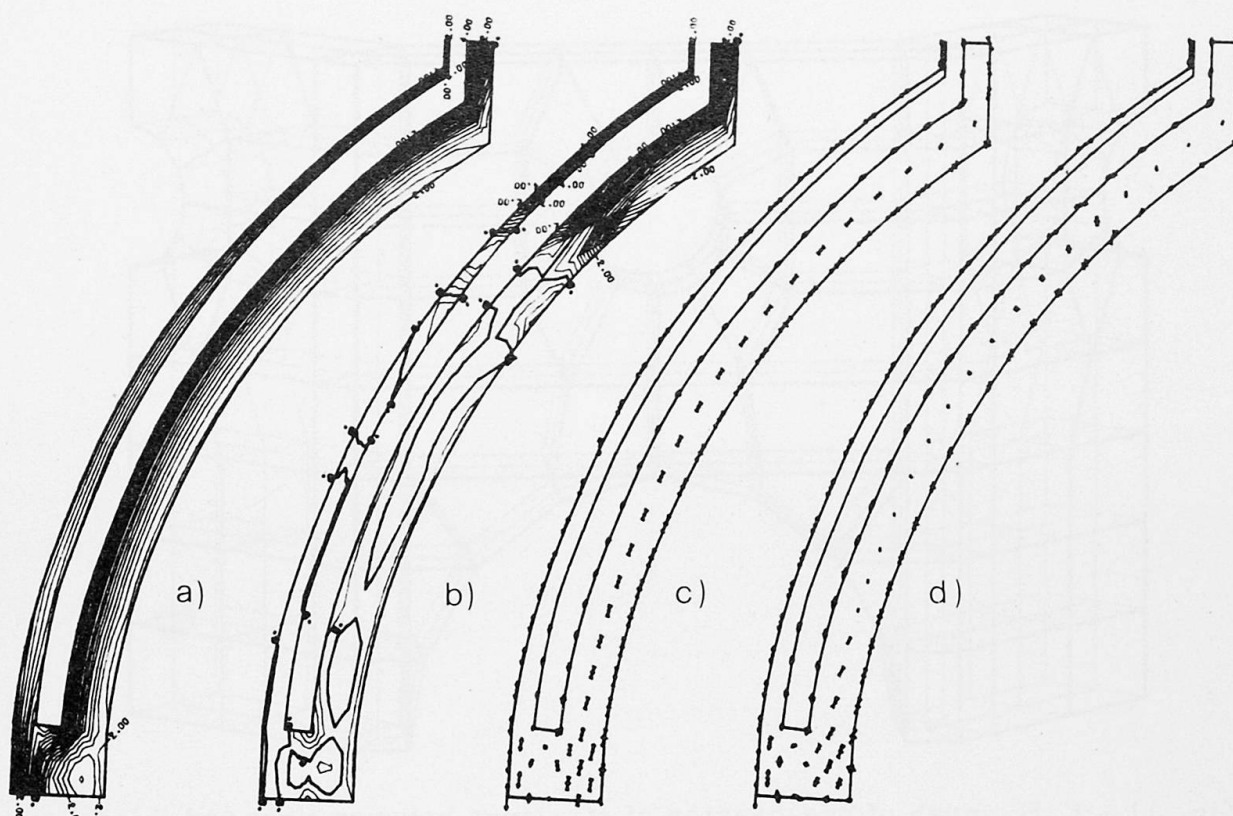
Fig. 9- a) Contour lines for  $\sigma_x$  on vertical cross-section at mid-panel, uncracked structure, thermal load at Jan.; b) as a), but for cracked structure, max. extension of cracks; c) principal stresses on vertical cross-section at mid-panel, uncracked structure, thermal load at Jan.; d) as c), but for cracked structure, max. extension of cracks

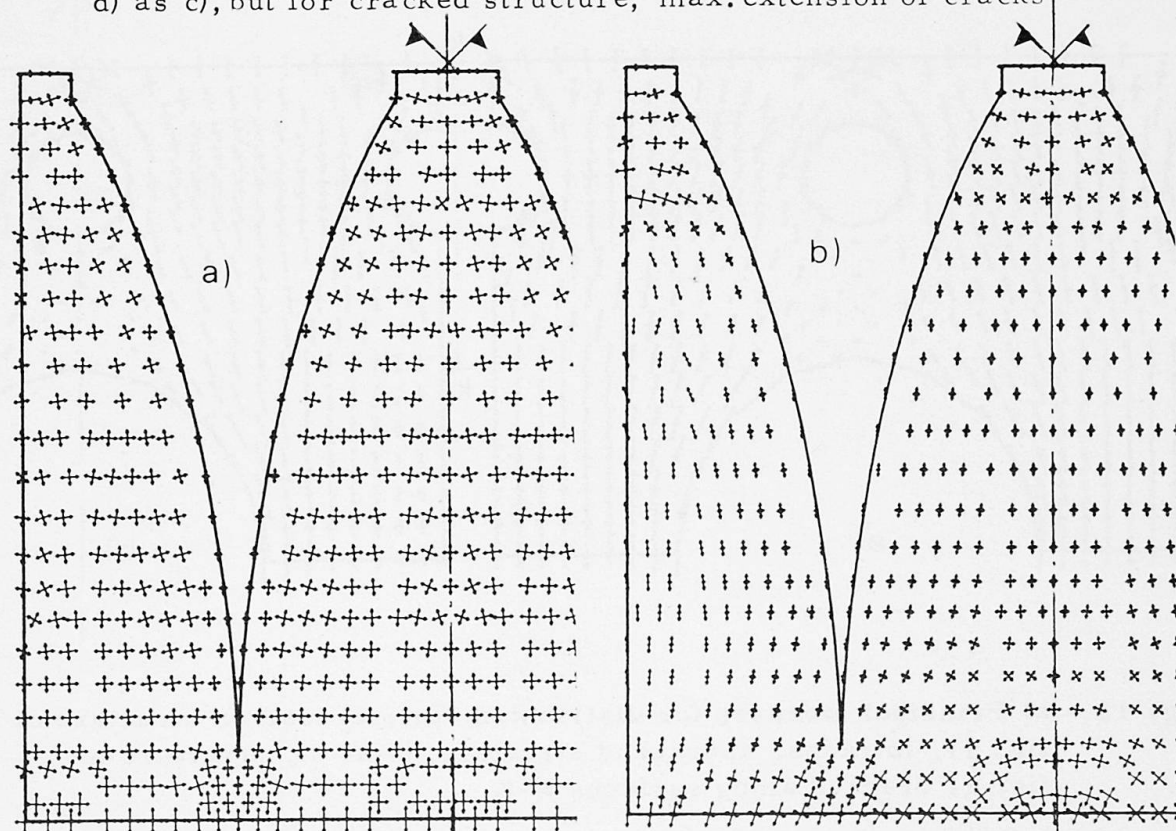
Fig. 10 - a) Thermal load at Jan., uncracked structure; principal stresses on extrados; b) as a), but for cracked structure, max. extension of cracks

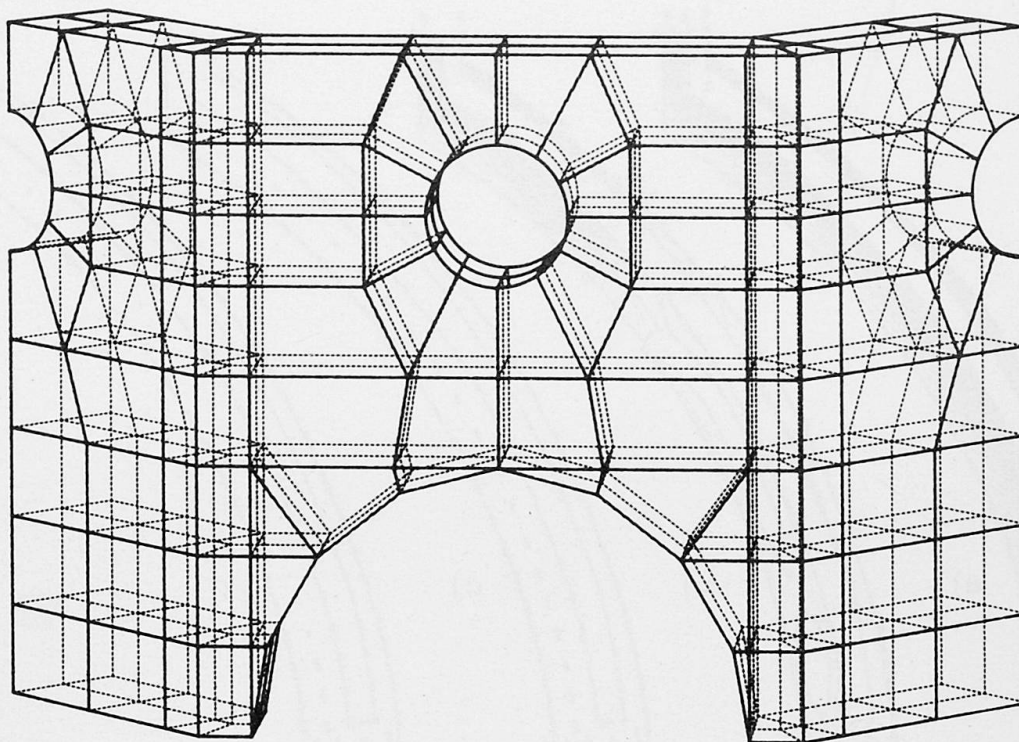
Fig. 11 - F.E. mesh of one-quarter of structure between first and third gallery

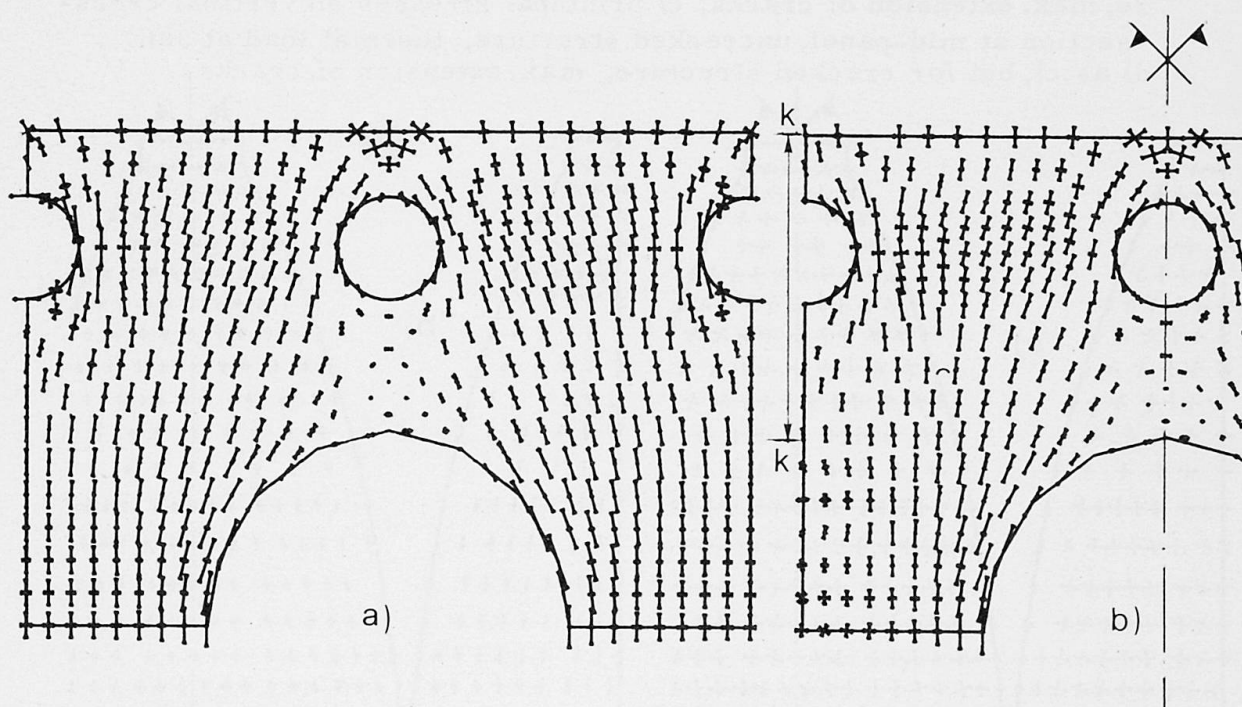
Fig. 12 - a) Principal stresses for distributed vertical load on structure of fig. 11, intrados, uncracked structure; b) as a), structure of fig. 11 cracked along surfaces K-K

Some of the results are illustrated in figure 12. In particular, the stress pattern seen from fig. 12a is confirmed by results of theoretical studies concerning curved wall-beams on interrupted supports [2] and continuous, curved intrados beams [3]. The upshot of it all is that the difference in stiffness between "solid" panels and "arch-supported" ones produces a bias in the horizontal tensile stresses at panel centers, especially under vertical loads. This bias is enhanced by the stress-concentration effect due to the "eyes" piercing the drum panels. If we analyze the possible superpositions of the previously considered stress states, it looks as if the structure possessed a natural propensity to cracking just in the "solid-supported" panels, starting from the "eyes" and following nearly vertical paths.
