**Artikel:** Analysis of a Brunelleschi-type dome including thermal loads  
**Autor:** Chiarugi, A. / Fanelli, M. / Giuseppetti, G.  
**DOI:** <https://doi.org/10.5169/seals-35847>

## Analysis of a Brunelleschi-Type Dome Including Thermal Loads

This paper deals with an important historical monument: the Florence Cathedral dome. A Brunelleschi-type octagonal double-shell dome structure, was studied using a finite element model which reproduced its general geometry and various cases of load and restraint. The material was assumed to be linear-elastic, however, non-linear geometry was introduced by analysing gradual crack development as indicated by the present situation. Besides static loads with various assumed restraints, thermal loads were also considered in accordance with yearly periodic variations. The superposition of these effects gives some hints on the origin of the present cracks and the static performance of the cracked structure.

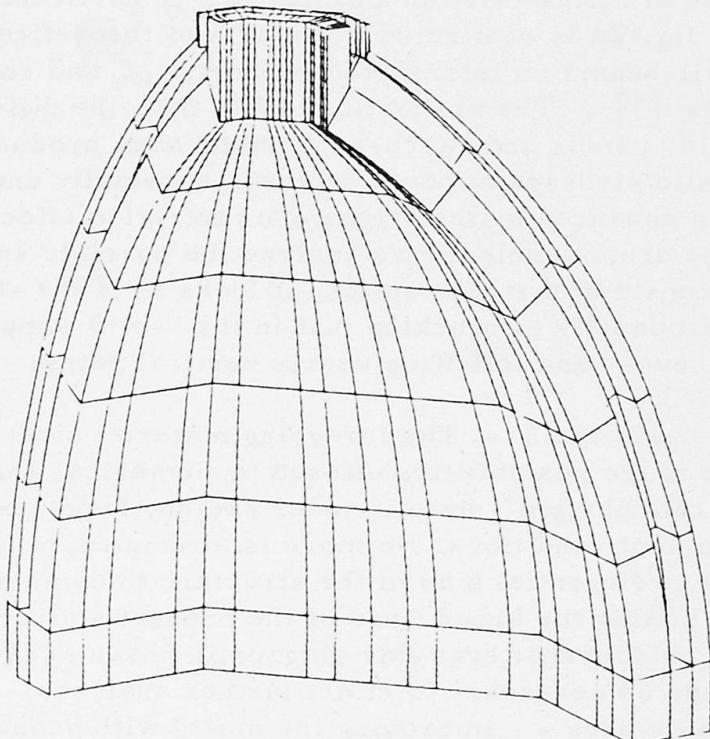
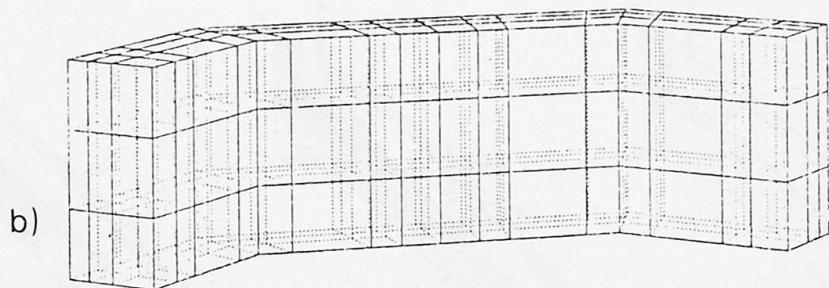
Fig. 1 a)

Fig. 1 - a) F.E. mesh of a quarter of the dome ; b) F.E. mesh of the drum underlying the dome

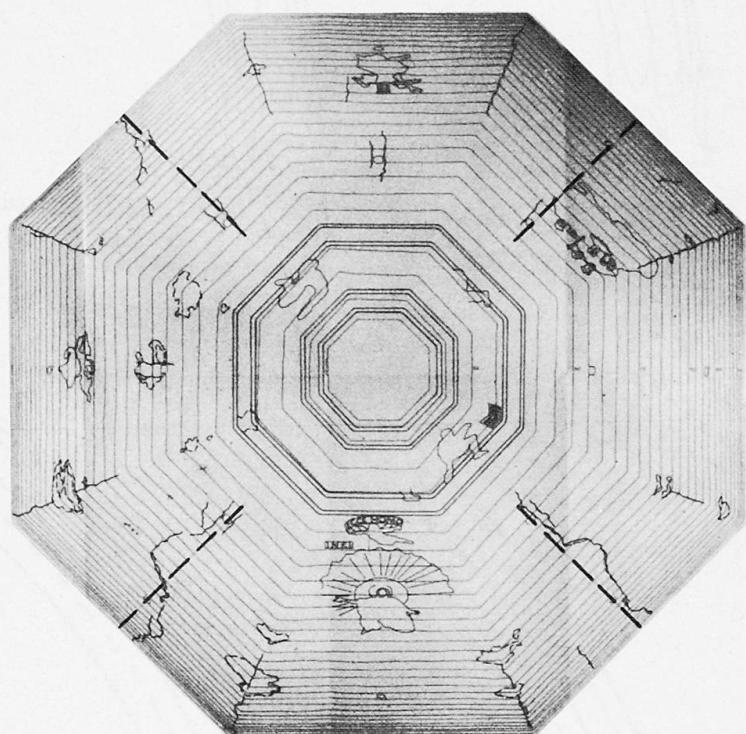
Fig. 2 - Nadiral view of crack pattern in Florence Cathedral dome  
(- - -) assumed cracks

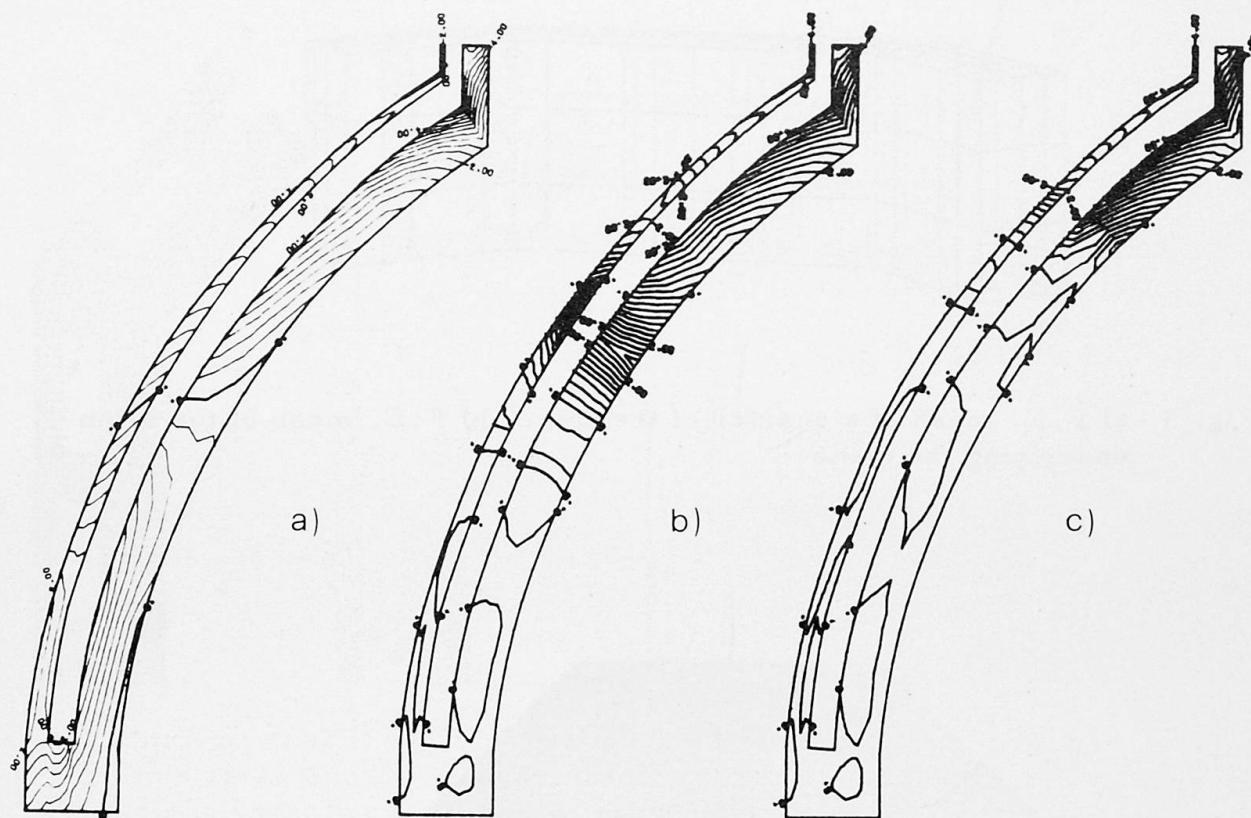
Fig. 3 - Contour lines of  $\sigma_x$  in the cross-section at mid-panel (load = dead-weight); a) uncracked structure; b) crack up to one-half height; c) crack up to two-third height

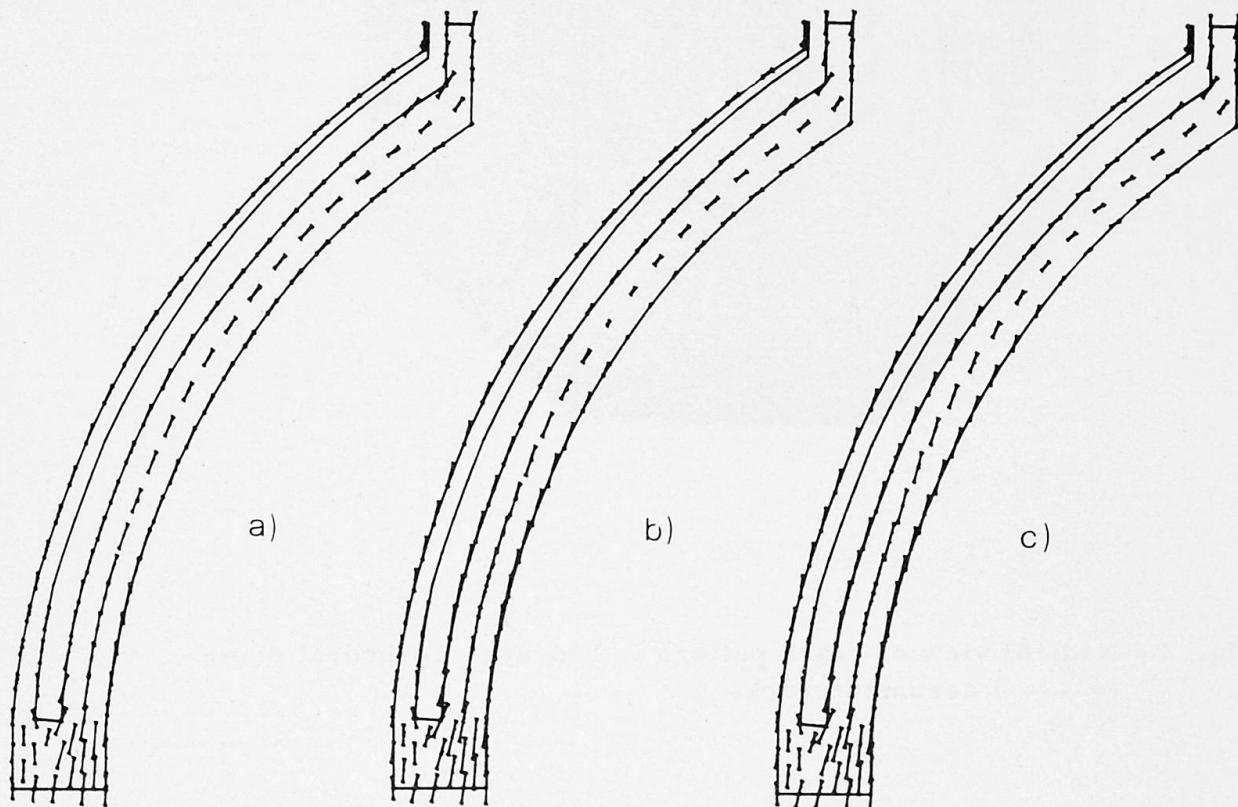
Fig. 4 - Principal stresses in cross-section at mid-panel: a) b) c) as in fig. 3 (load=deadweight)

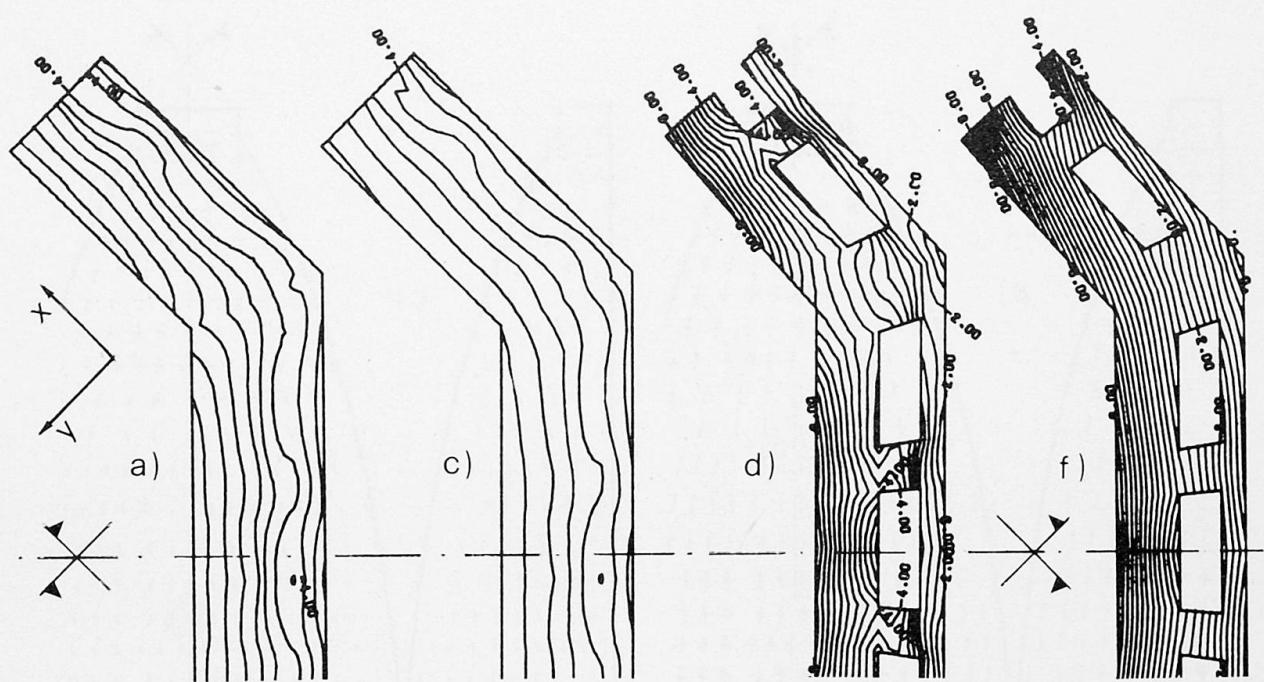
Fig. 5 - Contour lines of  $\sigma_z$  in horizontal sections: a) c) as in fig. 3 for hor. sect. at level of first gallery (load=deadweight); d) f) same as a) c) but for hor. sect. at level between second and third layer of elements in fig. 1 a)

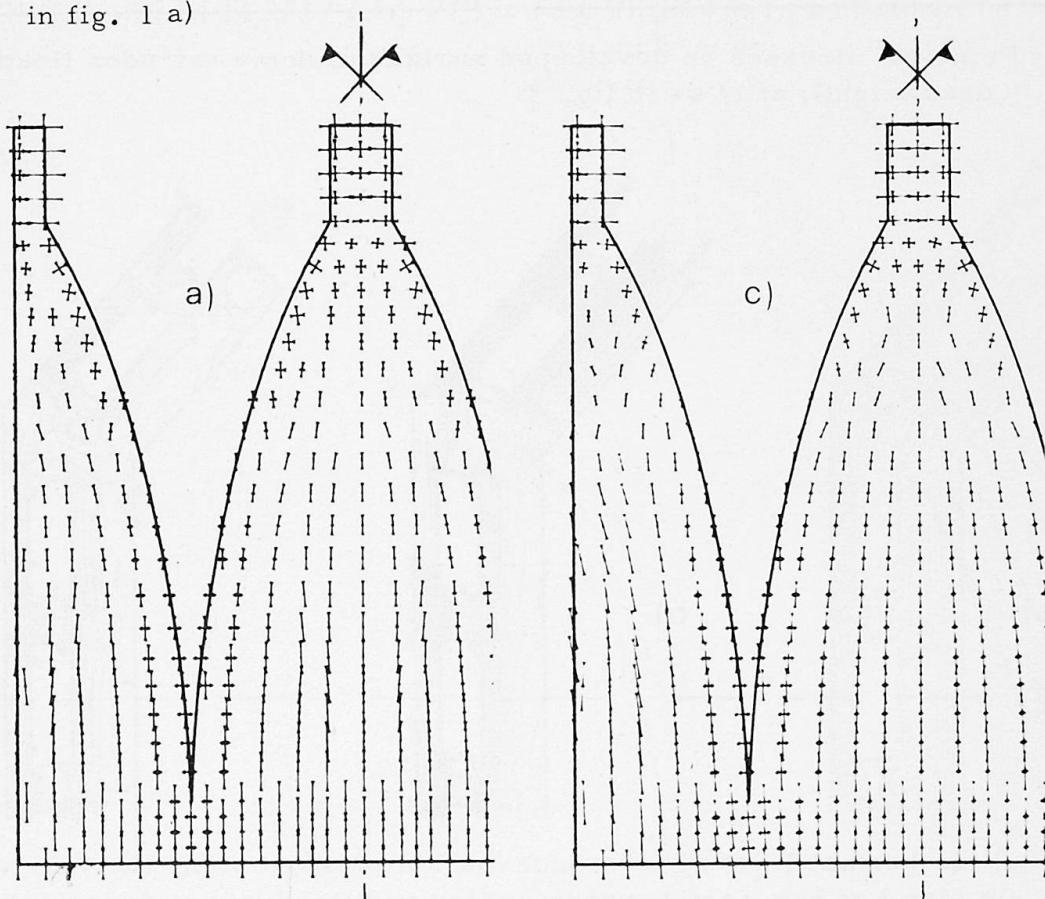
Fig. 6 - Principal stresses on developed surface of dome intrados (load = deadweight); a) c) as in fig. 3

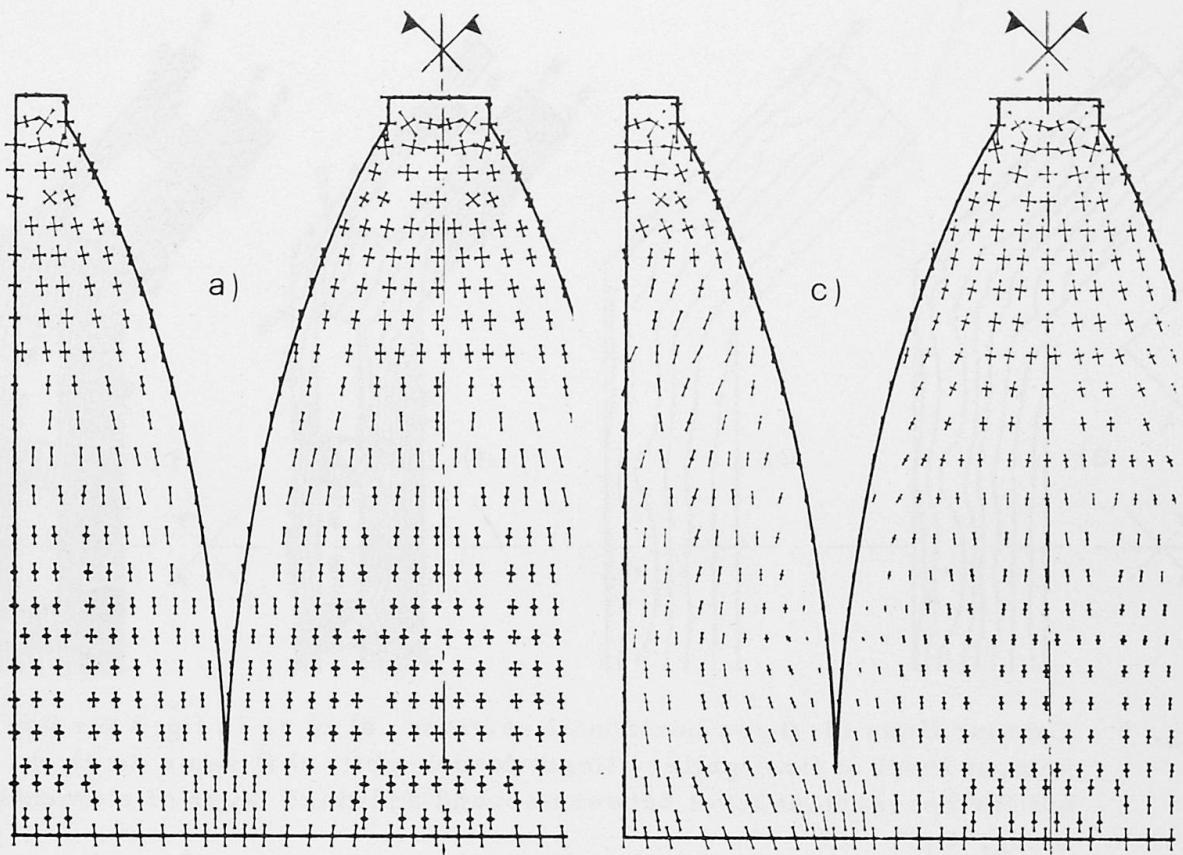
Fig. 7 - Principal stresses on developed surface of dome extrados (load = deadweight); a) c) as in fig. 3

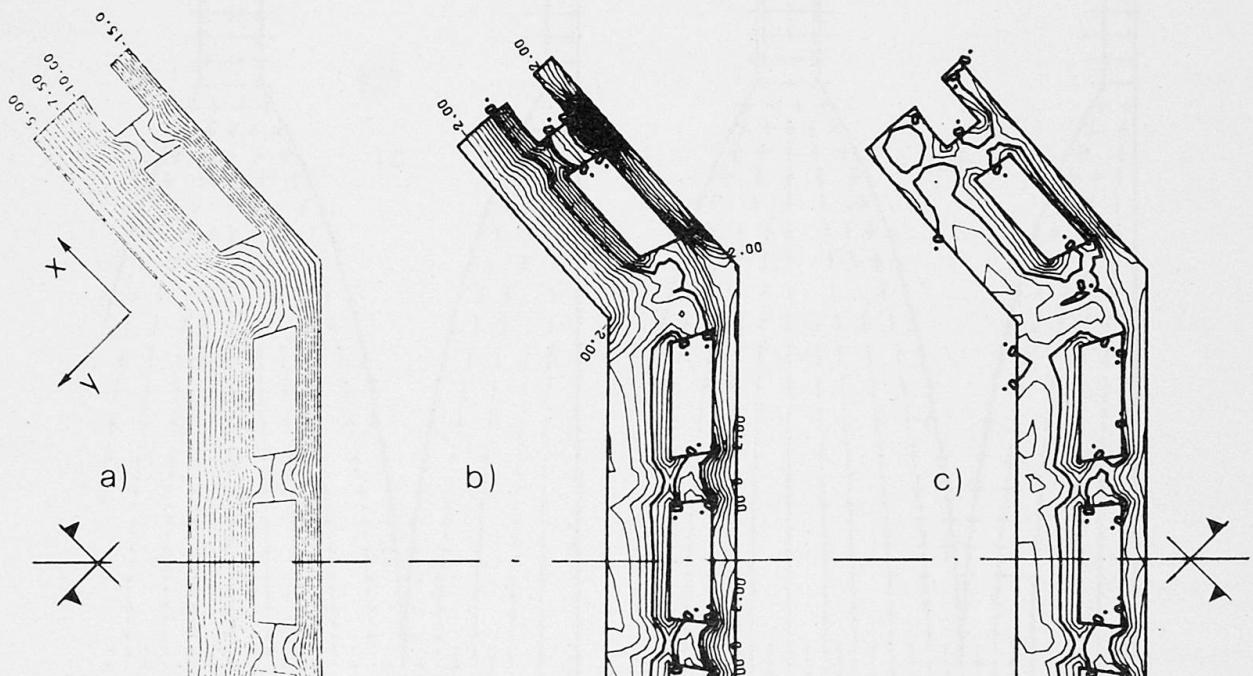
Fig. 8 - a) Isothermal lines at most unfavourable instant along the yearly cycle (Jan.) at hor. sect. between second and third layer of elements in fig. 1 a); b) Horiz. sect. between second and third layer of elements in fig. 1 a): contour lines for  $\sigma_x$ , uncracked structure, thermal load at Jan.; c) as b), but for cracked structure, maximum extension of cracks

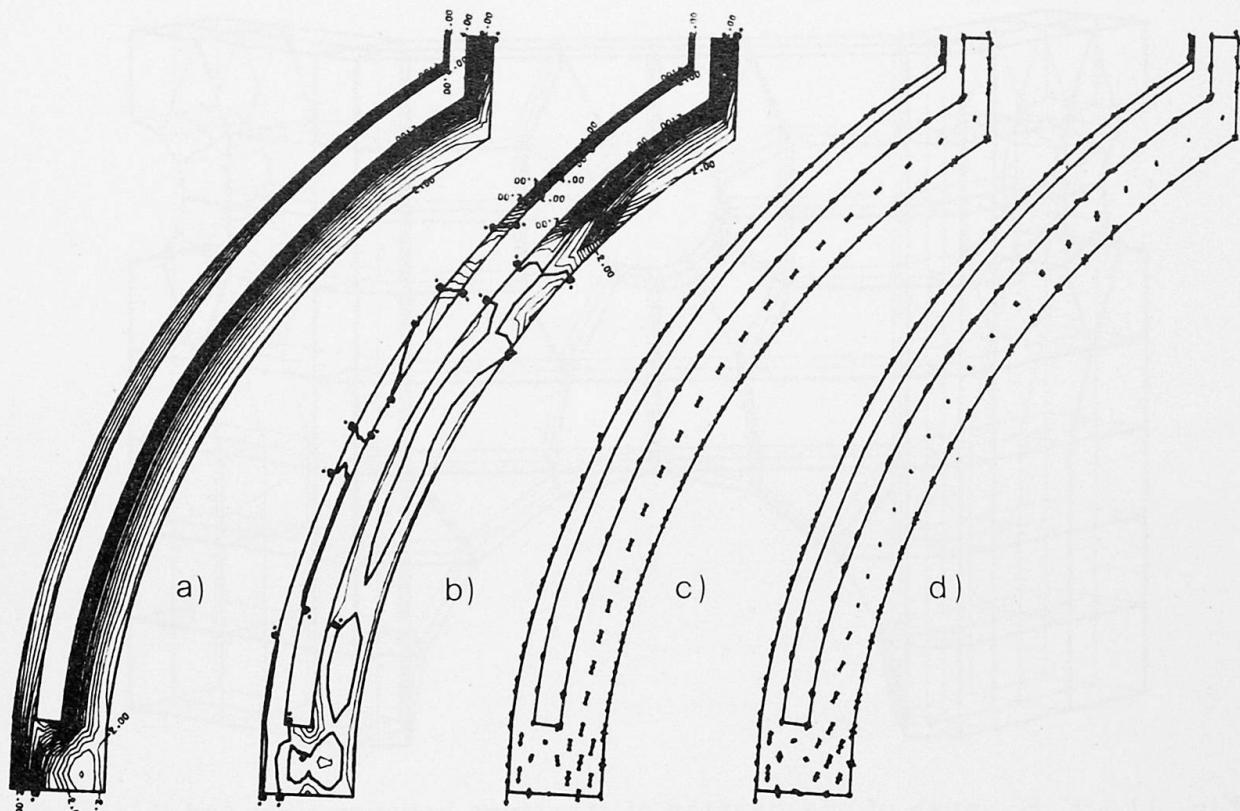
Fig. 9- a) Contour lines for  $\sigma_x$  on vertical cross-section at mid-panel, uncracked structure, thermal load at Jan.; b) as a), but for cracked structure, max. extension of cracks; c) principal stresses on vertical cross-section at mid-panel, uncracked structure, thermal load at Jan. ; d) as c), but for cracked structure, max. extension of cracks

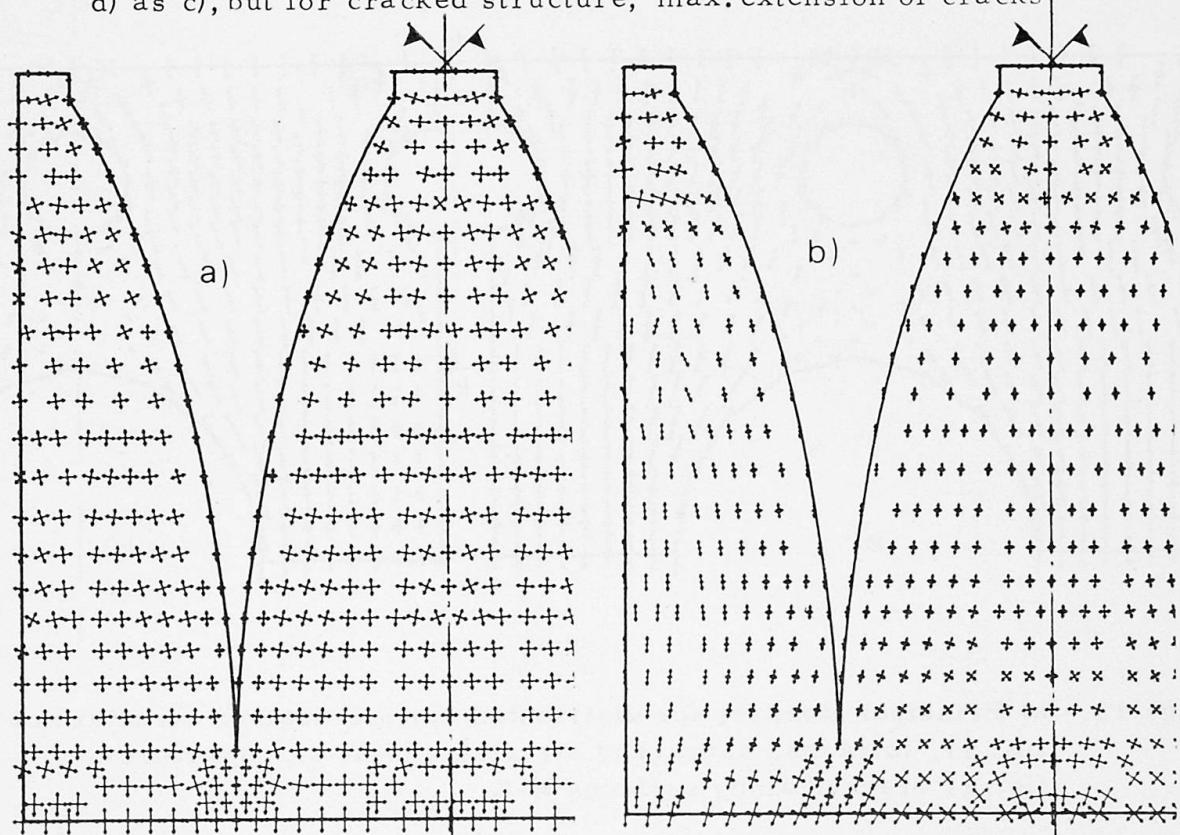
Fig. 10 - a) Thermal load at Jan., uncracked structure; principal stresses on extrados; b) as a), but for cracked structure, max. extension of cracks

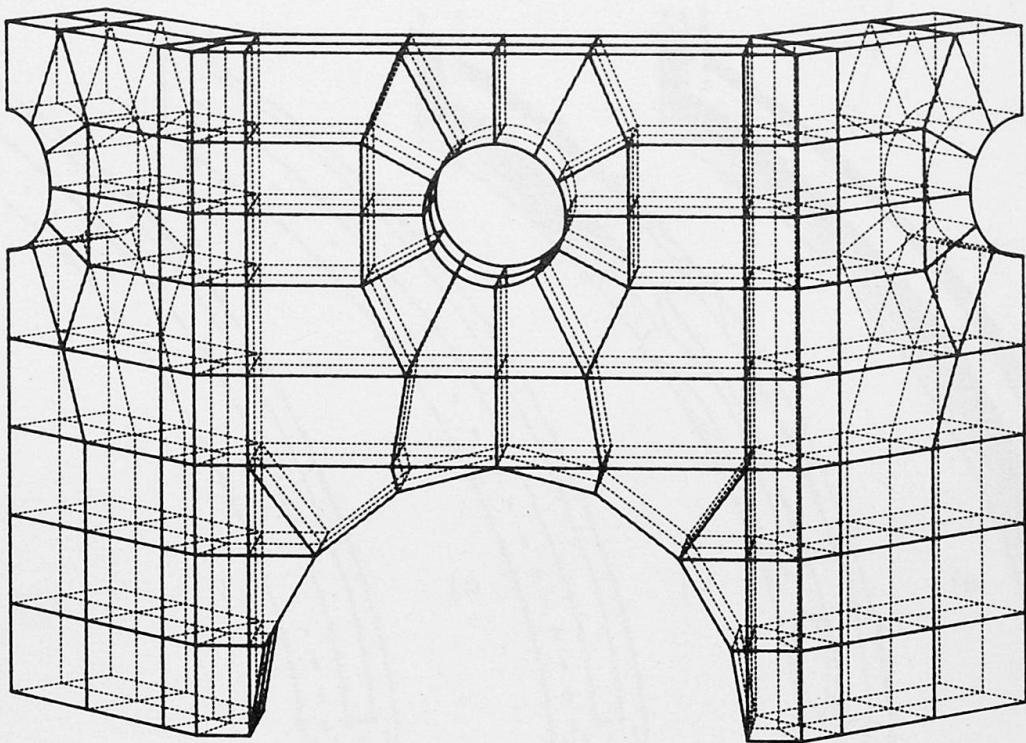
Fig. 11 - F.E. mesh of one-quarter of structure between first and third gallery

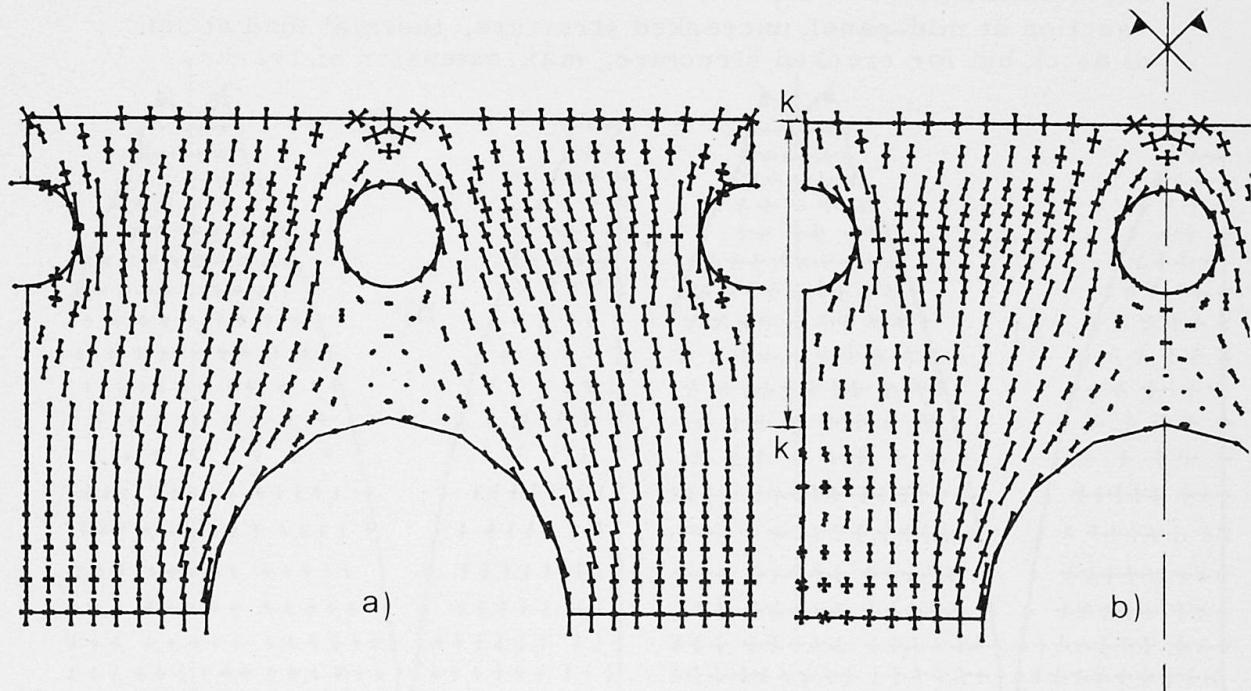
Fig. 12 - a) Principal stresses for distributed vertical load on structure of fig. 11, intrados, uncracked structure; b) as a), structure of fig. 11 cracked along surfaces K-K

Some of the results are illustrated in figure 12. In particular, the stress pattern seen from fig. 12a is confirmed by results of theoretical studies concerning curved wall-beams on interrupted supports [2] and continuous, curved intrados beams [3]. The upshot of it all is that the difference in stiffness between "solid" panels and "arch-supported" ones produces a bias in the horizontal tensile stresses at panel centers, especially under vertical loads. This bias is enhanced by the stress-concentration effect due to the "eyes" piercing the drum panels. If we analyze the possible superpositions of the previously considered stress states, it looks as if the structure possessed a natural propensity to cracking just in the "solid-supported" panels, starting from the "eyes" and following nearly vertical paths.
