Artikel: Non-linear analysis and strengthening of a reinforced concrete building
Autor: Cantù, Ester / Cauvin, Aldo
DOI: <https://doi.org/10.5169/seals-35853>

Non-linear Analysis and Strengthening of a Reinforced Concrete Building

Severe disorders appearing in a reinforced concrete framed building led to the necessity of determining its safety level. This aim was achieved both with experimental tests and with numerical analyses, linear and non-linear. Non-linear analysis proved to be very useful in determining the moment redistribution capability of the structure and realistic values of displacements.

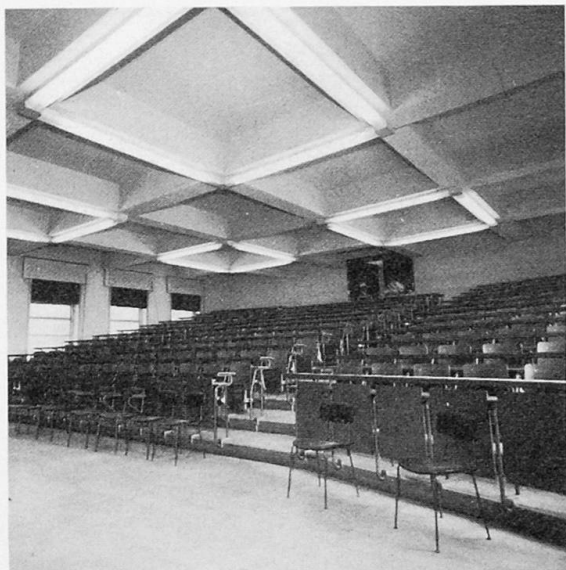
Fig.1 Typical floor

The aforesaid considerations were applied to the case of a recently built r.c. building, where damages occurred due to excessive deflections (Figs.1 and 2). The building is schematically shown in Fig.3: it is composed of 3 floors, the ground floor being used as lecture-hall. The others were partitioned in order to be used as studies and laboratories.

The floors, 15 meters square, are orthogonal grids of r.c. beams. These beams were designed as simply supported, despite the fact that no discontinuities exist between the beams and their supporting columns.
