Zeitschrift: IABSE reports = Rapports AIPC = IVBH Berichte
Band: 46 (1983)

Artikel: A method to assess the reliability of actual buildings
Autor: Zaupa, Francesco / Modena, Claudio / Odorizzi, Stefano
DOI: <https://doi.org/10.5169/seals-35858>

A Method to Assess the Reliability of Actual Buildings

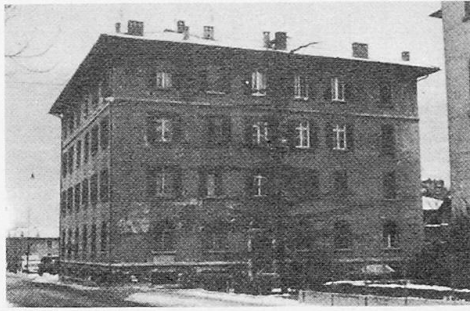
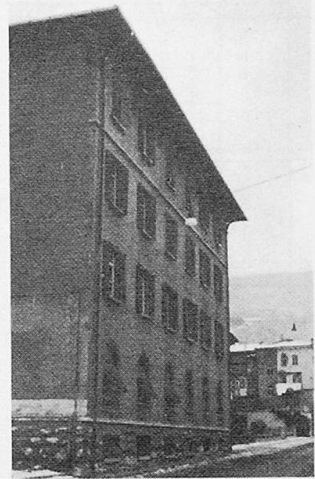
In another paper [2] a method of survey was described which could produce the quantities to form such status indexes. For the sake of completeness a standard survey schedule is shown in figure 1 and the status indexes employed are listed in the table presented in the following, together with their classification. The geometrical ones are explicated in figure 2.

SCHEMA N° 1
FONDAZIONI
Civ. n°
p.ed.
F. Mapa n°
Data
Il Tecnico rilevatore

SCHEMA N° 7
COPERTURA
Civ. n°
p.ed.
F. Mapa n°
Data
Il Tecnico rilevatore

SCHEMA N° 3
PIANO RIALZATO
Civ. n°
p.ed.
F. Mapa n°
Data
Il Tecnico rilevatore

SCHEMA N° 8
SEZIONE VERTICALE

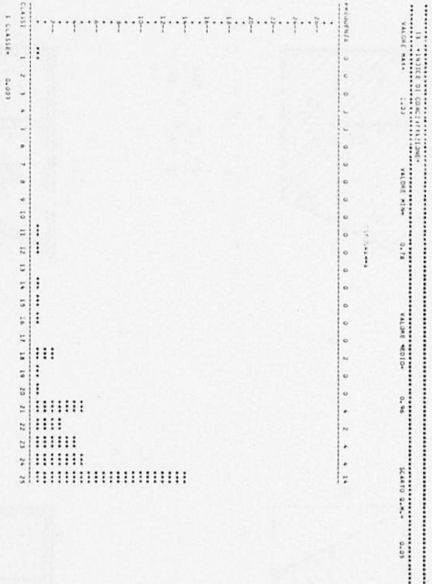
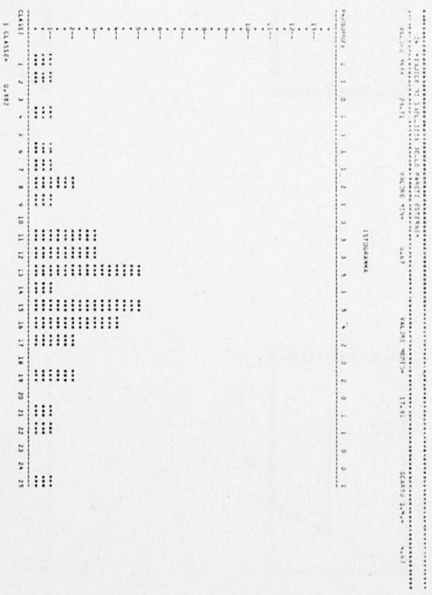
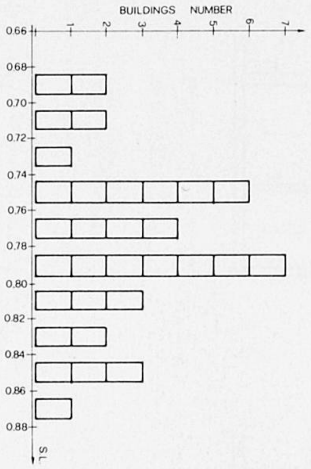
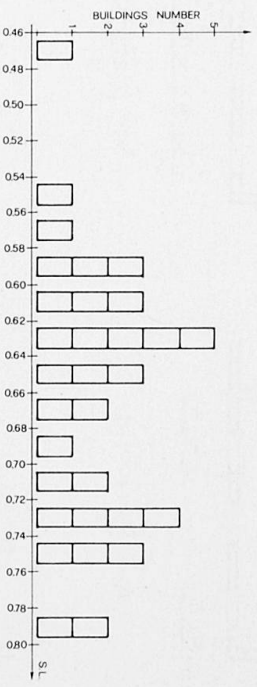
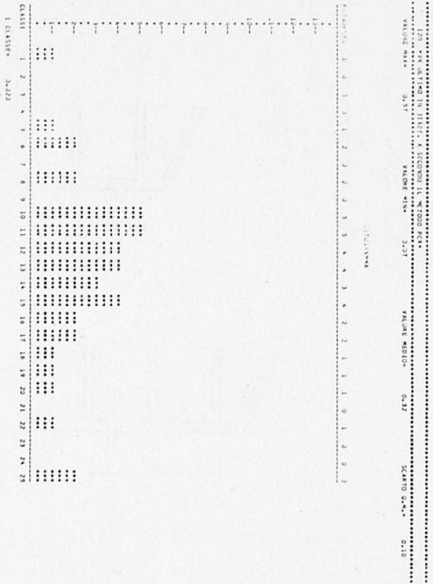
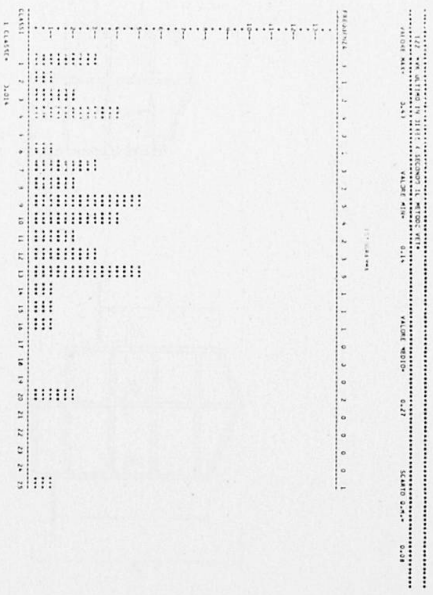
As an example the statistical distribution of indexes I 3 and I 4 are shown in figure 3.

The statistical distributions of VK are shown in figure 5a(POR method) and 5b(VET method), for seismic forces acting in one of the principal directions of the buildings.

The reliability of the obtained results can be firstly judged by comparison of figures 5a,b, and figures 4a,b, where the statistical distribution of the global safety indexes obtained from the two formulations of the safety function proposed in [1] are plotted, for a slightly reduced sample.
