Artikel: Seismic strengthening procedures for existing structures

Seismic Strengthening Procedures for Existing Structures

Loring A. WYLLIE, Jr.
Struct. Eng.
Degenkolb Assoc.
San Francisco, CA, USA

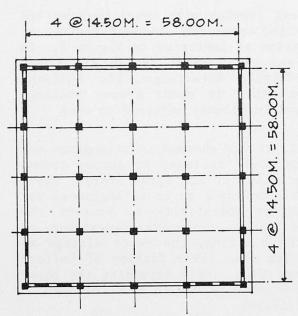
Figure 1. Typical plan of threestory Office Building in Example 1. Walls present only in upper two stories.

The existing building is a three-story reinforced concrete structure 58 meters square in plan, as shown in Figure 1. It is an office building. The First Floor is a slab on grade while the upper two floors are a concrete waffle slab

or two-way ribbed slab. The roof is of steel framing with metal decking and fill. The lateral force resisting system in the upper two stories consists of shear walls in the corner bays on each elevation as indicated in Figure 2. In the first story there are no shear walls and all lateral forces are to be resisted by concrete frames which lack ductile detailing. The building sustained spalling of columns in the first story in minor ground shaking, particularly in the stiffer exterior frames and in columns adjacent to some interior non-structural masonry walls.

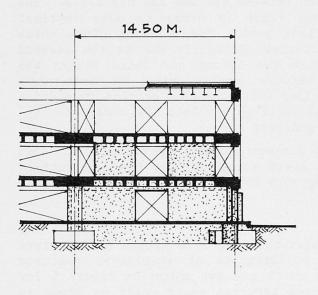
Figure 3. Partial elevation of strengthened wall system in Example 1.

Figure 4. Section through strengthened wall in Example 1.

The strengthening solution is outlined in Figures 3 and 4. Shear walls 400mm thick were added in the First Floor beneath the existing 200mm thick shear walls in the upper stories. These walls were extended upward in the Second Floor by adding a thickening of 500mm, thereby both strengthening the Second Floor as well as providing a very positive connection between the new and old walls. The thicker wall was necessary in the Second Floor in order to pass vertical reinforcement past the existing Second Floor beam. The existing 200mm thick walls were judged adequate for the top stories, basically due to the reduced mass of the roof framing. Connection with the Second and Third Floors was achieved by removing the thin slab between waffle ribs to pass wall reinforcement and place concrete. Foundations were added to provide foundation bearing in conjunction with existing spread footings for both the added gravity loads as well as the greatly increased overturning forces.

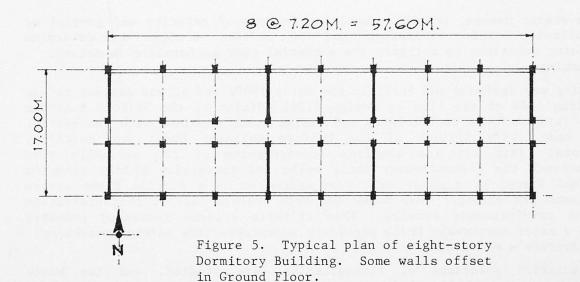
Figure 6. Scheme A strengthening adding concrete piers to existing columns to create shear wall bracing system on side walls.

Many alternative solutions of strengthening were studied, and two basic solutions were presented to the owner for consideration. Both solutions included adding new reinforced concrete shear walls in the Ground Floor where shear walls were discontinuous, with suitably reinforced doorway openings to accommodate functional uses. Scheme A involved adding reinforced concrete sections to each side of the exterior columns to develop a shear wall system between the new piers and the existing spandrel beams. This scheme is illustrated in Figure 6. Scheme B consists of adding exposed structural steel bracing on the two long sides, as shown in Figure 7, to resist the entire lateral forces in the longitudinal direction. In Scheme B, the existing top negative moment reinforcing in the spandrel beams would be cut to weaken the stiff concrete exterior frame and protect the concrete columns from extensive damage. Scheme B also recognizes that some cracking of the concrete frame in an earthquake would be necessary before the existing concrete become flexible enough to allow the steel bracing to resist lateral forces.

Scheme A requires partial vacating of the building to allow work to proceed and results in a loss of windows for natural light. This scheme is probably more pleasant aesthetically and is estimated to cost about 35% of the building's replacement cost. Scheme B allows most of the work to be performed on the outside of the building without vacating the building except portions of the Ground Floor for the shear wall work. The exposed steel frame does not result in a loss of windows. Scheme B is estimated to cost about 25% of the building's replacement cost. At the time of writing, the owner is studying the merits of the two schemes and arranging for funds to finance the strengthening work.

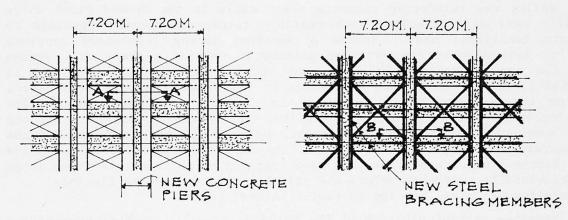
Figure 7. Scheme B strengthening adding steel bracing to existing frame on side walls.

Section B-B in Figure 7.
