Artikel: Seismic strengthening procedures for existing structures
Autor: Wyllie, Loring A. Jr.
DOI: <https://doi.org/10.5169/seals-35870>

Seismic Strengthening Procedures for Existing Structures

Loring A. WYLLIE, Jr.
Struct. Eng.
Degenkolb Assoc.
San Francisco, CA, USA

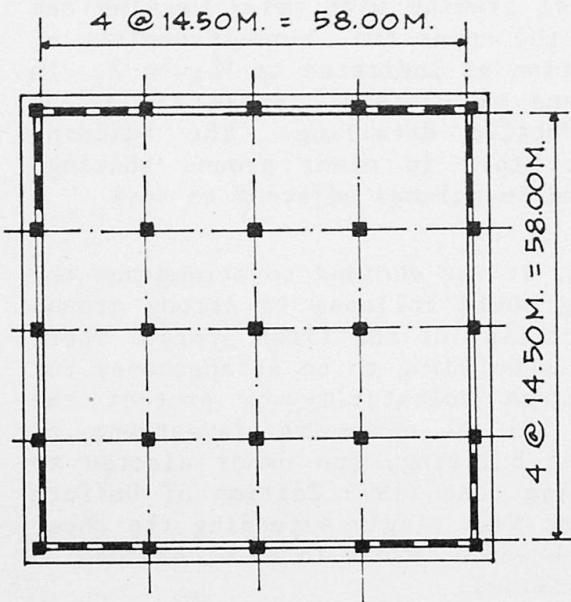
Figure 1. Typical plan of three-story Office Building in Example 1. Walls present only in upper two stories.

The existing building is a three-story reinforced concrete structure 58 meters square in plan, as shown in Figure 1. It is an office building. The First Floor is a slab on grade while the upper two floors are a concrete waffle slab

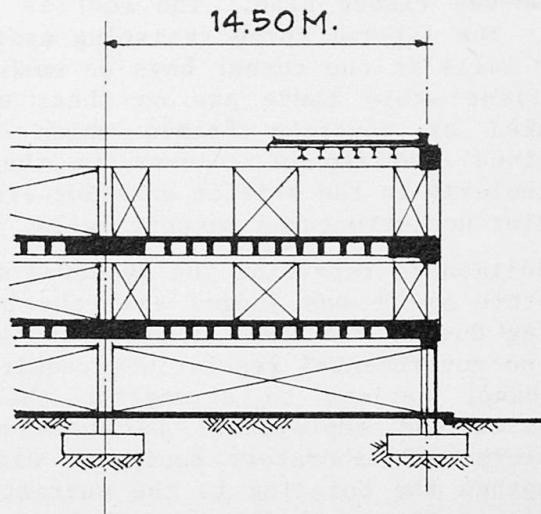
Figure 2. Partial elevation of exterior frame showing extent of existing walls in Example 1.

or two-way ribbed slab. The roof is of steel framing with metal decking and fill. The lateral force resisting system in the upper two stories consists of shear walls in the corner bays on each elevation as indicated in Figure 2. In the first story there are no shear walls and all lateral forces are to be resisted by concrete frames which lack ductile detailing. The building sustained spalling of columns in the first story in minor ground shaking, particularly in the stiffer exterior frames and in columns adjacent to some interior non-structural masonry walls.

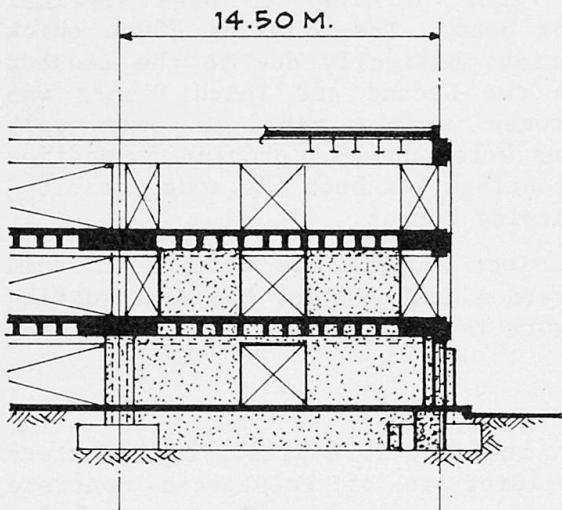
Figure 3. Partial elevation of strengthened wall system in Example 1.

The strengthening solution is outlined in Figures 3 and 4. Shear walls 400mm thick were added in the First Floor beneath the existing 200mm thick shear walls in the upper stories. These walls were extended upward in the Second Floor by adding a thickening of 500mm, thereby both strengthening the Second Floor as well as providing a very positive connection between the new and old walls. The thicker wall was necessary in the Second Floor in order to pass vertical reinforcement past the existing Second Floor beam. The existing 200mm thick walls were judged adequate for the top stories, basically due to the reduced mass of the roof framing. Connection with the Second and Third Floors was achieved by removing the thin slab between waffle ribs to pass wall reinforcement and place concrete. Foundations were added to provide foundation bearing in conjunction with existing spread footings for both the added gravity loads as well as the greatly increased overturning forces.

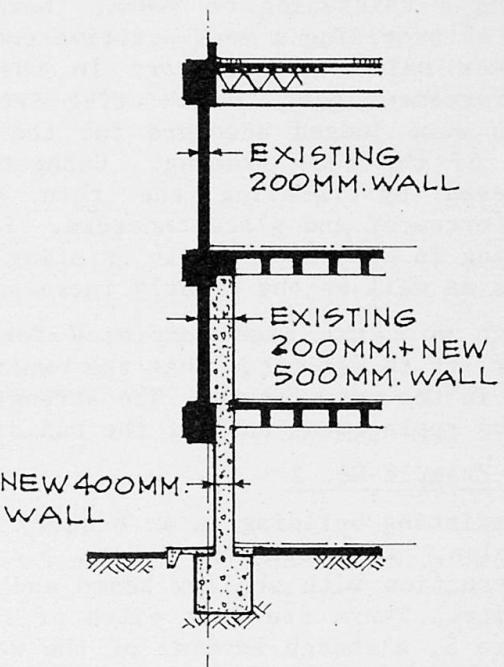
Figure 4. Section through strengthened wall in Example 1.

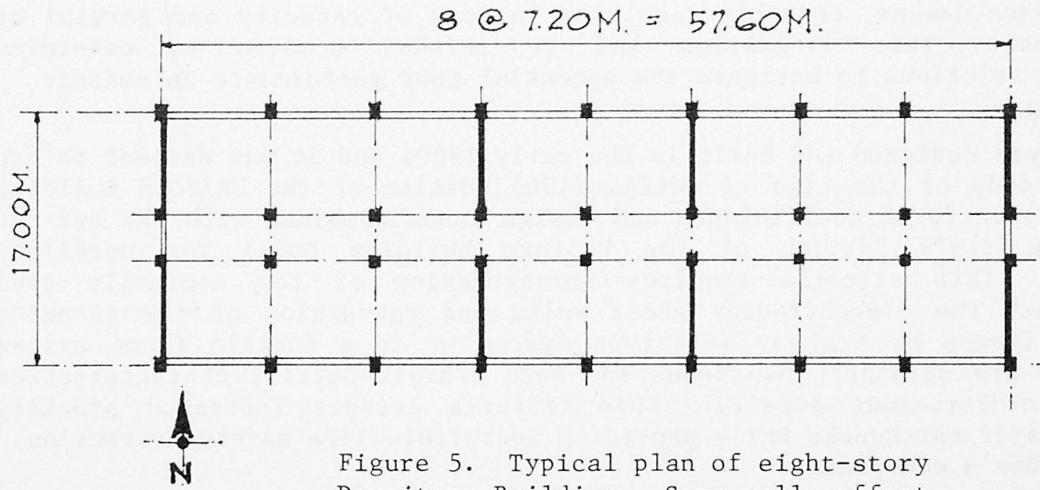
Figure 5. Typical plan of eight-story Dormitory Building. Some walls offset in Ground Floor.

The existing building is an 8-story dormitory building 57.6 meters by 17 meters in plan, as shown in Figure 5. The building is of reinforced concrete construction with shallow beams and slabs which are not shown in Figure 5 for clarity. There are four pairs of reinforced concrete shear walls as shown in Figure 5, although several of the walls are discontinuous in the Ground Floor. The two long sides are framed with 600mm square columns and beams or spandrels of reinforced concrete 2000mm deep extending from the window head in one story to the window sill in the story above. The columns are tied columns with ties at 450mm centers. The building has not been subjected to strong ground shaking but the owner has requested an evaluation of its potential seismic performance and recommendations for mitigation measures if appropriate.

The evaluation revealed that the building has sufficient shear walls in the north-south direction to adequately brace the building in that direction, but the discontinuous shear walls in the Ground Floor result in overturning forces being resisted by nominally tied columns which have traditionally exhibited a lack of ductility in earthquakes. In the east-west or longitudinal direction, the two exterior frames resist virtually all of the lateral forces due to their stiffness, and the deep spandrel beams are stronger than the columns which will force the inevitable inelastic response into columns. The nominally tied columns have virtually no ductility and their potential inelastic response will

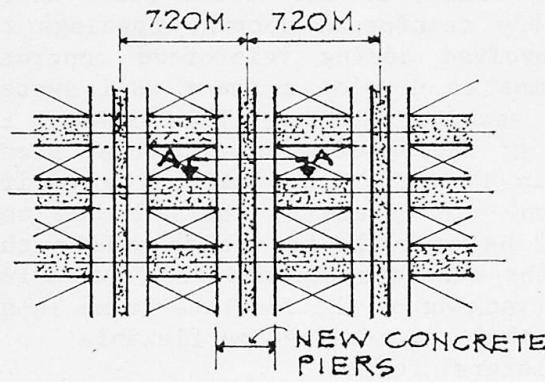
Figure 6. Scheme A strengthening adding concrete piers to existing columns to create shear wall bracing system on side walls.

Section A-A in Figure 6.

Many alternative solutions of strengthening were studied, and two basic solutions were presented to the owner for consideration. Both solutions included adding new reinforced concrete shear walls in the Ground Floor where shear walls were discontinuous, with suitably reinforced doorway openings to accommodate functional uses. Scheme A involved adding reinforced concrete sections to each side of the exterior columns to develop a shear wall system between the new piers and the existing spandrel beams. This scheme is illustrated in Figure 6. Scheme B consists of adding exposed structural steel bracing on the two long sides, as shown in Figure 7, to resist the entire lateral forces in the longitudinal direction. In Scheme B, the existing top negative moment reinforcing in the spandrel beams would be cut to weaken the stiff concrete exterior frame and protect the concrete columns from extensive damage. Scheme B also recognizes that some cracking of the concrete frame in an earthquake would be necessary before the existing concrete become flexible enough to allow the steel bracing to resist lateral forces.

Scheme A requires partial vacating of the building to allow work to proceed and results in a loss of windows for natural light. This scheme is probably more pleasant aesthetically and is estimated to cost about 35% of the building's replacement cost. Scheme B allows most of the work to be performed on the outside of the building without vacating the building except portions of the Ground Floor for the shear wall work. The exposed steel frame does not result in a loss of windows. Scheme B is estimated to cost about 25% of the building's replacement cost. At the time of writing, the owner is studying the merits of the two schemes and arranging for funds to finance the strengthening work.

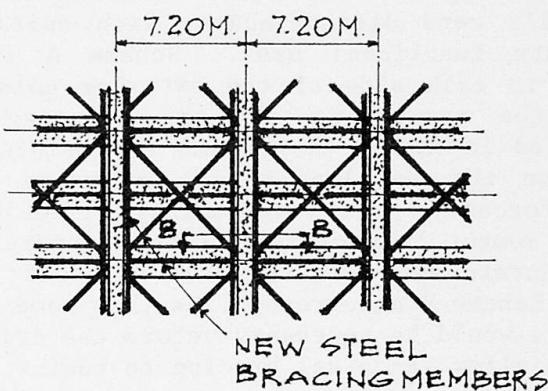
Figure 7. Scheme B strengthening adding steel bracing to existing frame on side walls.

Section B-B in Figure 7.
