**Artikel:** Strengthening of steel buildings against earthquakes

Autor: Kato, Ben / Takanashi, Koichi / Tanaka, Atsuo

# Strengthening of Steel Buildings Against Earthquakes

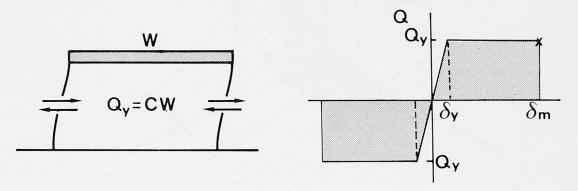
Fig.1 A portal frame

Fig. 2 Story shear vs. sidesway relation

in which  $S_V$  = spectral pseudo-velocity response for undamped system and M = total mass of the structure. As a simple example, further derivation of the above equations will be done on a portal frame as shown in Fig. 1. In the case that the frame is yielded and undergoes considerable plastic deformation up to  $\delta m$  as shown in Fig.2, Eqs. 1 and 2 can be expressed as follows;

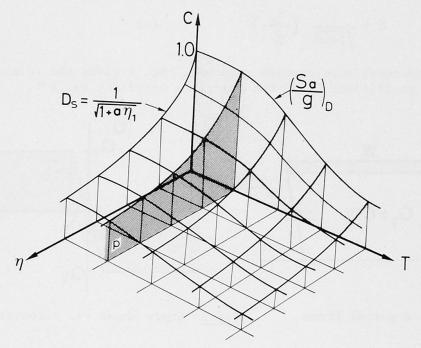
Fig.3 The same energy absorption level in the  $C-\eta-T$  space

in which  $T_c$  = the specific period depending on the soil condition at the site. In a graphical way, the index can be represented by the curve in the C-T plane of Fig. 3. The required ductility ratio  $\eta_1$  is dependent on the shapes of skeleton members. The possible ductility ratios must be evaluated for the width-to-thickness ratios of section shapes, the slenderness ratios of laterally unsupported members and the slenderness ratios of brace members in the braced frames. In the regulations of the Code the maximum value of the required yield shear coefficient  $C_1$  is determined 0.5 for steel structure. In other words it is concluded that steel frames are expected to have some ductility.  $C_1$  in Eq. 5 can be considered eventually a function of T and  $\eta_1$ . Then the value of  $C_1$  moves on a surface of the spreading roof shown in Fig. 3. According to the revised regulation of the Building Code, the design yield shear coefficient must be on or above the surface.

In the case that the insufficiency in the strength and the ductility exists, the story shear coefficient C is plotted under the roof in Fig. 3. By the energy absorption concept similar to that described in the preceding article, there can be considered another roof on which C, n and T are related at the same energy absorption level.

Also the laminated roofs can exist for various levels of the energy absorption. Fig. 5 shows the section of such a structure made by the cutting plane denoted as p in Fig. 3. The solid curve represents the section of the roof required by the Building Code.

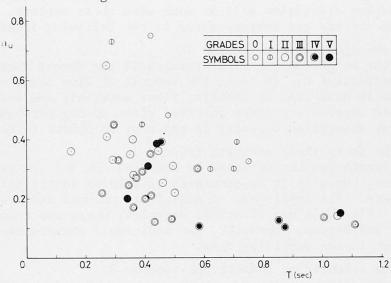
Fig. 4  $\alpha$  -T relation of damaged buldings

From the investigation results on the damaged steel buildings, the estimated maximum story shear coefficient  $\alpha_u$  (the ultimate strength/the sustained weight) is plotted against the corresponding natural period of the building as shown in Fig. 4. The damage grades classified in Fig. 4 are:

The details of the damage analysis are reported in the literature[1]. Hence, further discussion is eliminated here. However, it must be stressed that in the shorter natural period range, higher shear coefficients are required to reduce the structural damage.

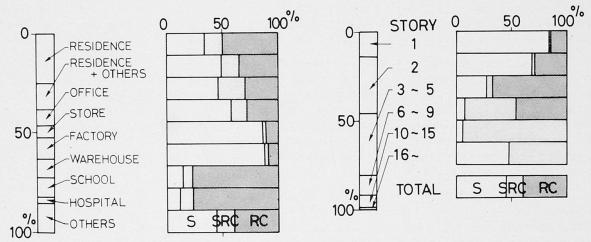
S;steel, SRC;mixed, RC;reinforced concrete

Fig.8 Usage of three types of structures (right) in different types of buildings (left)

Fig.9 Usage of three types of structures (right) in different story buildings (left)

statistics of the annual total of newly constructed floor area in 1979 that steel structures are widely used for factories, warehouses and stores as shown in Fig. 8. Moreover, low rise buildings are often made of steel frames as shown in Fig. 9. Therefore, the inspection of earthquake resistance capacity of existing buildings and the strengthening become very important. In fact a municipal government set force their plans for strengthening houses along the Standard described in this paper. Some of them have been already examined and will be strengthened in the suitable methods.
