**Band:** 46 (1983)

**Artikel:** Strengthening of steel buildings against earthquakes

**Autor:** Kato, Ben / Takanashi, Koichi / Tanaka, Atsuo

## Strengthening of Steel Buildings Against Earthquakes

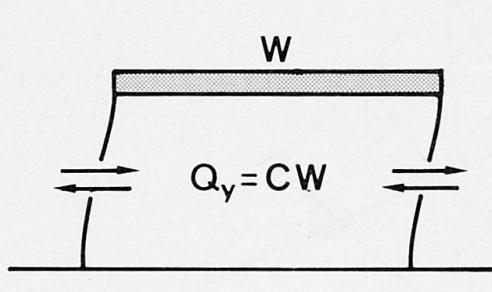
Fig.1 A portal frame

in which  $S_v$  = spectral pseudo-velocity response for undamped system and  $M$  = total mass of the structure. As a simple example, further derivation of the above equations will be done on a portal frame as shown in Fig. 1. In the case that the frame is yielded and undergoes considerable plastic deformation up to  $\delta_m$  as shown in Fig.2, Eqs. 1 and 2 can be expressed as follows;

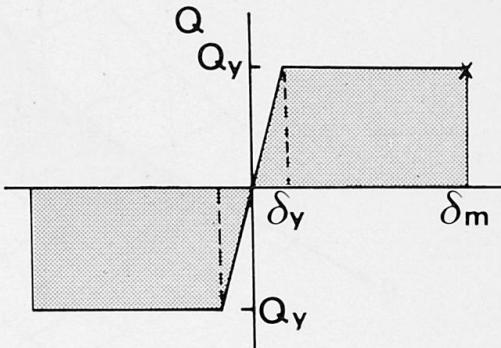
Fig.2 Story shear vs. sidesway relation

in which  $g$  = the acceleration of gravity,  $\omega$  = the natural circular frequency,  $C$  = the yield shear coefficient and  $\eta$  = the cumulative ductility ratio defined as  $\eta = \delta_m/\delta_y - 1$ . After the vibration theory,

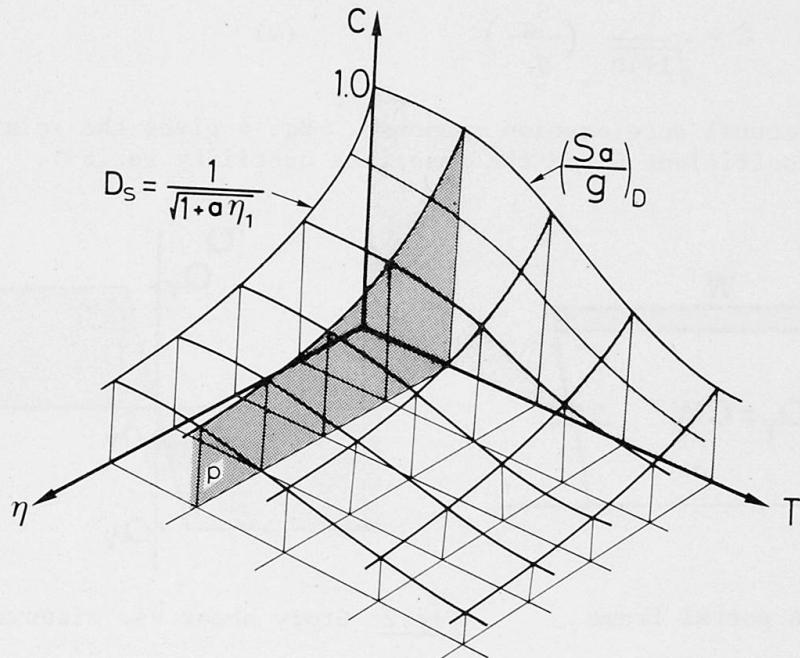
Fig.3 The same energy absorption level in the C- $\eta$ -T space

in which  $T_c$  = the specific period depending on the soil condition at the site. In a graphical way, the index can be represented by the curve in the C-T plane of Fig. 3. The required ductility ratio  $\eta_1$  is dependent on the shapes of skeleton members. The possible ductility ratios must be evaluated for the width-to-thickness ratios of section shapes, the slenderness ratios of laterally unsupported members and the slenderness ratios of brace members in the braced frames. In the regulations of the Code the maximum value of the required yield shear coefficient  $C_1$  is determined 0.5 for steel structure. In other words it is concluded that steel frames are expected to have some ductility.  $C_1$  in Eq. 5 can be considered eventually a function of  $T$  and  $\eta_1$ . Then the value of  $C_1$  moves on a surface of the spreading roof shown in Fig. 3. According to the revised regulation of the Building Code, the design yield shear coefficient must be on or above the surface.

In the case that the insufficiency in the strength and the ductility exists, the story shear coefficient  $C$  is plotted under the roof in Fig. 3. By the energy absorption concept similar to that described in the preceding article, there can be considered another roof on which  $C$ ,  $\eta$  and  $T$  are related at the same energy absorption level.

Also the laminated roofs can exist for various levels of the energy absorption. Fig. 5 shows the section of such a structure made by the cutting plane denoted as  $p$  in Fig. 3. The solid curve represents the section of the roof required by the Building Code.

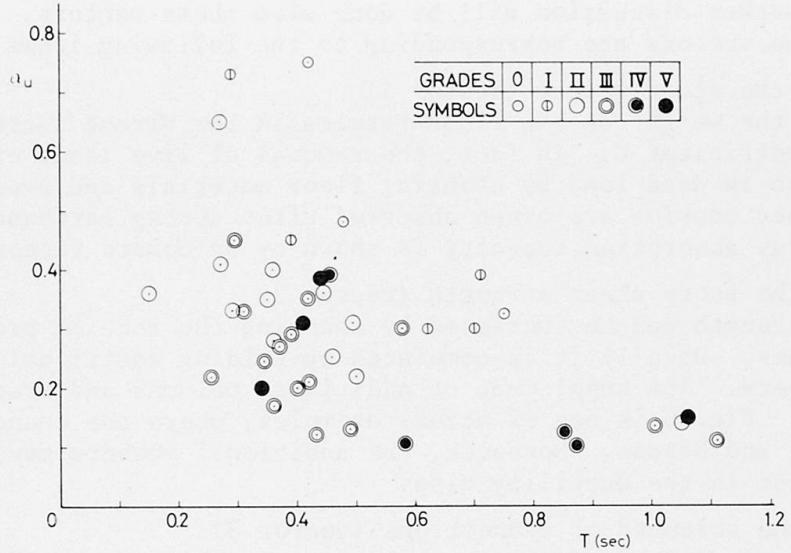
Fig.4  $\alpha_u$ -T relation of damaged buildings

From the investigation results on the damaged steel buildings, the estimated maximum story shear coefficient  $\alpha_u$  (the ultimate strength/the sustained weight) is plotted against the corresponding natural period of the building as shown in Fig. 4. The damage grades classified in Fig. 4 are:

- (a) 0 = No damage, (b) I = No structural damage,
- (c) II = Lightly damaged, (d) III = Moderately damaged,
- (e) IV = Heavily damaged, (f) V = Collapse or Seriously damaged.

The details of the damage analysis are reported in the literature[1]. Hence, further discussion is eliminated here. However, it must be stressed that in the shorter natural period range, higher shear coefficients are required to reduce the structural damage.

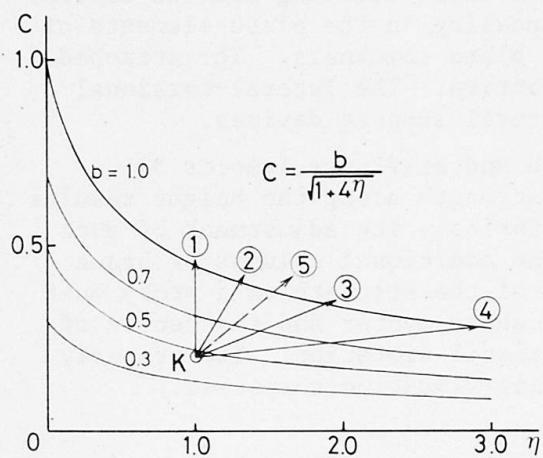
Fig.5 The same energy absorption levels in the C- $\eta$  plane

By help of the methods suggested in the Diagnosis Standard, the existing  $C$  and  $\eta$  of an inspected frame can be estimated. Such a set of  $(\eta, C)$  represents a point like  $K$  in Fig. 5. The curve of  $b = 0.5$ , passed near point  $K$  in the figure, shows energy absorption level considerably lower than the design level. Therefore, the point  $K$  must

be moved into the region above the solid curve by means of several methods for strengthening. The details of the proposed methods will be discussed in the next.

There are various methods for strengthening and repairing. Some of them are efficient in increasing the strength, namely, the yield shear coefficient  $C$ . Some are efficient in increasing the cumulative ductility ratio  $\eta$  or both of  $C$  and  $\eta$ . The amount of increase in  $C$  and  $\eta$  can be graphically expressed by a vector in the  $C$ - $\eta$ - $T$  space. The vectors in Fig. 5 represent the projections of such vectors. Regardless of the change in the natural periods of remedied structures, the further discussion will be done with these vectors. The numerals beside the vectors are corresponding to the following items.

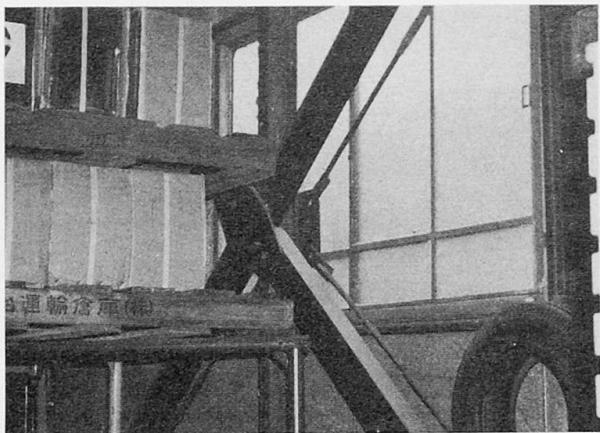
Fig.6 Channel braces added

The story shear strength can be increased by changing the section properties of columns and beams. Usually it is completed by welding additional cover plates to the members. The supplement of additional columns and brace members is most effective. Fig. 6 is one of actual examples, where the channel members are added to steel rod braces. Moreover, the additional members may sometimes produce the increase in the ductility also.

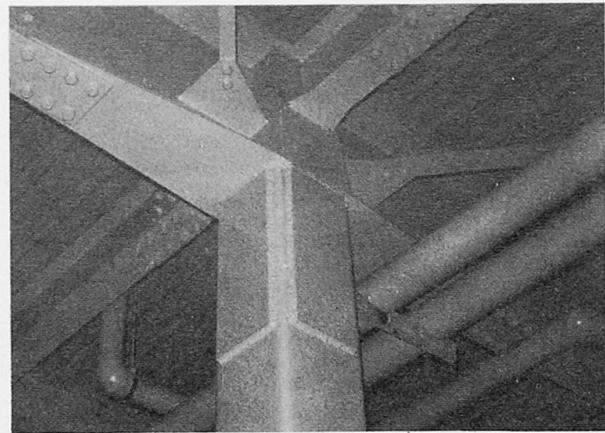
Fig.7 Coverplates welded

The member ductility is improved to avoid the local buckling and the lateral-torsional buckling in members. The local buckling in the plate elements of sections can be prevented by increasing the plate thickness. The attached coverplates as shown in Fig. 7 are also effective. The lateral-torsional buckling is prevented by properly placed lateral support devices.

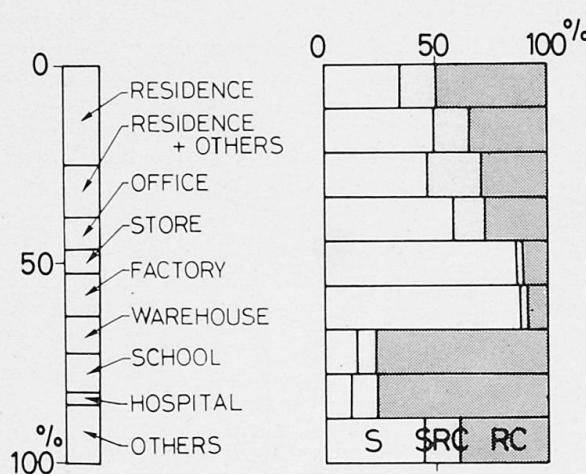
Fig.8 Usage of three types of structures (right) in different types of buildings (left)

statistics of the annual total of newly constructed floor area in 1979 that steel structures are widely used for factories, warehouses and stores as shown in Fig. 8. Moreover, low rise buildings are often made of steel frames as shown in Fig. 9. Therefore, the inspection of earthquake resistance capacity of existing buildings and the strengthening become very important. In fact a municipal government set force their plans for strengthening houses along the Standard described in this paper. Some of them have been already examined and will be strengthened in the suitable methods.

S: steel, SRC: mixed, RC: reinforced concrete
