**Zeitschrift:** IABSE reports = Rapports AIPC = IVBH Berichte

**Artikel:** Steel buildings with low annual energy consumption

**Autor:** Elmroth, Arne / Johannesson, Carl Michael

## Steel Buildings with Low Annual Energy Consumption

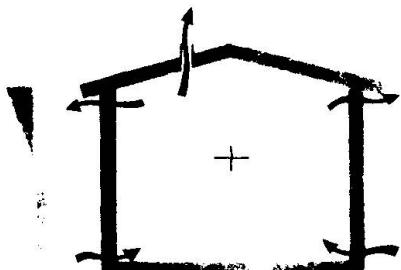
Fig 1 An insufficiently air-tight building where cold air seeps in at floor level and warm air leaks out at roof level due to thermal forces, wintertime. The pressure gradient is for temperature related pressures on a calm day and fore evenly distributed air leakage.

The governing force for air-leakage and ventilation in buildings is the difference in pressure of the air inside and outside the building. The forces affecting the air adjacent to and inside the building (excluding ventilation fans) and setting it in motion are wind and temperature. On a calm winters day the air pressure in the lower part of a building is lower inside the building than outside, and in the upper part of the building the air pressure on the inside is higher than that outside. The result is that cold air will seep in at floor level and that warm air will leak through the upper walls and the roof, fig 1, giving rise to, apart from the increased energy consumption, uncomfortable draughts at floor level. Such draughts are unacceptable in a quality building. At roof level, and especially in the eaves area, warm air leaks out which, when cooled, may even give rise to condensation and moisture problems in the roof itself. In order to reduce the seepage of cold air at floor level and the leakage of warm air at roof level it is necessary that the climate shield of the building be air-tight.

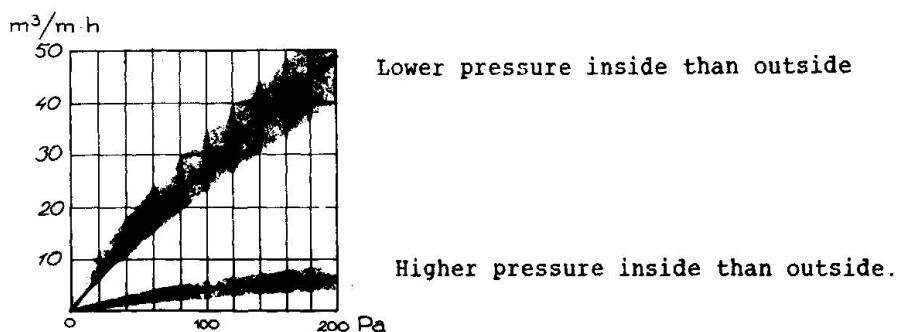
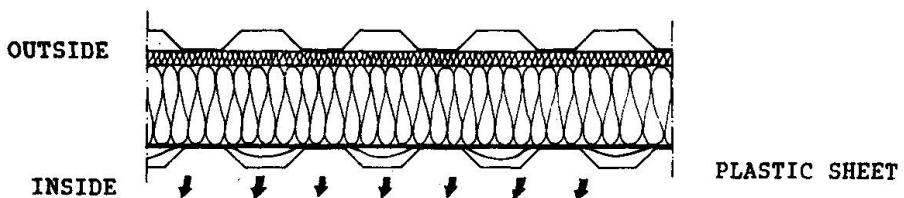
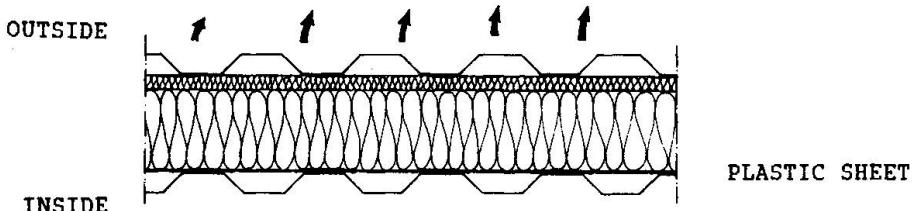
Lower inside air pressure: the plastic sheet is pressed against the ground plate and against the thermal insulation.

Higher inside air pressure: the plastic sheet is pulled towards the profiled sheet wall causing leakage

**Fig. 2** If the plastic sheet is fixed to the ground plate only by means of a profiled steel sheet the air pressure at floor level will pull the sheet away from the ground plate and allow air leakage. If the air pressure is higher inside than outside the sheet will be pressed against the ground plate and reduce leakage. The latter case is however not the most usual one.

The air-tight membrane in walls constructed with cold formed sheet steel studs and sheet steel cladding is a plastic sheet between the inside surface of the thermal insulation and the inside wall finish. This form of construction creates no problems on undisturbed walls. If the wall is punctured by vents, adjoining walls, joints, windows etc great care must be taken in the design of these details. For example where the bottom edge of the plastic sheet is free - when the plastic sheet is fixed in place with a profiled steel sheet - air will seep in easily if the inside air pressure is lower than that outside. If the air pressure inside is higher than that outside the plastic sheet is pressed against the ground plate, reducing air leakage. It is most common to find lower air pressure at floor level which makes it necessary to find a better method of construction to avoid the free edge of the plastic sheet which is found today. Figure 2.

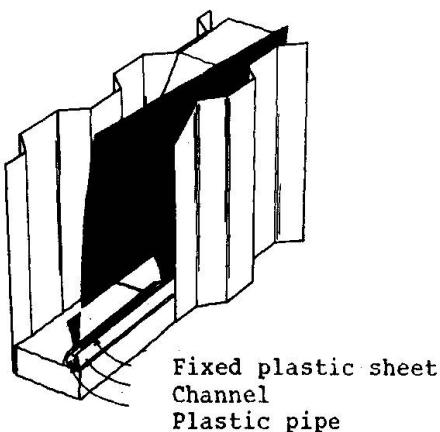
**Fig. 3** If the plastic sheet is fixed in a channel with a plastic pipe, electric conduit for example, excellent air tightness is achieved.

There are several methods of ensuring good air-tightness in the ground plate detail, one of which is a sheet steel channel in which the plastic sheet is clamped by means of a plastic pipe as shown in fig 3. When tested, this detail gave 100 times less leakage than that of a free sheet edge. Another version of the same detail which also gives a low leakage value is to fasten the plastic sheet between a fixing strip and sealant as shown in fig 4. These details cost very little but are essential; the extra cost being very quickly repaid.

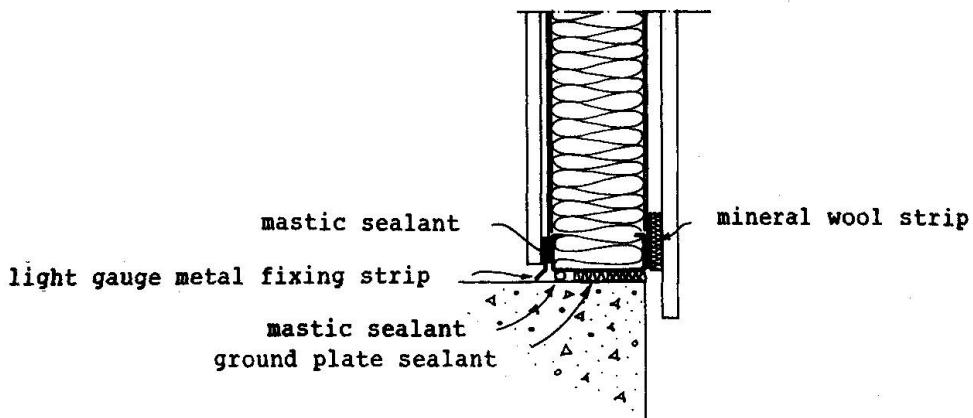
**Fig 4** An alternative method of achieving good air-tightness in the ground plate detail is to fasten the plastic sheet with a special light gauge metal fixing strip. A mastic sealant or sealing strip placed between the plate and the sheet will ensure air-tightness. The joint between the ground-plate and the concrete foundation slab must be well sealed; mineral wool with a joint sealant on the inside gives an acceptable result.

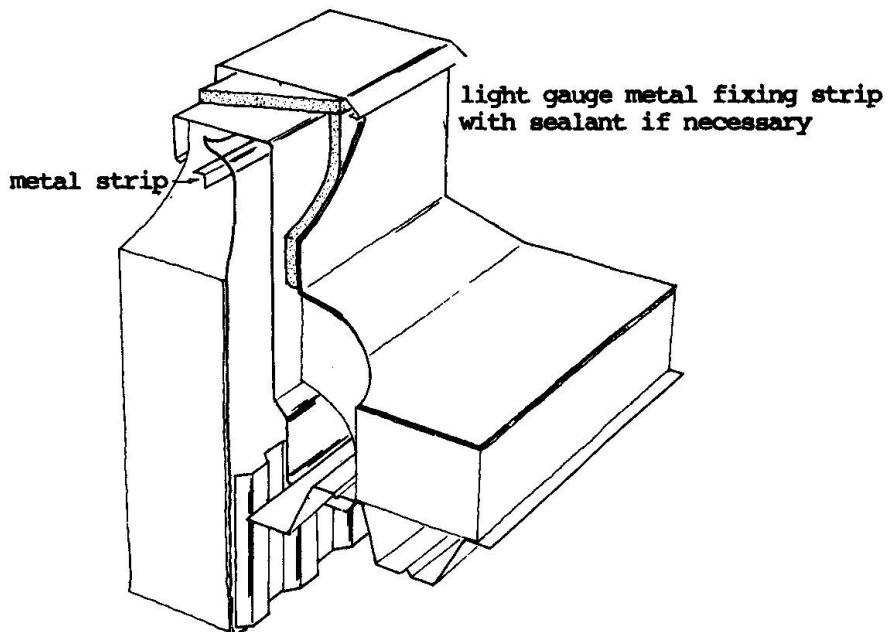
**Fig 5** If the plastic sheet at the roof eaves is placed round the outside of the eaves beam there is a risk for air leakage being as the air pressure is often higher inside the building than outside. The sheet is drawn away from the beam and leakage occurs. The sheet must therefore be fixed with, for example, a fixing strip and mastic sealant in order to obtain sufficient air-tightness.

There is normally some kind of special light gauge sheet steel eaves beam which causes the plastic sheet to be led round it in some way, usually on the outside. The internal excess air pressure presses the sheet away from the eaves beam creating a gap for leakage. This is an unsatisfactory detail which is simple to resolve. Here again all that is required is a light gauge metal fixing-strip which fixes the plastic sheet to the eaves beam, with a sealant between if necessary, as shown in fig 5. Again the cost per metre is very low. Minor adjustments in detailing can give greatly improved air tightness.

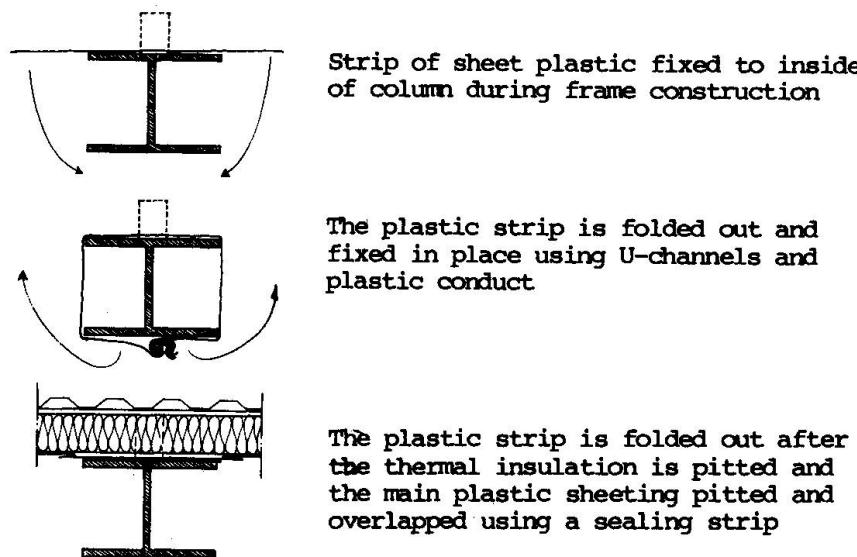
**Fig. 6** It can be difficult to place the plastic sheeting when steel columns are placed inside the facade. A strip of plastic sheet is therefore fitted directly after the completion of the frame and carefully fastened so as to avoid wind damage during construction. When the thermal insulation and the plastic vapour barrier are in place the strip is folded out to give a good overlap joint with the main plastic sheet.

The method of jointing the plastic sheet in the external walls is also of consequence to air-tightness. One method used which gives good joint tightness is to wrap a 0.5 m wide strip of plastic sheet round the column before the horizontal studs are fixed in place. Sealant is applied to the support details and the strip of sheet kept wrapped around the column. When the plastic sheet in the wall has been fitted in place after the completion of the thermal insulation, the wrapped around strip is folded out and sealed in the overlaps with a sealing strip as shown in fig 6. Overlapping edges in the plastic sheet without any form of sealing strip or the pressing together of the overlap will not give satisfactory air-tightness. This detail is not costly but does require thorough workmanship. The wrapped around strip of sheet must be carefully fastened during construction to avoid wind damage.

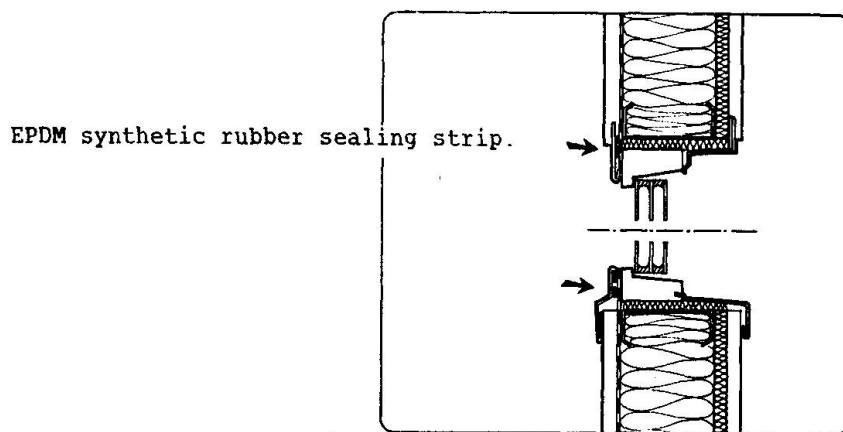
**Fig 7** Window detailing. The plastic sheet in the wall is drawn over the window frame and fastened with a special sealing strip. An EPDM synthetic rubber sealing strip between the plastic sheet and the window frame considerably reduces the risk for air-leakage.

It is of great importance from the point of view of air-tightness that the air-tight membrane is not punctured by ducts, electric conduit etc. Improved detailing and instruction is required here. It is of great importance that all services are planned in detail while the building is still on the drawing board and that ducts are avoided as far as possible. Fig 7 shows an example of a window-wall detail. Note the thermal insulation and the positioning of the air-tight sealant against the air-tight sheet in the wall.

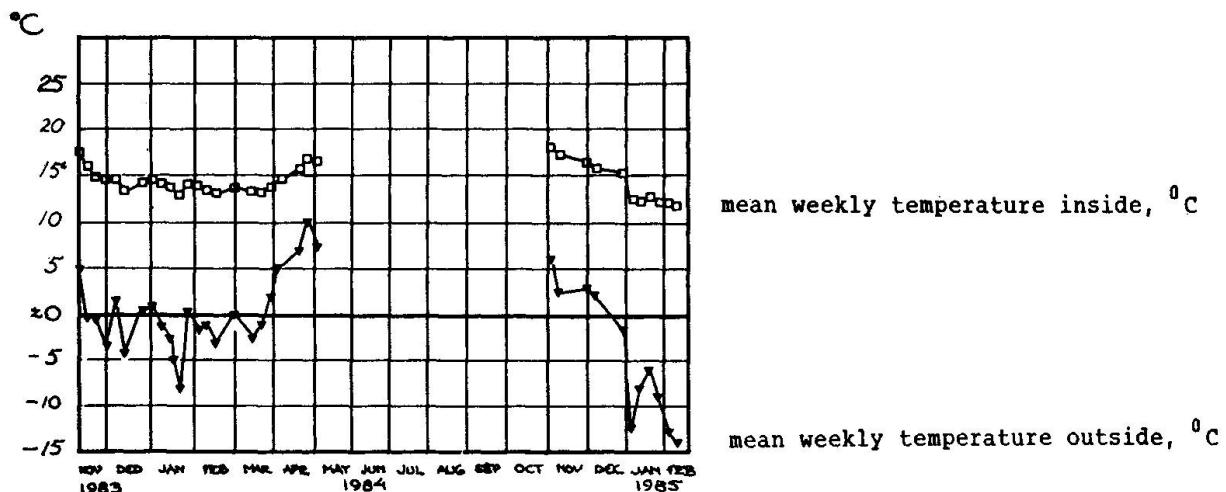
Fig. 7 Mean weekly temperature outside and inside respectively recorded at the Ekerö Tennis Centre during Nov. 1983 to Feb. 1985

The mean weekly temperature inside and outside the building has been continuously recorded during the heating seasons 1983/84 and 84/85. The temperature inside the building has never been below a mean weekly value of +12°C. During the period Nov. 83 to March 84 the mean weekly temperature was +14°C, see fig 8. During the winter of 1983/84, which was relatively mild, the building was never heated with the installed heating system. The heat produced by the lighting system was sufficient to keep the building at a suitable temperature in which to play tennis. It was first during the extreme winter of 1984/85 when the mean weekly temperature fell to -10°C for 6-8 weeks (which is 6-8°C below the mean monthly average for Stockholm) that the infra-red roof panels were used.

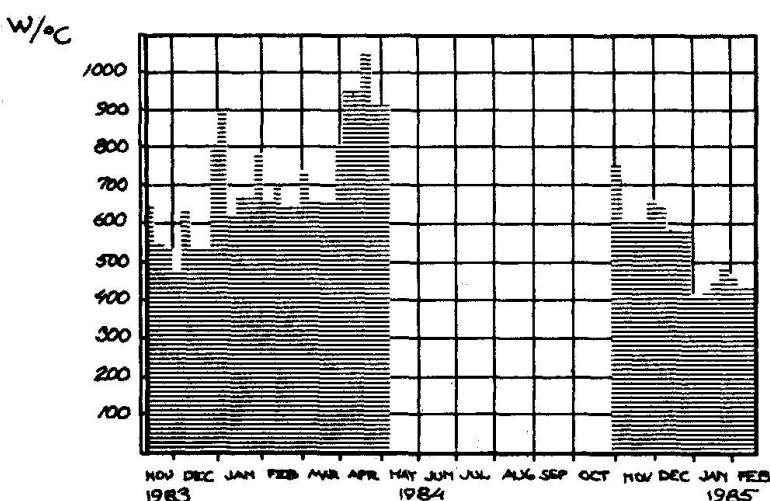
Fig. 8 Energy consumption for the Ekerö Tennis Centre during Nov. 1983-Feb. 1985. No recording during May 1984-Oct. 1984.

The total annual energy consumption, which is almost totally used for lighting is 70 000 kWh.
