**Artikel:** Steel buildings with low annual energy consumption

Autor: Elmroth, Arne / Johannesson, Carl Michael

# Steel Buildings with Low Annual Energy Consumption

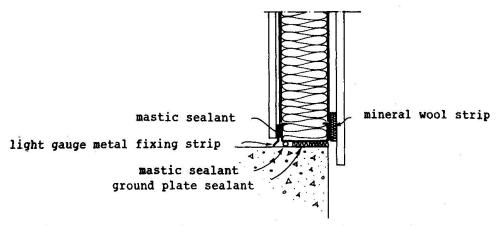
<u>Fig 3</u> If the plastic sheet is fixed in a channel with a plastic pipe, electric conduit for example, excellent air tightness is achieved.

There are several methods of ensuring good air-tightness in the ground plate detail, one of which is a sheet steel channel in which the plastic sheet is clamped by means of a plastic pipe as shown in fig 3. When tested, this detail gave 100 times less leakage than that of a free sheet edge. Another version of the same detail which also gives a low leakage value is to fasten the plastic sheet between a fixing strip and sealant as shown in fig 4. These details cost very little but are essential; the extra cost being very quickly repaid.

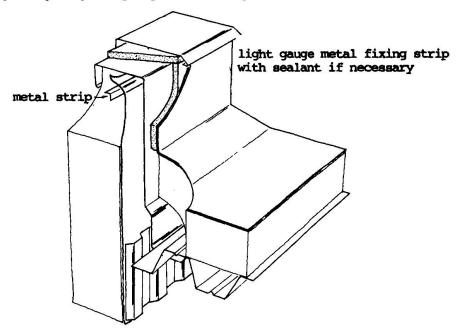
Fig 5 If the plastic sheet at the roof eaves is placed round the outside of the eaves beam there is a risk for air leakage being as the air pressure is often higher inside the building than outside. The sheet is drawn away from the beam and leakage occurs. The sheet must therefore be fixed with, for example, a fixing strip and mastic sealant in order to obtain sufficient air-tightness.

There is normally some kind of special light gauge sheet steel eaves beam which causes the plastic sheet to be led round it in some way, usually on the outside. The internal exess air pressure presses the sheet away from the eaves beam creating a gap for leakage. This is an unsatisfactory detail which is simple to resolve. Here again all that is required is a light gauge metal fixing-strip which fixes the plastic sheet to the eaves beam, with a sealent between if necessary, as shown in fig 5. Again the cost per metre is very low. Minor adjustments in detailing can give greatly improved air tightness.

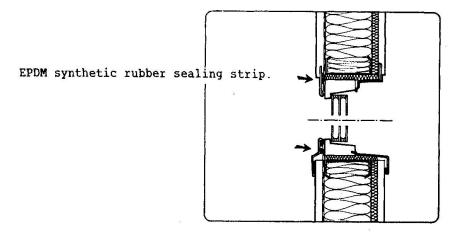
<u>Fig 7</u> Window detailing. The plastic sheet in the wall is drawn over the window frame and fastened with a special sealing strip. An EPDM synthetic rubber sealing strip between the plastic sheet and the window frame considerably reduces the risk for air-leakage.

It is of great importance from the point of view of air-tightness that the air-tight membrane is not punctured by ducts, electric conduit etc. Improved detailing and instruction is required here. It is of great importance that all services are planned in detail while the building is still on the drawing board and that ducts are avoided as fas as possible. Fig 7 shows an example of a window-wall detail. Note the thermal insulation and the positioning of the air-tight sealant against the air-tight sheet in the wall.

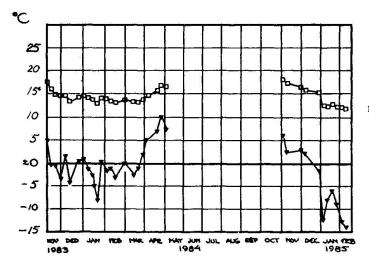
mean weekly temperature inside, OC

mean weekly temperature outside, OC

Fig.7 Mean weekly temperature outside and inside respectively recorded at the Ekerö Tennis Centre during Nov. 1983 to Feb. 1985

The mean weekly temperature inside and outside the bulding has been continuously recorded during the heating seasons 1983/84 and 84/85. The temperature inside the building has never been below a mean weekly value of +12°C. During the period nov. 83 to March 84 the mean weekly temperature was +14°C, se fig 8. During the winter of 1983/84, which was relatively mild, the building was never heated with the installed heating system. The heat produced by the lighting system was sufficient to keep the building at a suitable temperature in which to play tennis. It was first during the extreme winter of 1984/85 when the mean weekly temperature fell to -10°C for 6-8 weeks (which is 6-8°C below the mean monthly average for Stockholm) that the infra-red roof panels were used.

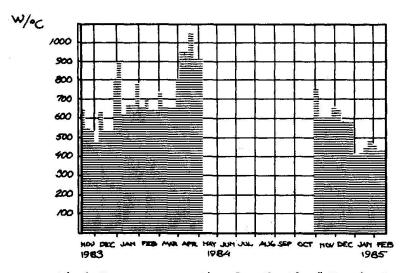
Fig 6 Energy consumption for the Ekerö Tennis Centre curing Nov. 1983-Feb. 1985. No recording during May 1984-Oct. 1984.

The total annual energy consumption, which is almost totally used for lighting is 70 000 kWh.
