Zeitschrift: IABSE reports = Rapports AIPC = IVBH Berichte
Band: 48 (1985)

Steel Buildings with Low Annual Energy Consumption

Arne ELMROTH

Carl Michael JOHANNESSON

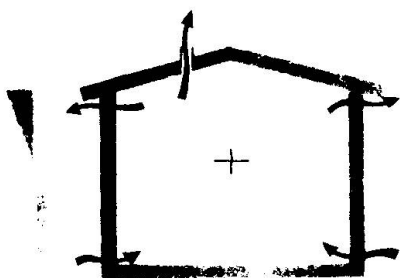
Air pressure on a calm day
Air leakage
Cold outside - warm inside

Fig 1 An insufficiently air-tight building where cold air seeps in at floor level and warm air leaks out at roof level due to thermal forces, wintertime. The pressure gradient is for temperature related pressures on a calm day and fore evenly distributed air leakage.

The governing force for air-leakage and ventilation in buildings is the difference in pressure of the air inside and outside the building. The forces affecting the air adjacent to and inside the building (excluding ventilation fans) and setting it in motion are wind and temperature. On a calm winters day the air pressure in the lower part of a building is lower inside the building than outside, and in the upper part of the building the air pressure on the inside is higher than that outside. The result is that cold air will seep in at floor level and that warm air will leak through the upper walls and the roof, fig 1, giving rise to, apart from the increased energy consumption, uncomfortable draughts at floor level. Such draughts are unacceptable in a quality building. At roof level, and especially in the eaves area, warm air leaks out which, when cooled, may even give rise to condensation and moisture problems in the roof itself. In order to reduce the seepage of cold air at floor level and the leakage of warm air at roof level it is necessary that the climate shield of the building be air-tight.

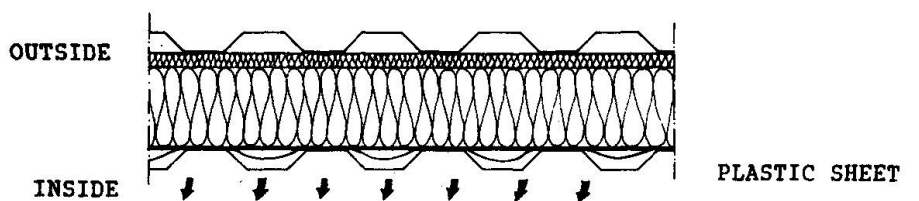
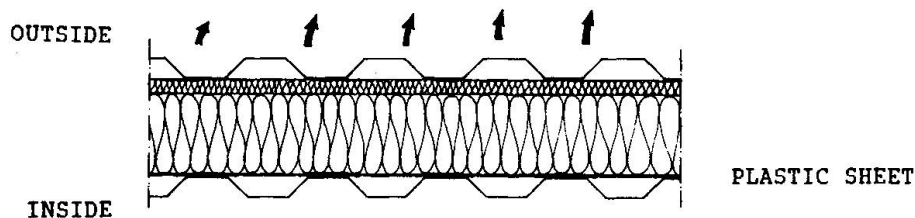
Lower pressure inside than outside

Higher pressure inside than outside.

Lower inside air pressure: the plastic sheet is pressed against the ground plate and against the thermal insulation.

Higher inside air pressure: the plastic sheet is pulled towards the profiled sheet wall causing leakage

Fig 2 If the plastic sheet is fixed to the ground plate only by means of a profiled steel sheet the air pressure at floor level will pull the sheet away from the ground plate and allow air leakage. If the air pressure is higher inside than outside the sheet will be pressed against the ground plate and reduce leakage. The latter case is however not the most usual one.

The air-tight membrane in walls constructed with cold formed sheet steel studs and sheet steel cladding is a plastic sheet between the inside surface of the thermal insulation and the inside wall finish. This form of construction creates no problems on undisturbed walls. If the wall is punctured by vents, adjoining walls, joints, windows etc great care must be taken in the design of these details. For example where the bottom edge of the plastic sheet is free - when the plastic sheet is fixed in place with a profiled steel sheet - air will seep in easily if the inside air pressure is lower than that outside. If the air pressure inside is higher than that outside the plastic sheet is pressed against the ground plate, reducing air leakage. It is most common to find lower air pressure at floor level which makes it necessary to find a better method of construction to avoid the free edge of the plastic sheet which is found today. Figure 2.

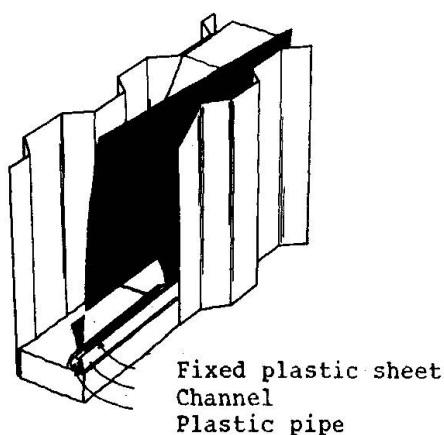
Fig 3 If the plastic sheet is fixed in a channel with a plastic pipe, electric conduit for example, excellent air tightness is achieved.

There are several methods of ensuring good air-tightness in the ground plate detail, one of which is a sheet steel channel in which the plastic sheet is clamped by means of a plastic pipe as shown in fig 3. When tested, this detail gave 100 times less leakage than that of a free sheet edge. Another version of the same detail which also gives a low leakage value is to fasten the plastic sheet between a fixing strip and sealant as shown in fig 4. These details cost very little but are essential; the extra cost being very quickly repaid.

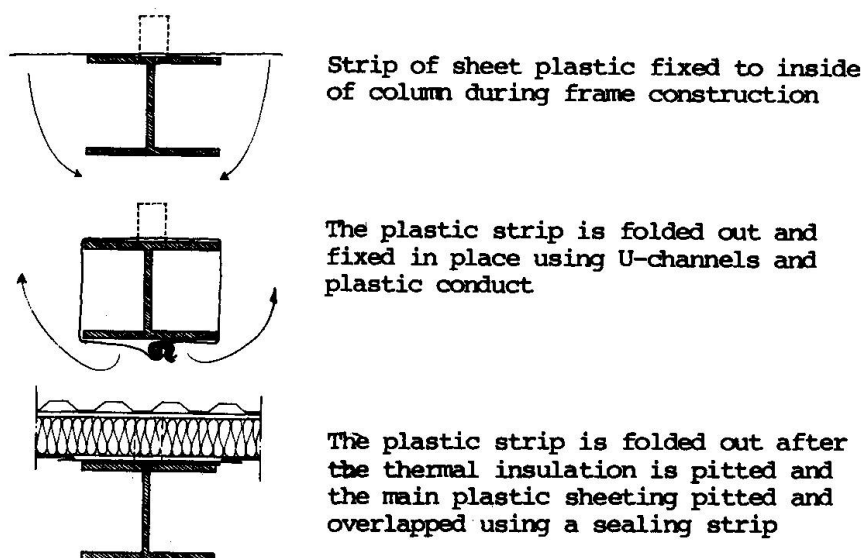
Fig. 6 It can be difficult to place the plastic sheeting when steel columns are placed inside the facade. A strip of plastic sheet is therefore fitted directly after the completion of the frame and carefully fastened so as to avoid wind damage during construction. When the thermal insulation and the plastic vapour barrier are in place the strip is folded out to give a good overlap joint with the main plastic sheet.

The method of jointing the plastic sheet in the external walls is also of consequence to air-tightness. One method used which gives good joint tightness is to wrap a 0.5 m wide strip of plastic sheet round the column before the horizontal studs are fixed in place. Sealant is applied to the support details and the strip of sheet kept wrapped around the column. When the plastic sheet in the wall has been fitted in place after the completion of the thermal insulation, the wrapped around strip is folded out and sealed in the overlaps with a sealing strip as shown in fig 6. Overlapping edges in the plastic sheet without any form of sealing strip or the pressing together of the overlap will not give satisfactory air-tightness. This detail is not costly but does require thorough workmanship. The wrapped around strip of sheet must be carefully fastened during construction to avoid wind damage.

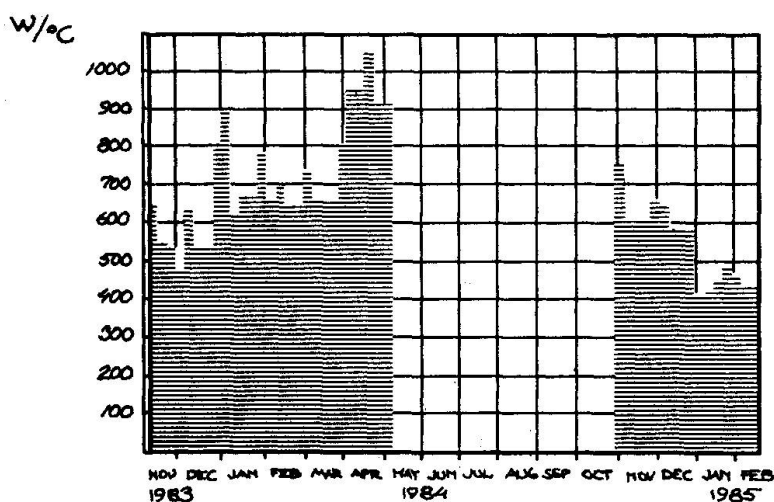
Fig 8 Energy consumption for the Ekerö Tennis Centre during Nov. 1983-Feb. 1985. No recording during May 1984-Oct. 1984.

The total annual energy consumption, which is almost totally used for lighting is 70 000 kWh.
