**Artikel:** Steel buildings with low annual energy consumption

**Autor:** Elmroth, Arne / Johannesson, Carl Michael

## Steel Buildings with Low Annual Energy Consumption

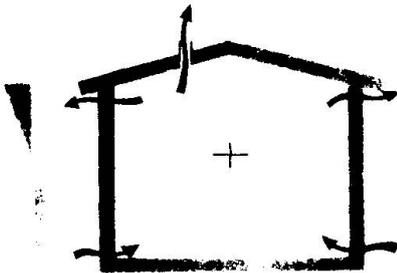
Air pressure on a calm day  
Air leakage  
Cold outside - warm inside

**Fig 1** An insufficiently air-tight building where cold air seeps in at floor level and warm air leaks out at roof level due to thermal forces, wintertime. The pressure gradient is for temperature related pressures on a calm day and fore evenly distributed air leakage.

The governing force for air-leakage and ventilation in buildings is the difference in pressure of the air inside and outside the building. The forces affecting the air adjacent to and inside the building (excluding ventilation fans) and setting it in motion are wind and temperature. On a calm winters day the air pressure in the lower part of a building is lower inside the building than outside, and in the upper part of the building the air pressure on the inside is higher than that outside. The result is that cold air will seep in at floor level and that warm air will leak through the upper walls and the roof, fig 1, giving rise to, apart from the increased energy consumption, uncomfortable draughts at floor level. Such draughts are unacceptable in a quality building. At floor level, and especially in the eaves area, warm air leaks out which, when cooled, may even give rise to condensation and moisture problems in the roof itself. In order to reduce the seepage of cold air at floor level and the leakage of warm air at roof level it is necessary that the climate shield of the building be air-tight.

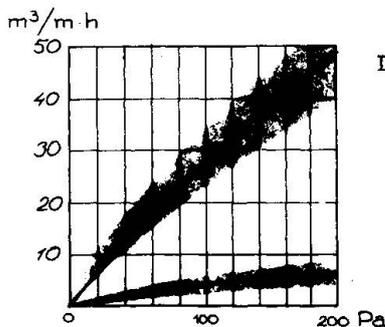
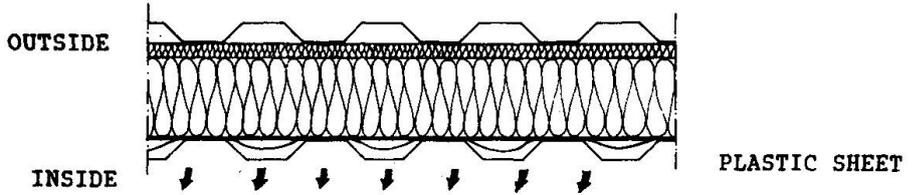
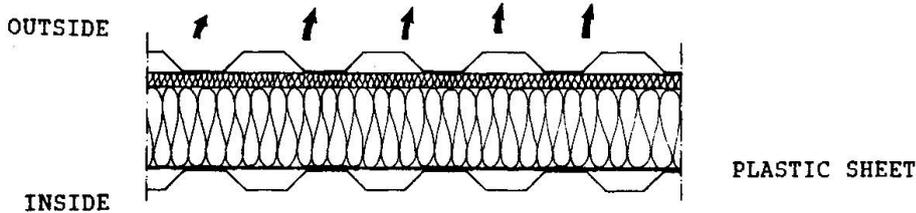
Lower pressure inside than outside

Higher pressure inside than outside.

Lower inside air pressure: the plastic sheet is pressed against the ground plate and against the thermal insulation.

Higher inside air pressure: the plastic sheet is pulled towards the profiled sheet wall causing leakage

**Fig 2** If the plastic sheet is fixed to the ground plate only by means of a profiled steel sheet the air pressure at floor level will pull the sheet away from the ground plate and allow air leakage. If the air pressure is higher inside than outside the sheet will be pressed against the ground plate and reduce leakage. The latter case is however not the most usual one.

The air-tight membrane in walls constructed with cold formed sheet steel studs and sheet steel cladding is a plastic sheet between the inside surface of the thermal insulation and the inside wall finish. This form of construction creates no problems on undisturbed walls. If the wall is punctured by vents, adjoining walls, joints, windows etc great care must be taken in the design of these details. For example where the bottom edge of the plastic sheet is free - when the plastic sheet is fixed in place with a profiled steel sheet - air will seep in easily if the inside air pressure is lower than that outside. If the air pressure inside is higher then that outside the plastic sheet is pressed against the ground plate, reducing air leakage. It is most common to find lower air pressure at floor level which makes it necessary to find a better method of construction to avoid the free edge of the plastic sheet which is found today. Figure 2.

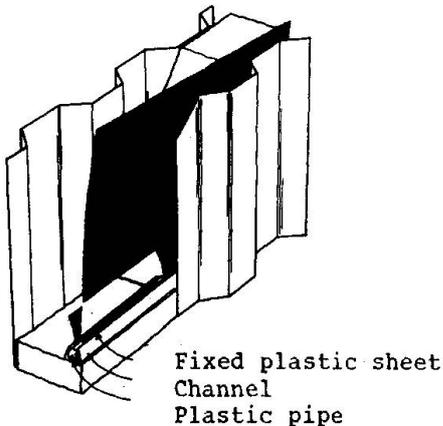
**Fig 3** If the plastic sheet is fixed in a channel with a plastic pipe, electric conduit for example, excellent air tightness is achieved.

There are several methods of ensuring good air-tightness in the ground plate detail, one of which is a sheet steel channel in which the plastic sheet is clamped by means of a plastic pipe as shown in fig 3. When tested, this detail gave 100 times less leakage than that of a free sheet edge. Another version of the same detail which also gives a low leakage value is to fasten the plastic sheet between a fixing strip and sealant as shown in fig 4. These details cost very little but are essential; the extra cost being very quickly repaid.

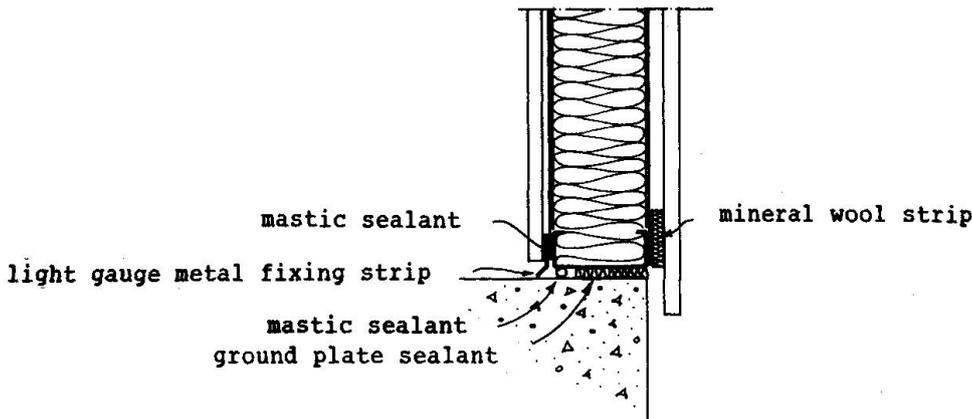
**Fig 4** An alternative method of achieving good air-tightness in the ground plate detail is to fasten the plastic sheet with a special light gauge metal fixing strip. A mastic sealant or sealing strip placed between the plate and the sheet will ensure air-tightness. The joint between the ground-plate and the concrete foundation slab must be well sealed; mineral wool with a joint sealant on the inside gives an acceptable result.

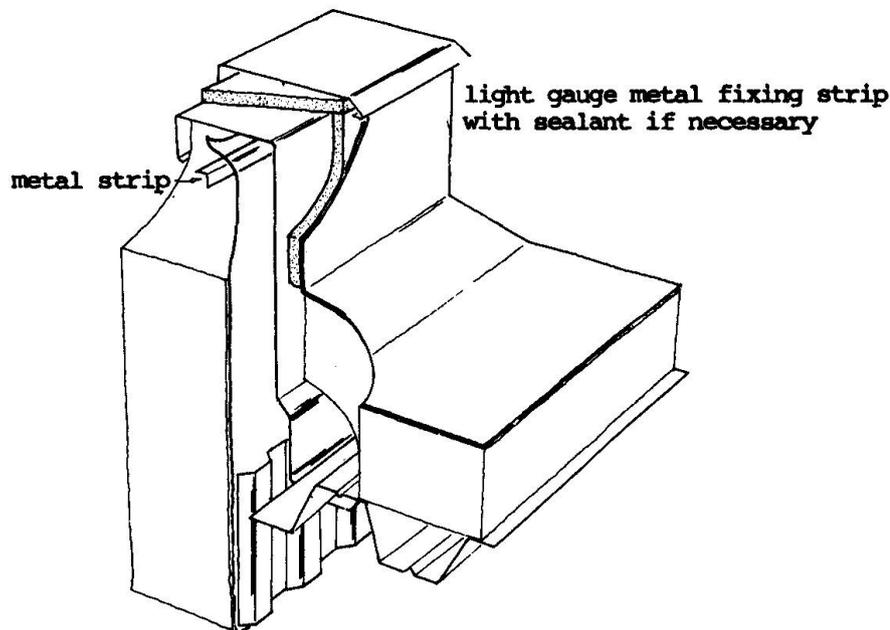
**Fig 5** If the plastic sheet at the roof eaves is placed round the outside of the eaves beam there is a risk for air leakage being as the air pressure is often higher inside the building than outside. The sheet is drawn away from the beam and leakage occurs. The sheet must therefore be fixed with, for example, a fixing strip and mastic sealant in order to obtain sufficient air-tightness.

There is normally some kind of special light gauge sheet steel eaves beam which causes the plastic sheet to be led round it in some way, usually on the outside. The internal excess air pressure presses the sheet away from the eaves beam creating a gap for leakage. This is an unsatisfactory detail which is simple to resolve. Here again all that is required is a light gauge metal fixing-strip which fixes the plastic sheet to the eaves beam, with a sealant between if necessary, as shown in fig 5. Again the cost per metre is very low. Minor adjustments in detailing can give greatly improved air tightness.

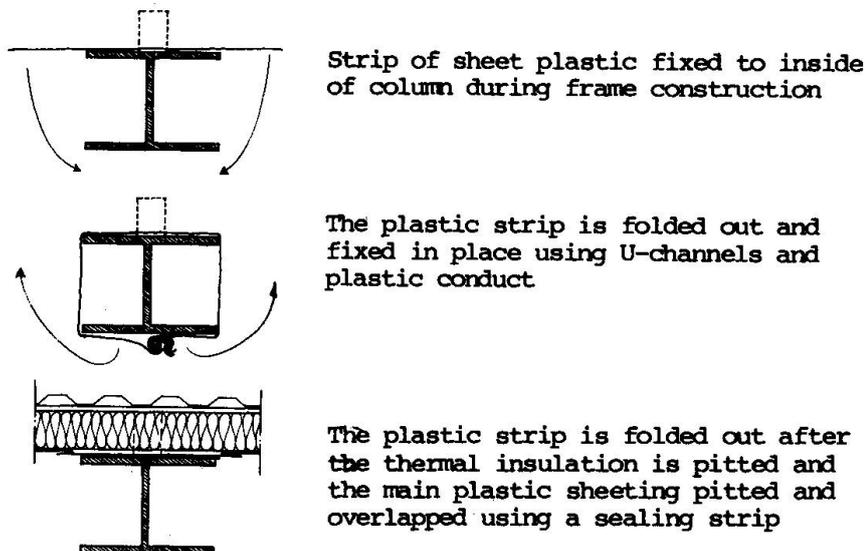
**Fig. 6** It can be difficult to place the plastic sheeting when steel columns are placed inside the facade. A strip of plastic sheet is therefore fitted directly after the completion of the frame and carefully fastened so as to avoid wind damage during construction. When the thermal insulation and the plastic vapour barrier are in place the strip is folded out to give a good overlap joint with the main plastic sheet.

The method of jointing the plastic sheet in the external walls is also of consequence to air-tightness. One method used which gives good joint tightness is to wrap a 0.5 m wide strip of plastic sheet round the column before the horizontal studs are fixed in place. Sealant is applied to the support details and the strip of sheet kept wrapped around the column. When the plastic sheet in the wall has been fitted in place after the completion of the thermal insulation, the wrapped around strip is folded out and sealed in the overlaps with a sealing strip as shown in fig 6. Overlapping edges in the plastic sheet without any form of sealing strip or the pressing together of the overlap will not give satisfactory air-tightness. This detail is not costly but does require thorough workmanship. The wrapped around strip of sheet must be carefully fastened during construction to avoid wind damage.

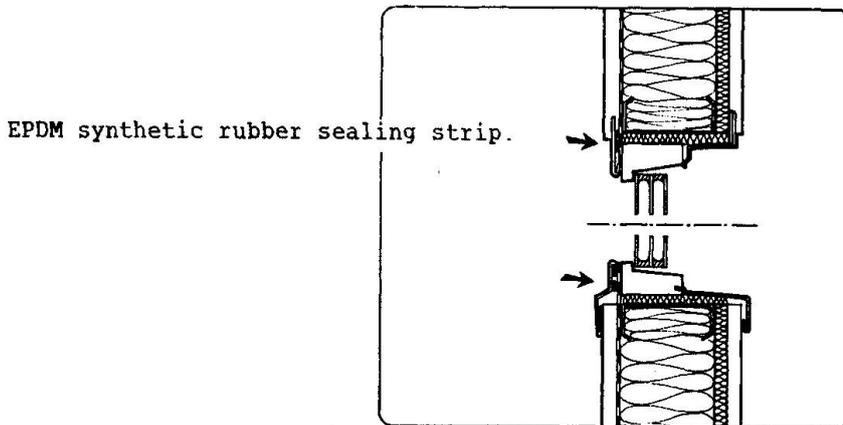
**Fig 7** Window detailing. The plastic sheet in the wall is drawn over the window frame and fastened with a special sealing strip. An EPDM synthetic rubber sealing strip between the plastic sheet and the window frame considerably reduces the risk for air-leakage.

It is of great importance from the point of view of air-tightness that the air-tight membrane is not punctured by ducts, electric conduit etc. Improved detailing and instruction is required here. It is of great importance that all services are planned in detail while the building is still on the drawing board and that ducts are avoided as far as possible. Fig 7 shows an example of a window-wall detail. Note the thermal insulation and the positioning of the air-tight sealant against the air-tight sheet in the wall.

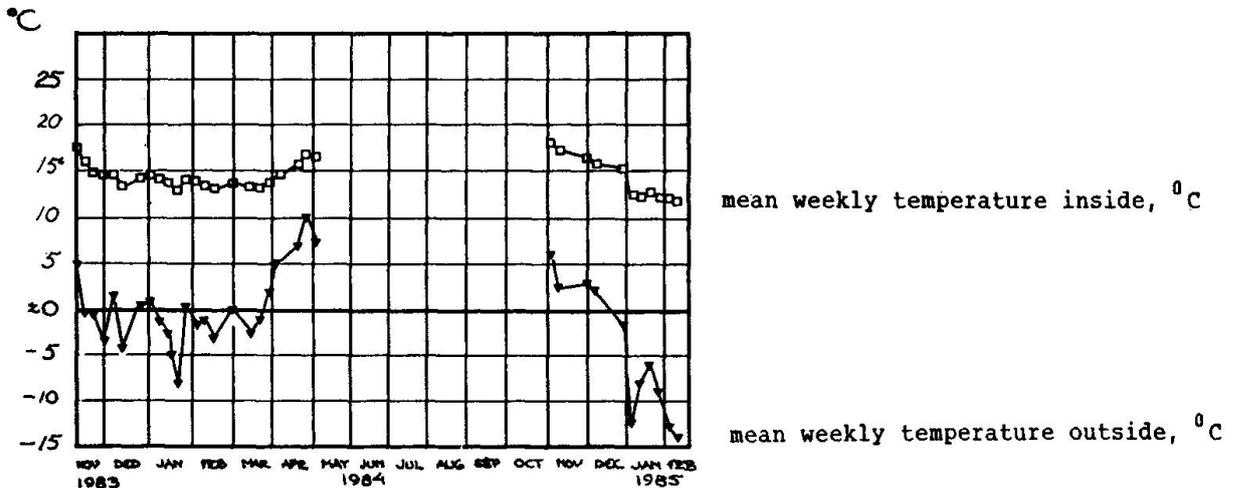
**Fig 7** Mean weekly temperature outside and inside respectively recorded at the Ekerö Tennis Centre during Nov. 1983 to Feb. 1985

The mean weekly temperature inside and outside the building has been continuously recorded during the heating seasons 1983/84 and 84/85. The temperature inside the building has never been below a mean weekly value of +12°C. During the period Nov. 83 to March 84 the mean weekly temperature was +14°C, see fig 8. During the winter of 1983/84, which was relatively mild, the building was never heated with the installed heating system. The heat produced by the lighting system was sufficient to keep the building at a suitable temperature in which to play tennis. It was first during the extreme winter of 1984/85 when the mean weekly temperature fell to -10°C for 6-8 weeks (which is 6-8°C below the mean monthly average for Stockholm) that the infra-red roof panels were used.

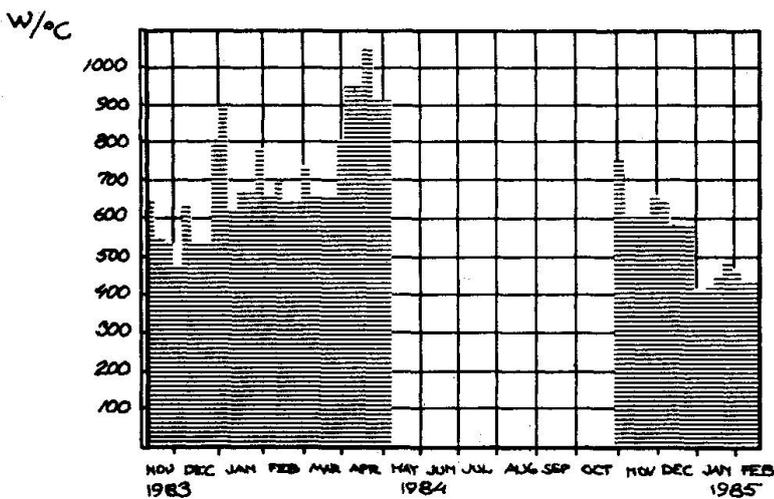
**Fig 8** Energy consumption for the Ekerö Tennis Centre during Nov. 1983-Feb. 1985. No recording during May 1984-Oct. 1984.

The total annual energy consumption, which is almost totally used for lighting is 70 000 kWh.
