Quality Assurance in the Eastern Scheldt Project

Wim COLENBRANDER

Rijkswaterstaat, Div. Locks and Weirs
Utrecht, The Netherlands

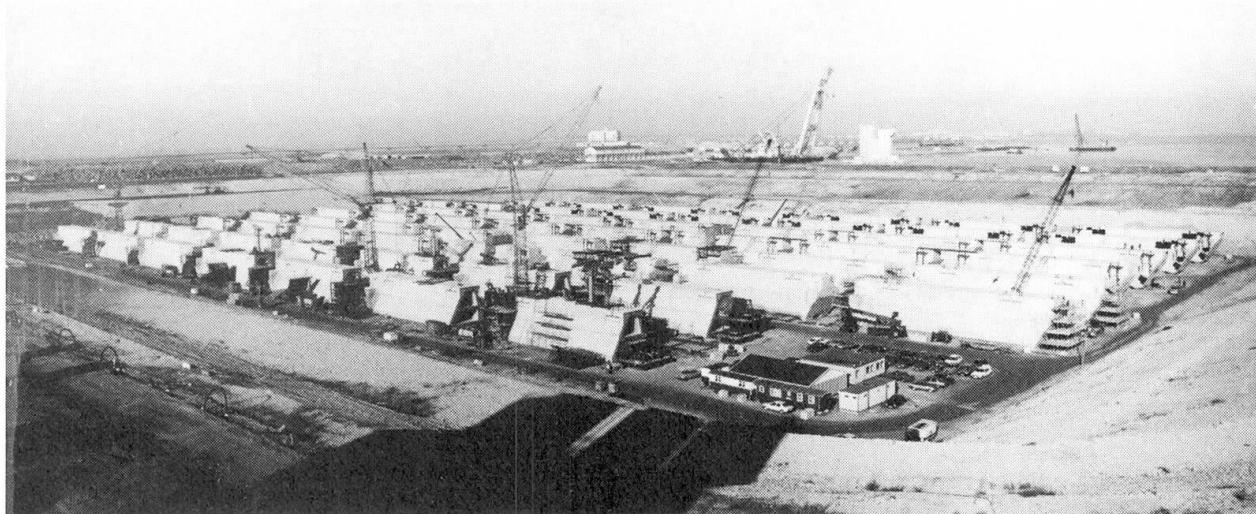
Photo 2 Sill-beams in construction dock (Jan. '85)

Placing of the sill-beams was estimated as one of the most complicated and riskful operations.

On one side the working conditions between the piers (increasing current-velocity and irregular flow-pattern) had to be faced, because of the fact that the flow-crosssection was reduced with 30 %.

On the other hand the extreme small tolerances between piers and sill-beams (minimum 5 cm) and the necessary fixation of the beams.
