**Zeitschrift:** IABSE reports = Rapports AIPC = IVBH Berichte  
**Band:** 51 (1986)

**Artikel:** Assessment of safety of pipelines subjected to soil liquefaction  
**Autor:** Kitaura, Masaru / Miyajima, Masakatsu  
**DOI:** <https://doi.org/10.5169/seals-39570>

## Assessment of Safety of Pipelines Subjected to Soil Liquefaction

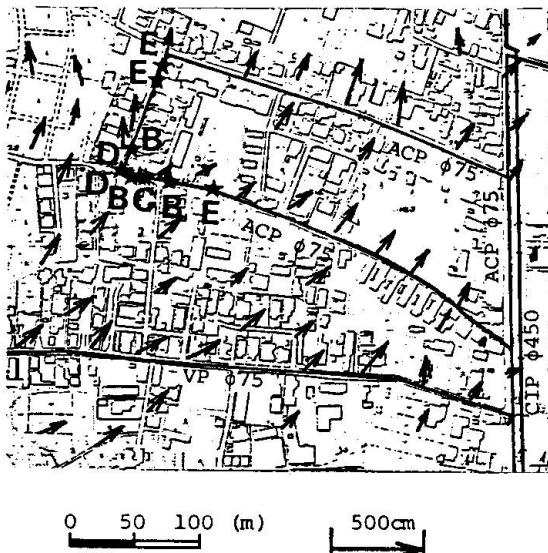
Fig. 1 Lateral spreading and pipe damage (Aoba-cho in Noshiro)

Permanent ground movement during the 1983 Nipponkai-Chubu Earthquake was measured by aerial photographs taken before and after the earthquake [1]. Figs. 1 and 2 show the permanent ground movement and pipe damage. A, B, C, D and E indicate the failure mode of the pipes in accordance with that

shown in Fig. 3 [2]. Length of arrows means the horizontal displacement of the permanent ground movement. Maximum displacement was about 5m in Noshiro City. Fig. 4 shows the relationship between the horizontal ground displacement and number of pipe damage in Noshiro City. This figure suggests that the much damage were caused at the sites where the horizontal ground displacement was greater than about 1m. Most of these areas were reported that the liquefaction occurred [3]. North slope of Maeyama hill in Kawatogawa area in Fig. 2, however, showed little sand volcano in spite that the large ground movement occurred. Based on these investigation data, the liquefaction-induced lateral spreading is classified into two types shown in Fig. 5. Type I is movement of competent surficial soils because of liquefaction of an underlying deposit (see Fig. 5 (a)), and type II is movement of surficial liquefied soils (see Fig. 5 (b)).

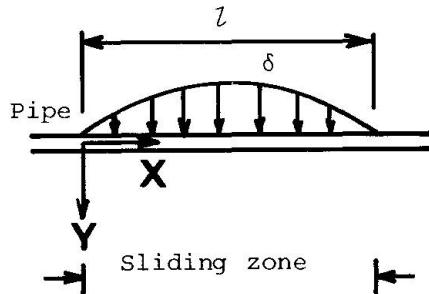
Fig. 6 Analytical model  
(Plane figure)

An analytical model shown in Fig. 6 is proposed to study the effects of liquefaction-induced lateral spreading on the damage to the pipelines. A pipeline is modeled as a Winkler beam. Shape of horizontal ground displacement is assumed as a sinusoidal curve here and it is transferred to the buried pipeline through the soil spring. The basic differential equations governing the motion of a pipeline can be written for transverse movements:

where,  $E$  is Young's modulus of the pipe material,  $I$  is geometrical moment of pipe inertia,  $\delta$  is maximum displacement of the lateral spreading,  $k_y$  is soil spring constant for transverse motion,  $l$  is stretch of the liquefied zone and  $v_1, v_2, v_3$  are transverse displacements of the pipe.

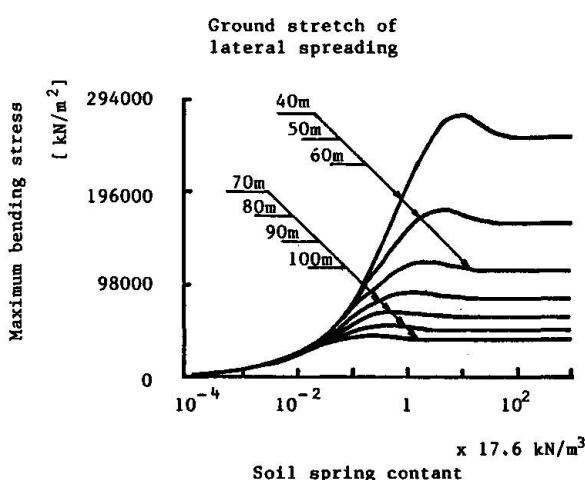
Fig. 7 Relationship between maximum bending stress and soil spring constant

Fig. 7 shows the relationship between the maximum bending stress and the soil spring constant. The welded steel pipeline whose nominal diameter is 400mm is analyzed here. Table 1 shows dimensions of the steel pipe which is used in the present study. The maximum displacement,  $\delta$ , in this case is 1m. Fig. 7 indicates that the maximum bending moment decreases in case that the soil spring constant is less than  $17.6 \text{ kN/m}^3$  ( $1.8 \times 10^{-3} \text{ kgf/cm}^3$ ). That is, the horizontal movement of competent soil affects the pipe behavior rather than that of liquefied soil does. It is interesting to note that the smaller the ground stretch of lateral spreading is, the greater the maximum bending moment is. These results suggest the conclusion that the pipe behavior due to liquefaction-induced lateral spreading is strongly influenced by the ground stretch of the lateral spreading and soil spring constant. The numerical example also indicates that the type I mentioned above is more destructive on the pipe than type II in case that the maximum horizontal displacement has the same value.

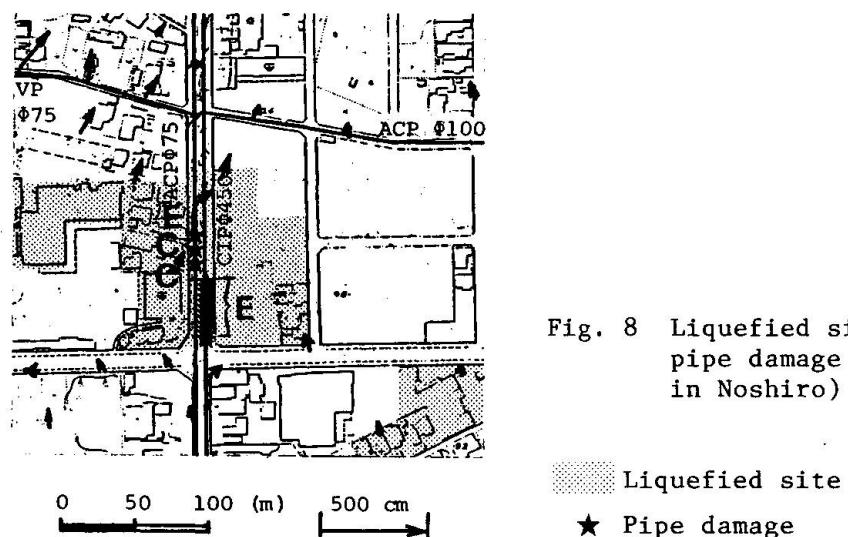
Fig. 8 Liquefied sites and pipe damage (Nagasaki in Noshiro)

One of the characteristics of the pipe damage due to the 1983 Nipponkai-Chubu Earthquake was that all of the damage to cast iron pipes (CIP) occurred at the liquefied site and most of them occurred at the joints of the pipes with large diameter of 400mm and 450mm. Fig. 8 indicates that such damage was caused at liquefied site near the boundary between the liquefied and non-liquefied sites.

■ Liquefied site  
★ Pipe damage

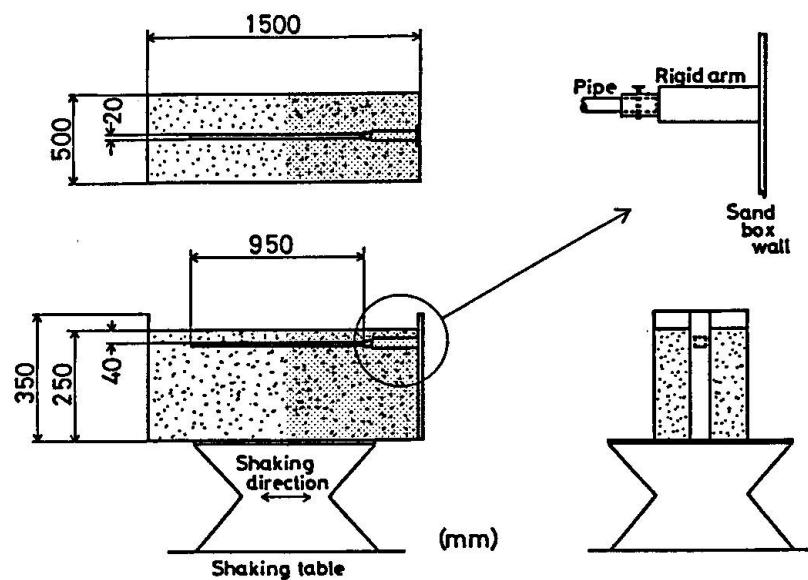
Fig. 9 General view of experimental apparatus

We conducted the experiments employing the model pipe in order to investigate the pipe strain characteristics near the boundary between the liquefied and non-liquefied sites [4]. Fig. 9 shows the general view of experimental apparatus. The buried pipe model was a rubber stick with 20mm diameter and 1000mm in length. Its elastic modulus was 79.4 MPa (810 kgf/cm<sup>2</sup>) and its weight per unit volume is 11.2 kN/m<sup>3</sup> (1.14 gf/cm<sup>3</sup>). One end of the model pipe was fixed at the rigid arm setting on the sand box. The half of the model ground was very loose and the other was densified by compaction. Exciting frequency was 5Hz. Exciting acceleration was about 200gal and exciting duration time was 30 seconds.

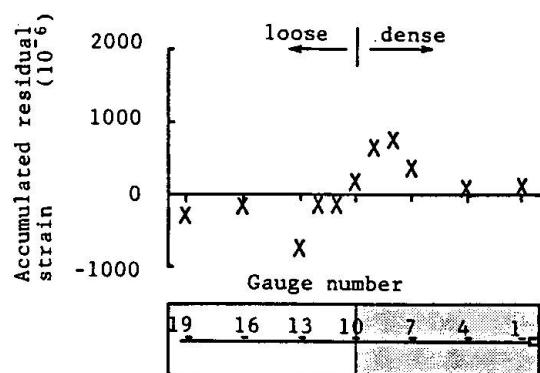
Fig. 10 Distribution of maximum accumulated residual strains of pipe

Figs. 10 and 11 show the distribution of the maximum accumulated residual strains of the model pipe and that of mean vibrating strains, respectively. The shaded portion in these figures indicate the non-liquefied area. It can be seen in these figures that both pipe strains express the maximum value in the liquefied ground near the boundary between liquefied and non-liquefied areas. The great similarity can be seen in a comparison of the damage to CIP and the experimental results. It is considered that the following factors affect the strain characteristics: the buoyancy acting on the pipeline buried in liquefied site, difference of dynamic characteristics between liquefied and non-liquefied ground, ground settlement due to liquefaction and so on. It is conceivable that these factors could influence the pipelines near the boundary between liquefied and non-liquefied sites more than those at the liquefied site. Care should be taken of such case.
