### Measures against Deterioration of Concrete Bridges due to Chloride Ions

#### Minoru FUJIWARA

#### Koichi MINOSAKU

This report presents an outline of "The Design and Construction Guidelines for Coastal Structures (Draft)" based on a survey on the chloride ion and the corrosion of steel in the existing concrete bridges, and on measurement of airborne chloride ions in coastal areas all over Japan.

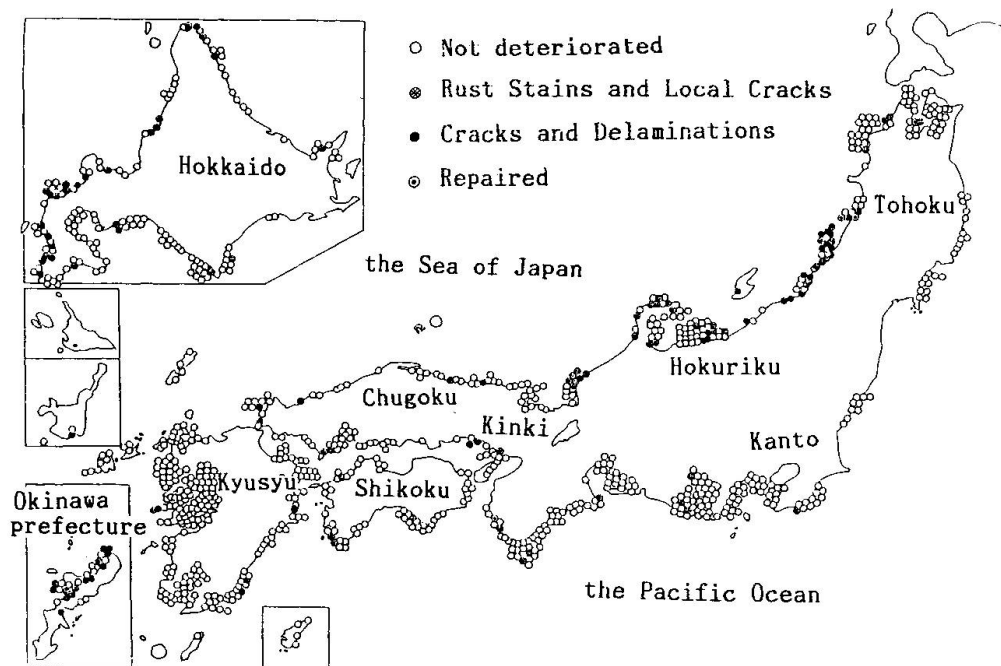
(1) Deterioration due to chloride ions is intensive in coastal areas of Hokkaido, Tohoku and Hokuriku Regions along the Sea of Japan where the north-west seasonal wind is strong, and in Okinawa Prefecture which belongs to the subtropical region and is regularly attacked by Typhoons, as shown in Figure 1.

Fig. 1 Actual Condition of Concrete Bridges

(2) The majority of deteriorated bridges are located in areas within 300m of the shoreline, and those within 100m show a higher rate of deterioration.

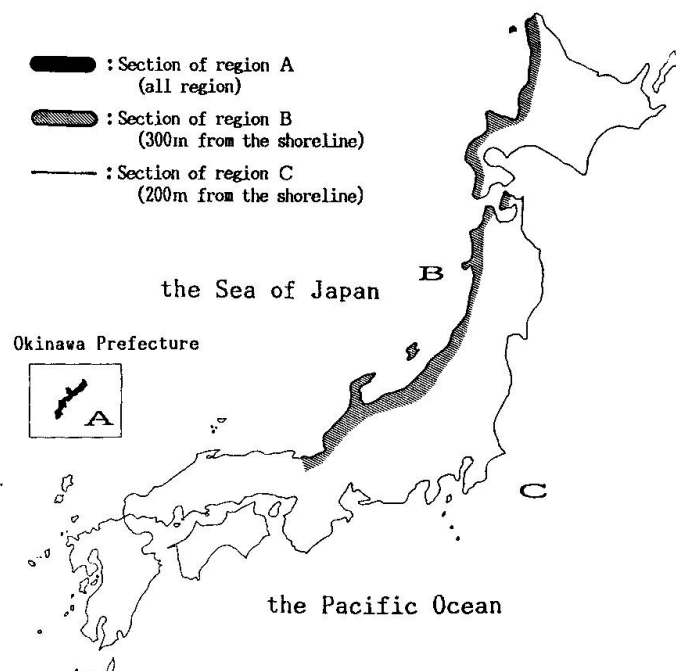
The Guidelines (Draft) defines the areas requiring measures to prevent deterioration of concrete bridges due to chloride ions using the distance from the shoreline as an

indicator, as shown in Figure 2. These areas are designated based on the results of a survey on airborne chloride ions as well as the above mentioned survey on the actual condition of concrete bridges.

1) See Fig. 2

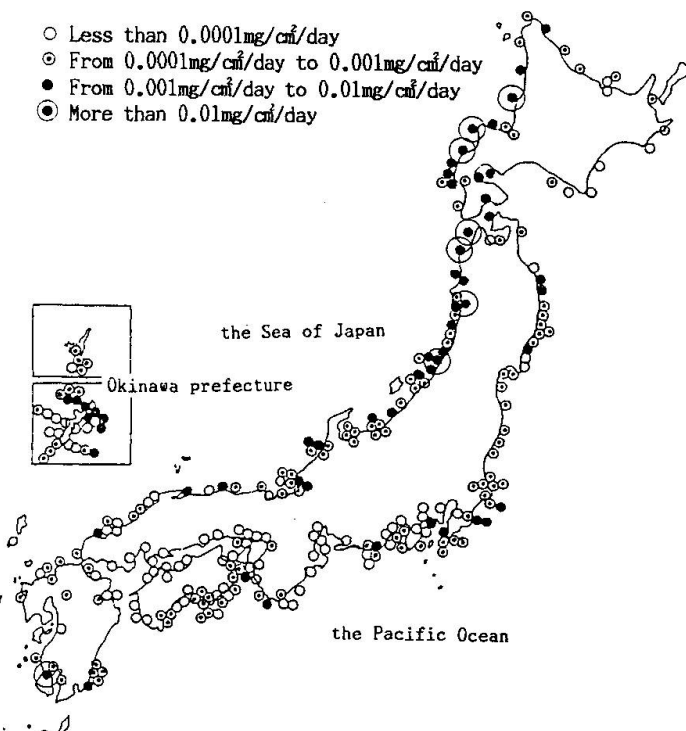
Airborne chloride ions were measured for 3 years from 1984 to 1987 at 266 points in coastal areas all over the country. Figure 3 shows the distribution of airborne chloride ions in the country based on the survey results. The Sea of Japan coastal areas in the Hokkaido, Tohoku and Hokuriku Regions and Okinawa Prefecture, in which a number of deteriorated bridges were found, recorded a higher airborne chloride ion content. Of these areas, the Pacific coast areas in Okinawa Prefecture and the Sea of Japan coastal area in the Tohoku Region recorded the airborne chloride ion content of  $0.1\text{mg}/\text{cm}^2$  (NaCl weight) on the daily average for the 3 year period even at points of 300m and 100m away from the shoreline, respectively. On the contrary to these areas, the airborne chloride ion content is low in areas along the Seto Inland Sea in which the daily average for the 3 year period is less than  $0.01\text{mg}/\text{cm}^2$  (NaCl weight) even at points within 100m. Although the airborne chloride ion content in other areas such as the Pacific coastal areas and the Sea of Japan coastal areas in the Chugoku and Kyushu Regions scattered widely, it tends to become smaller at points more than 300m away from the shoreline.

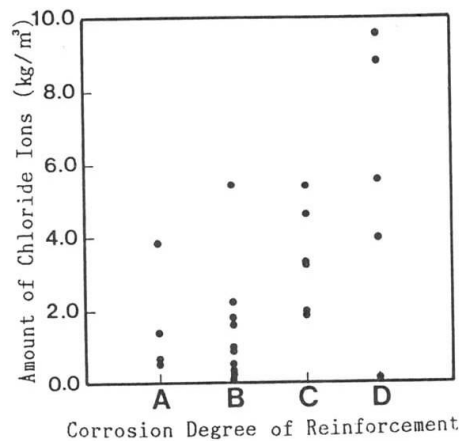
Fig. 4 Relation between Amount of Chloride Ions and the Corrosion Degree of Reinforcement (See, Table 1)

reinforcement and the chloride ion content is shown in Figure 4. The corrosion degree of reinforcement was judged in accordance with the criteria shown in Table 1. The average chloride ion content at the corrosion degree C, which indicates development of corrosion, was  $3.4\text{kg/m}^3$  with the standard deviation of  $1.4\text{kg/m}^3$ . Figure 5 shows the relation between the corrosion degree and the cover of reinforcement. The majority of reinforcement of which corrosion degree was C and D are in the range of the cover less than 5cm.

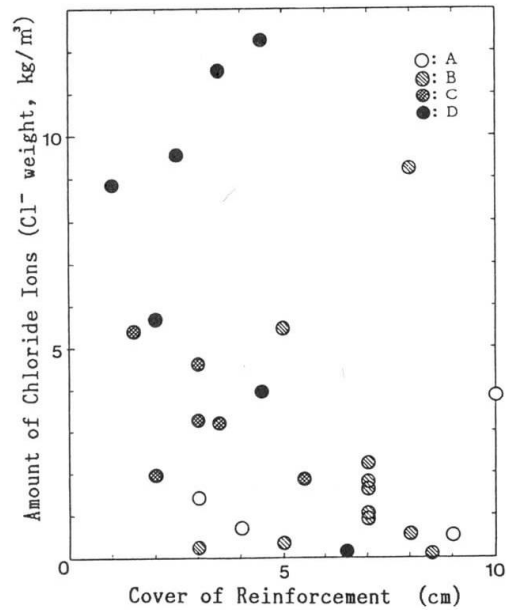
Fig. 5 Relation between the Corrosion Degree of Reinforcement (See, Table 1) and Cover of Reinforcement

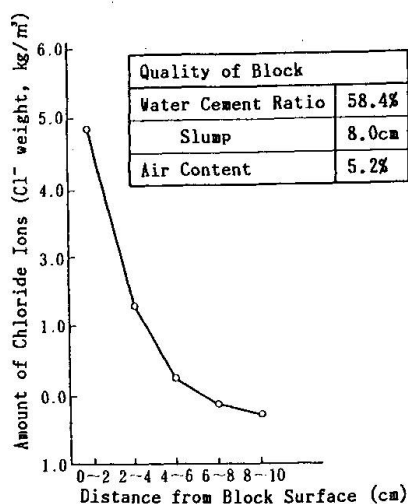
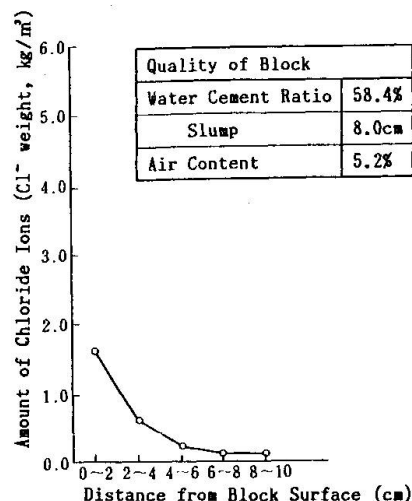
Figure 6 illustrates results obtained from this exposure test for 2 typical points. As to the block exposed at the point in the Sea of Japan coastal area in Tohoku Region where the average airborne chloride ion amounts to  $0.19\text{mg/cm}^2$  (NaCl weight), the penetrating chloride ion of approximately  $2.0\text{kg/m}^3$  ( $\text{Cl}^-$  weight) leading to the corrosion development deposits at 2-4cm depth from the surface during the 3 year period. On the other hand, as to the block exposed at the point in the Pacific coastal area in Kanto Region where the average daily airborne chloride ion is  $0.02\text{mg/cm}^2$  (NaCl weight), the quantity of chloride

ions deposited at 2-4cm depth from the surface during the 3 year period is about  $0.60\text{kg/m}^3$  ( $\text{Cl}^-$  weight). Thus, the chloride ions penetrating into concrete is proportional to the concentration of airborne chloride ions. Based on these results, The

(a) Exposing Point; the Sea of Japan Side of Tohoku Region, Exposing; 3years

(b) Exposing Point; Kanto Region, Exposing; 3years

Fig. 6 Distribution of Chloride Ions in Concrete
