Zeitschrift: IABSE reports = Rapports AIPC = IVBH Berichte
Band: 57/1/57/2 (1989)

Artikel: Measures against deterioration of concrete bridges due to chloride ions
Autor: Fujiwara, Minoru / Minosaku, Koichi
DOI: <https://doi.org/10.5169/seals-44310>

Measures against Deterioration of Concrete Bridges due to Chloride Ions

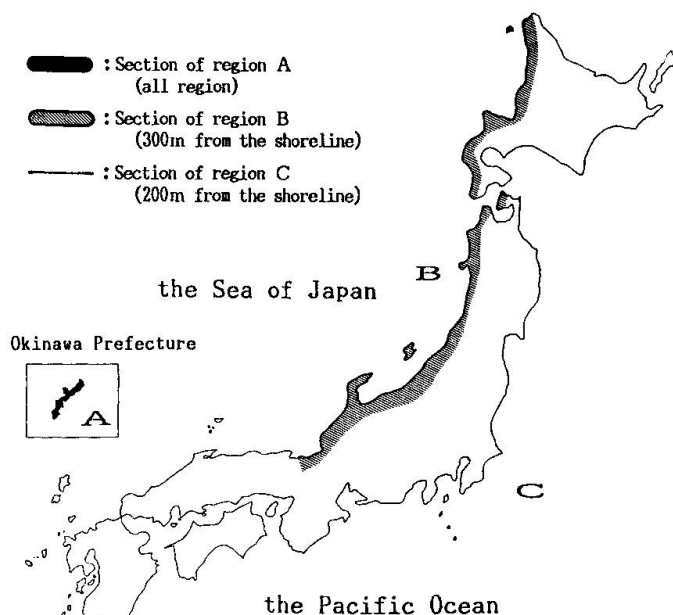
The Guidelines (Draft) defines the areas requiring measures to prevent deterioration of concrete bridges due to chloride ions using the distance from the shoreline as an

indicator, as shown in Figure 2. These areas are designated based on the results of a survey on airborne chloride ions as well as the above mentioned survey on the actual condition of concrete bridges.

1) See Fig. 2

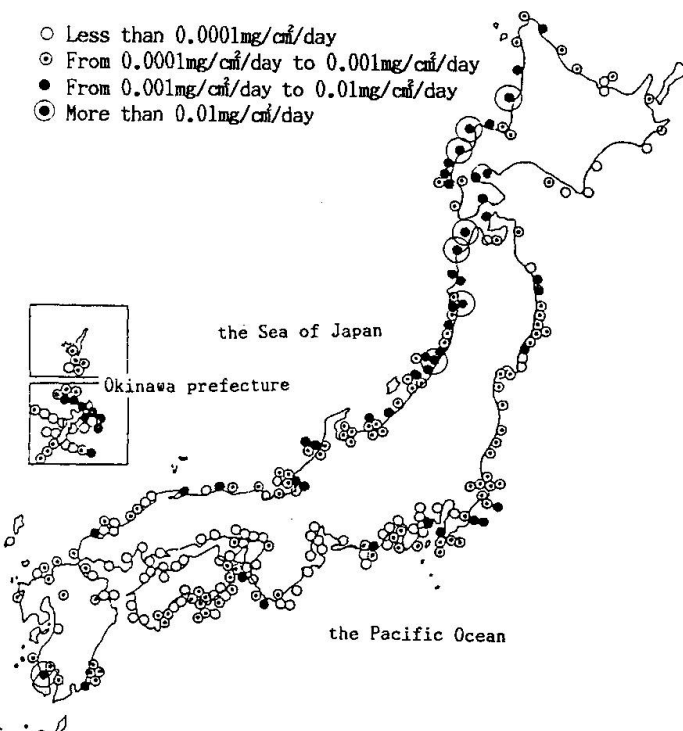
Airborne chloride ions were measured for 3 years from 1984 to 1987 at 266 points in coastal areas all over the country. Figure 3 shows the distribution of airborne chloride ions in the country based on the survey results. The Sea of Japan coastal areas in the Hokkaido, Tohoku and Hokuriku Regions and Okinawa Prefecture, in which a number of deteriorated bridges were found, recorded a higher airborne chloride ion content. Of these areas, the Pacific coast areas in Okinawa Prefecture and the Sea of Japan coastal area in the Tohoku Region recorded the airborne chloride ion content of $0.1\text{mg}/\text{cm}^2$ (NaCl weight) on the daily average for the 3 year period even at points of 300m and 100m away from the shoreline, respectively. On the contrary to these areas, the airborne chloride ion content is low in areas along the Seto Inland Sea in which the daily average for the 3 year period is less than $0.01\text{mg}/\text{cm}^2$ (NaCl weight) even at points within 100m. Although the airborne chloride ion content in other areas such as the Pacific coastal areas and the Sea of Japan coastal areas in the Chugoku and Kyushu Regions scattered widely, it tends to become smaller at points more than 300m away from the shoreline.

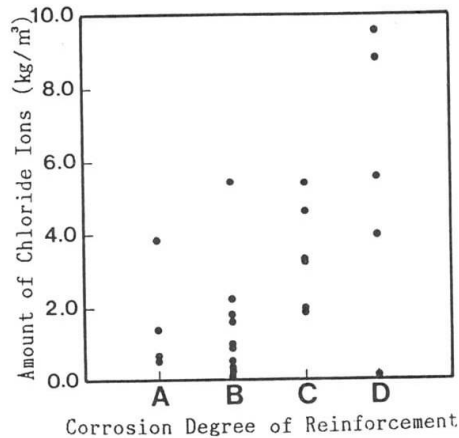
Fig. 4 Relation between Amount of Chloride Ions and the Corrosion Degree of Reinforcement (See, Table 1)

reinforcement and the chloride ion content is shown in Figure 4. The corrosion degree of reinforcement was judged in accordance with the criteria shown in Table 1. The average chloride ion content at the corrosion degree C, which indicates development of corrosion, was 3.4kg/m^3 with the standard deviation of 1.4kg/m^3 . Figure 5 shows the relation between the corrosion degree and the cover of reinforcement. The majority of reinforcement of which corrosion degree was C and D are in the range of the cover less than 5cm.

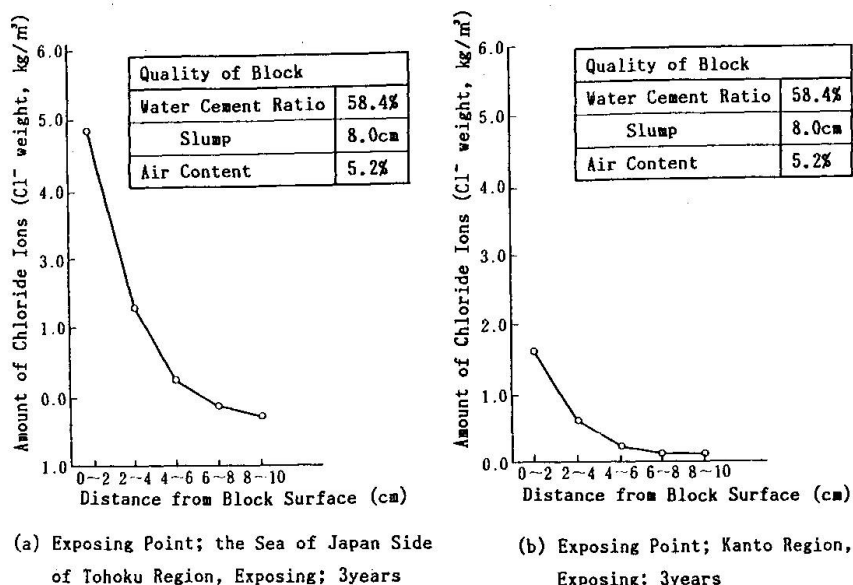
Figure 6 illustrates results obtained from this exposure test for 2 typical points. As to the block exposed at the point in the Sea of Japan coastal area in Tohoku Region where the average airborne chloride ion amounts to 0.19mg/cm^2 (NaCl weight), the penetrating chloride ion of approximately 2.0kg/m^3 (Cl^- weight) leading to the corrosion development deposits at 2-4cm depth from the surface during the 3 year period. On the other hand, as to the block exposed at the point in the Pacific coastal area in Kanto Region where the average daily airborne chloride ion is 0.02mg/cm^2 (NaCl weight), the quantity of chloride

ions deposited at 2-4cm depth from the surface during the 3 year period is about 0.60kg/m^3 (Cl^- weight). Thus, the chloride ions penetrating into concrete is proportional to the concentration of airborne chloride ions. Based on these results, The Guidelines (Draft) sets the standard minimum cover of reinforcement as shown in Table 3.

Fig. 6 Distribution of Chloride Ions in Concrete
