Ultrasonic Testing of Concrete

Ulrika WIBERG
Civil Engineer
Royal Inst. of Technology
Stockholm, Sweden

A research project concerning the use of ultrasonic technology for detection of deterioration in concrete is reported. The development possibilities for the technology in detecting damage on the basis of excitation of broadband sound pulses and with evaluation based on digital signal analysis are discussed. Results are presented from a series of tests on concrete cylinders with fatigue-induced cracks.

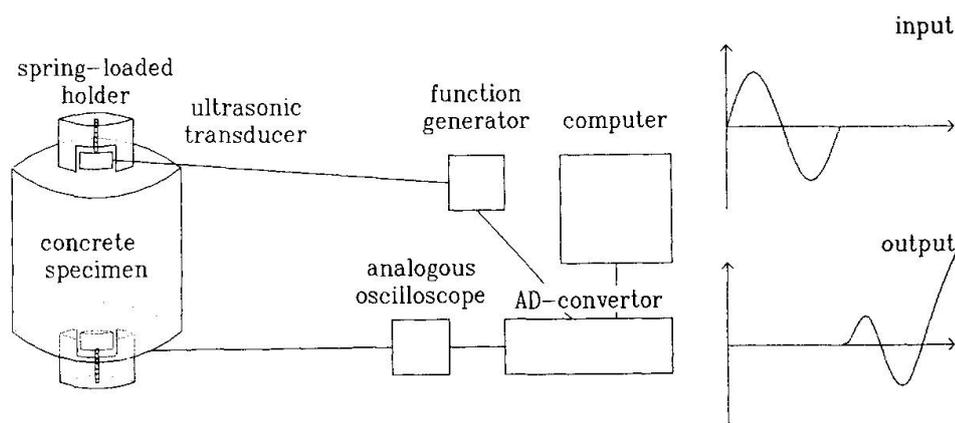
The transducers were applied to the concrete specimen in each separate ultrasonic measurement according to Fig. 1. In order to bring about a reproducible coupling the probes were mounted against a spring- loaded holder which produced a constant contact pressure. A coupling medium was applied between the probes and the concrete.

Fig. 1: Schematic diagram of test setup

In the test series, ultrasonic measurements were carried out with direct transmission in the axial direction of the cylinders . Piezo-electrical transducers with a high frequency response in the band from 40- 160 kHz were used as sending and receiving probes. In all measurements the electric input, shown in Fig. 1, consisted of one cycle of a sinusoidal wave in 130 kHz with a voltage of 250 V. The received signal was stored in digital form with a sampling frequency of 2 MHz.

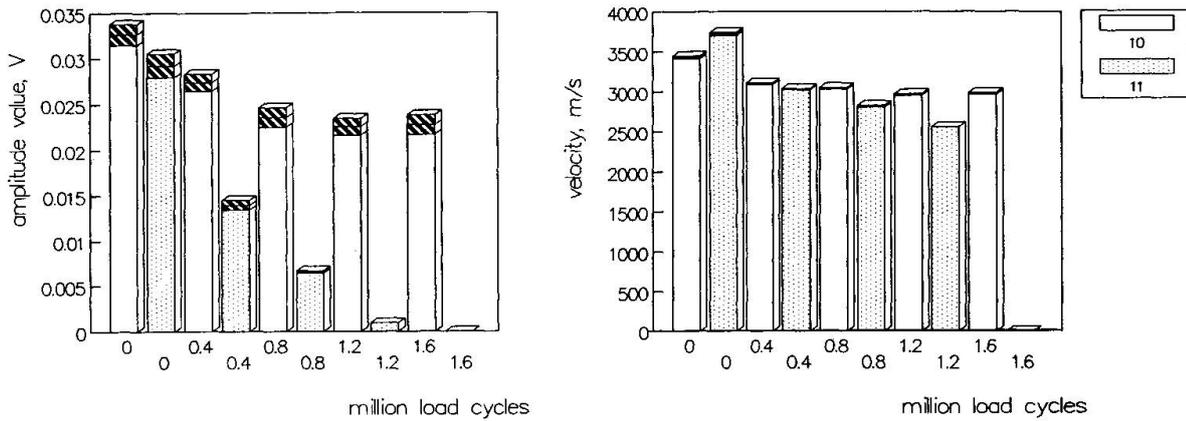
Mean values of velocities and amplitudes from signals measured with renewed coupling are presented in Fig. 2 together with the corresponding standard deviations.

Fig. 2: Mean values with standard deviations of eight repeated measurements from specimens 10 and 11, at different stages of loading. Amplitude of first received sound wave, left and Velocity, right.

The changes upon deterioration will be greater for amplitude measurements than for velocity measurements. The variation in values recorded with repeated measurements is however greater for amplitude than for velocity measurements. Several repeated measurements are therefore required to obtain a reproducible amplitude parameter. It is also shown that there are increasing difficulties to reproduce the entire signal when the concrete is deteriorated. A lack in coherence can in itself be an indication of an increased number of cracks in the concrete specimen.

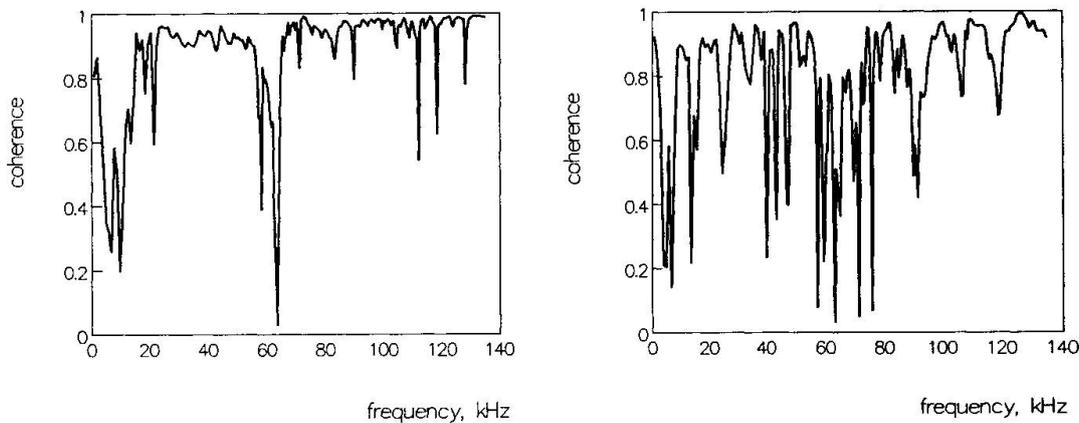
Apart from the deviations that can be calculated for selected analysis parameters, the reproducibility can be studied by calculation of the averaged coherence function between input and output signals. By this means a picture is obtained of how well the included frequencies are reproduced in all of the received signal. The coherence of the repeated measurements was therefore registered in each measurement stage. Calculated coherence functions for one of the cylinders are shown in Fig. 3 referring to two different occasions.

Fig. 3: Coherence functions for measurements on specimen number 11 at the initial stage, left, and after 0.8 million load cycles, right.

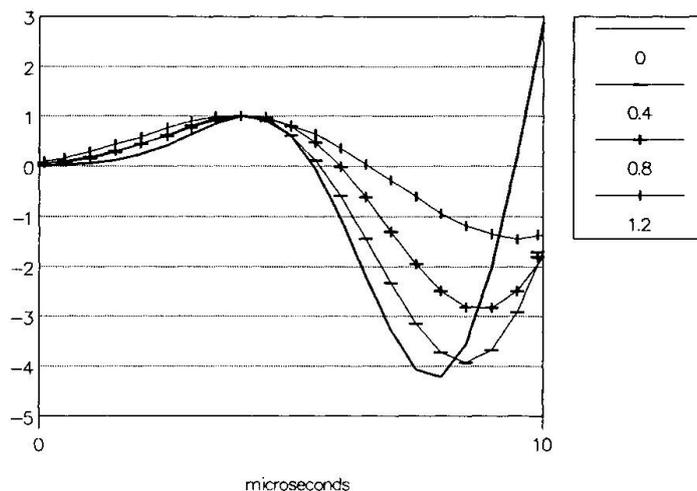
The duration of the first received wave was shown to be changed due to cracks. The appearance of this wave is shown in Fig. 4 for one of the specimens at different degrees of cracking.

Fig. 4: First parts of received waveforms from specimen 11 at 0, 0.4, 0.8 and 1.2 million cycles. Amplitude values are normalized with respect to the first received peak.

The duration of the first wave of the received signal will also be longer and thus contain lower frequencies with increased damage. The changes in the frequency contents of the received signal due to deterioration is therefore interesting.
