Zeitschrift: IABSE reports = Rapports AIPC = IVBH Berichte
Band: 57/1/57/2 (1989)

Artikel: Design approach with respect to durability
Autor: Miyamura, Atsunori / Kohama, Yoshiro
DOI: <https://doi.org/10.5169/seals-44243>

Design Approach with Respect to Durability

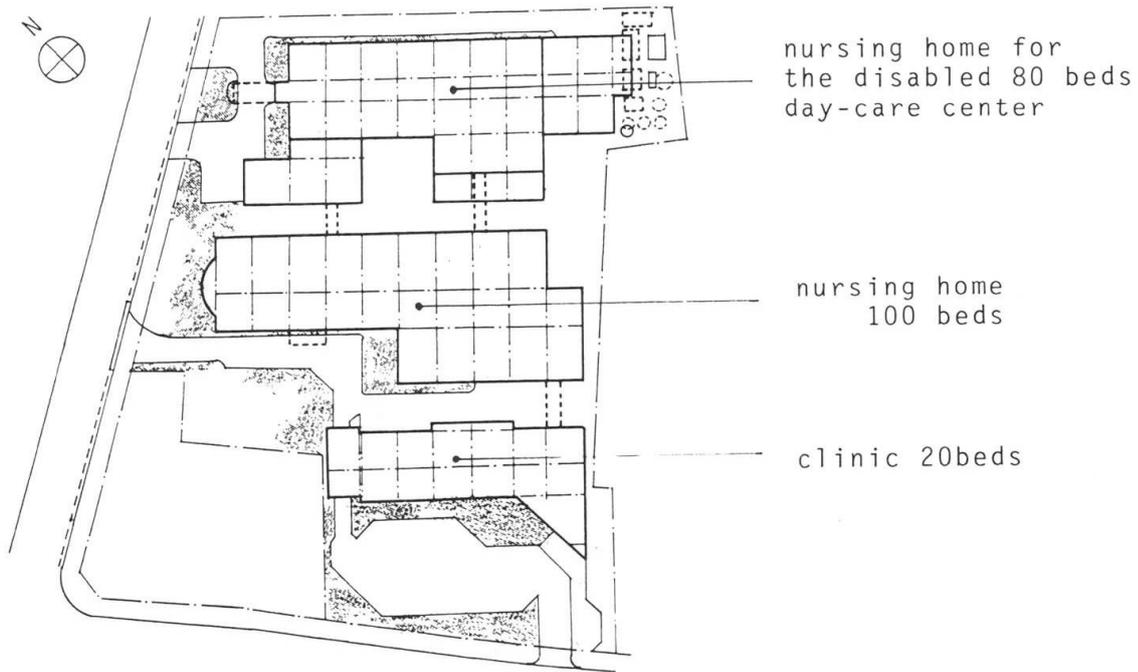
Fig. 1a Site plan of the complex

This private medical and welfare complex for the aged holds 200 beds and consists of three RC wings, namely, a medical clinic, two nursing homes and a day-care center as shown in Fig. 1. Various kinds of restriction surrounding this project demand more sophisticated design review not only structurally but also environmentally or even architecturally particularly of durability closely correlated to maintenance for the life span. Prominent properties are as follows.

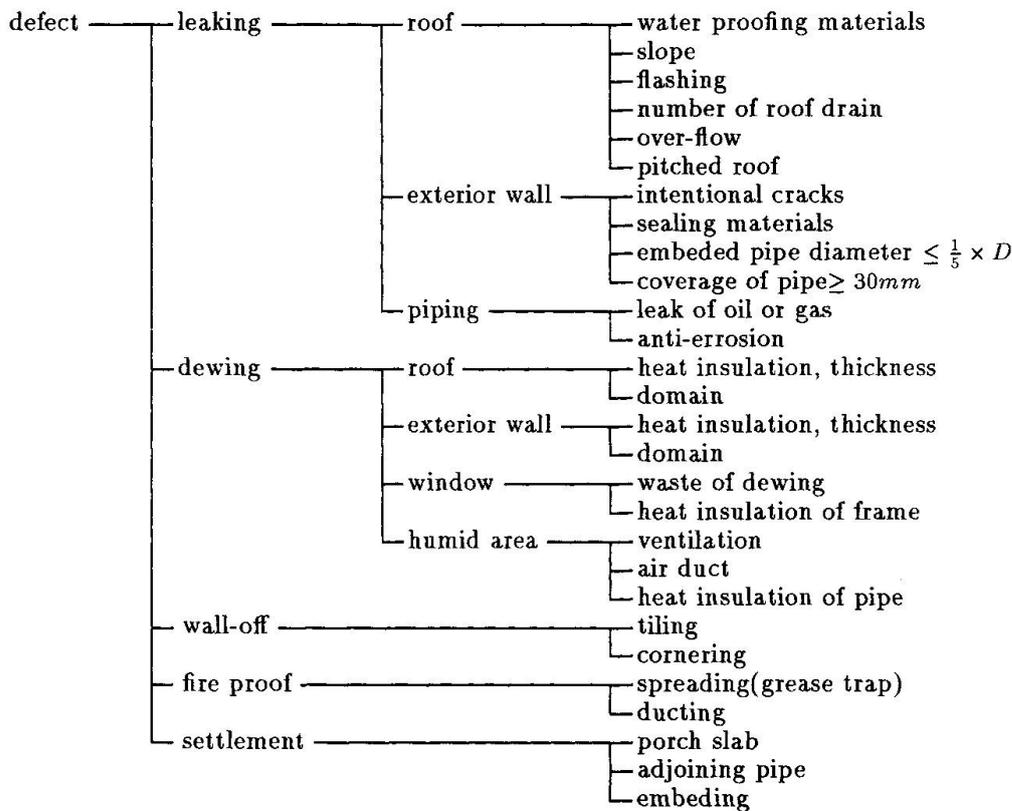
These ill-conditions can be extended into actual defects in detail which should be more practically evaluated at design specification and construction.

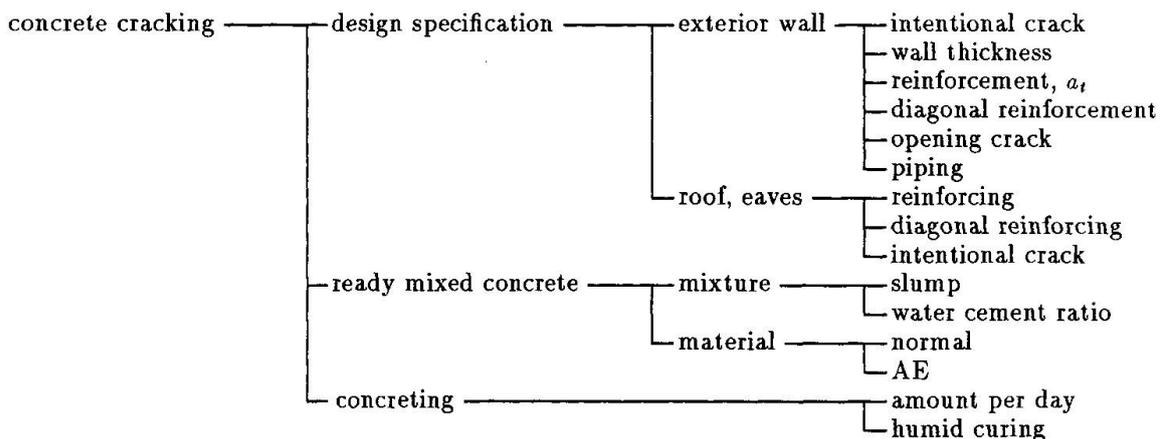
Furthermore, thus classified defects can be deployed more concretely from design and construction point of view. The following is an example of cracks which will be prevented as strictly as possible at each job stage.
