**Zeitschrift:** IABSE reports = Rapports AIPC = IVBH Berichte

**Band:** 57/1/57/2 (1989)

**Rubrik:** Session 1: General durability aspects from preliminary design to demolition

### GENERAL DURABILITY ASPECTS FROM PRELIMINARY DESIGN TO DEMOLITION

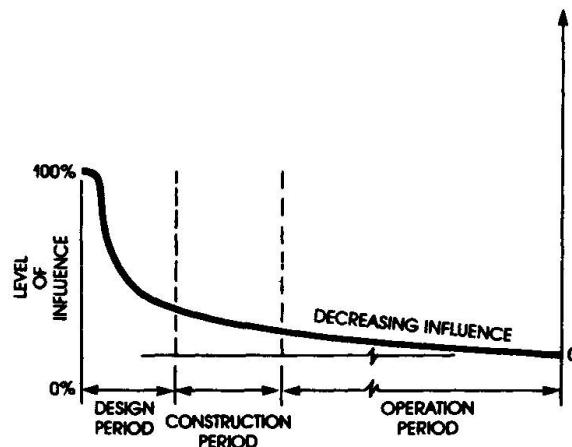
Figure 1

Opportunity to Influence Project Quality and Cost

The design phase has the greatest impact on the quality--another name for durability--and cost of the bridge. In a publication entitled Quality in the Constructed Project, {1} the ASCE included a chart that illustrated the effect on quality: (Figure 1).

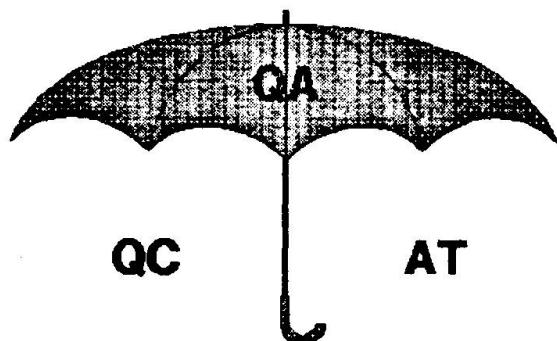
Figure 2

## DURABLE BRIDGES Quality Assurance Program

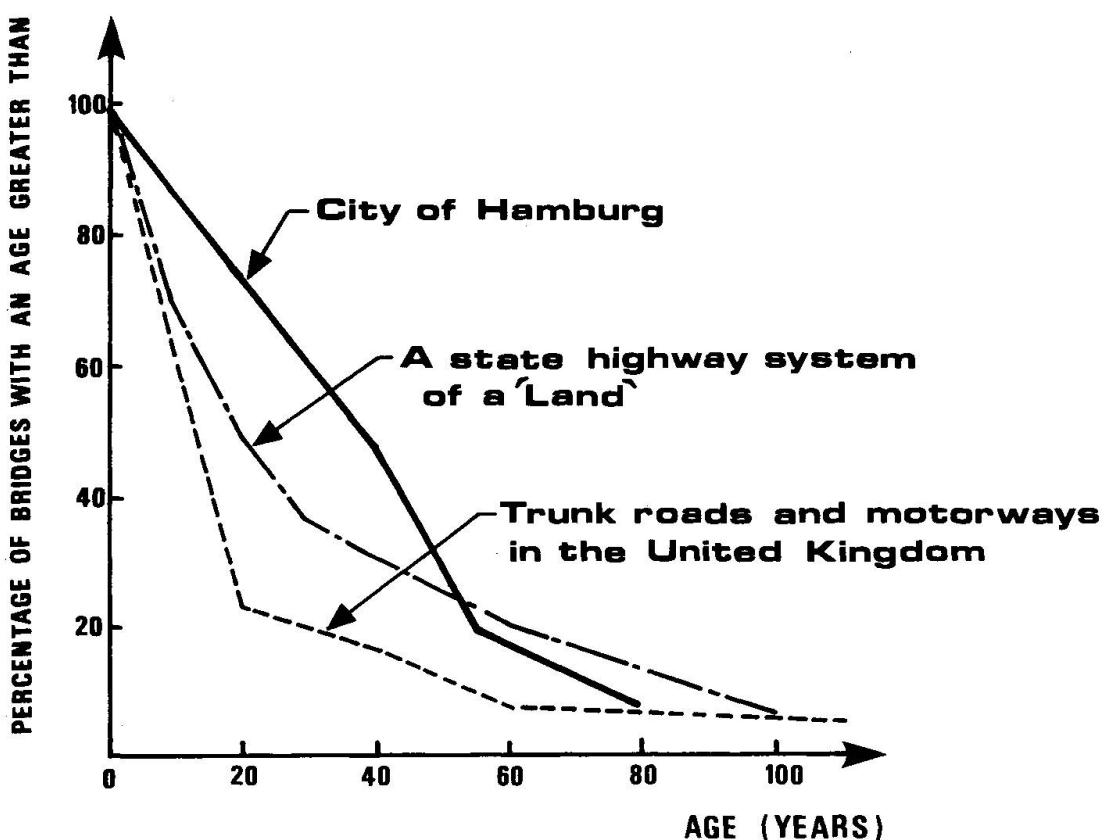
Fig. 1 : Example of age distribution

A rate of 0.6 leads to an assumed serviceable life of 170 years, and the rate of 0.2 raises this assumed life up to 500 years, what is obviously far too much. But this approach takes into account only an average replacement rate, which should be available for long periods. Now in all industrialised countries many more bridges were built in the last few decades than in the past, and this fact tends to lower the average age of the stock of bridges. Three examples of age distribution are shown in Figure 1, concerning the stock of bridges of two German Länder and of the United Kingdom. They show that in these regions 90 per cent of the bridges are less than 50 to 80 years old.

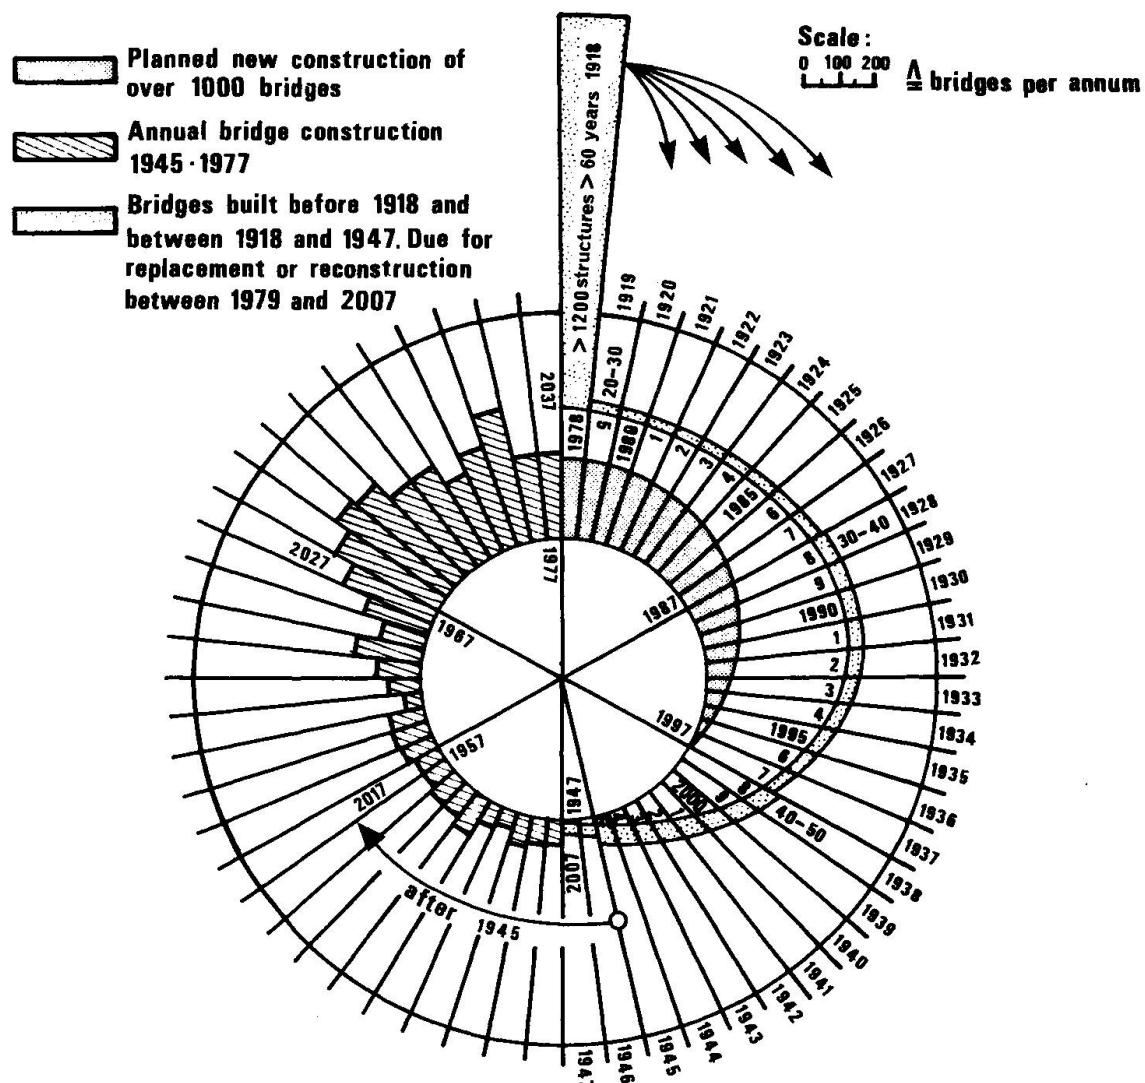
Fig. 2 : Bridge generation cycle of Rhine Palatinate Land

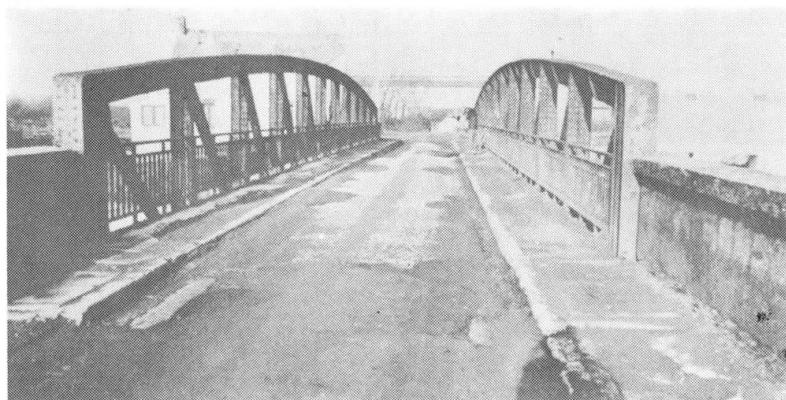
Fig. 3 : Old steel bridge

They were indeed fairly liberally dimensioned, because of the lack of knowledge in the calculation of structures, and fatigue does not seem yet to affect them. An exception, however, is to be mentioned concerning all steel bridges the deck of which is made out of little masonry arches : the latter are not waterproof and the corrosion has often strongly attacked the steel pieces supporting the deck.

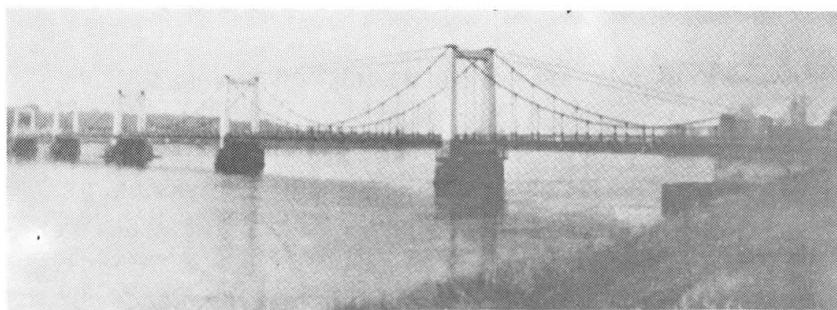
Fig. 4 : The Sully suspension bridge

Their load carrying capacity is frequently insufficient, and their maintenance condition rather poor. The collapse of one of them during the particularly cold winter of 1985 pointed out the vulnerability of the suspension bars of most of them, under low temperatures, due to the steel quality used at the time.

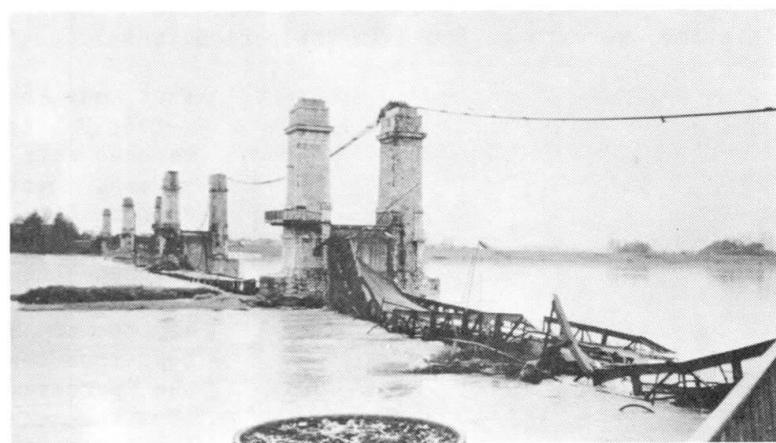
Fig. 5 : The same after collapse on Jan. 16. 1985

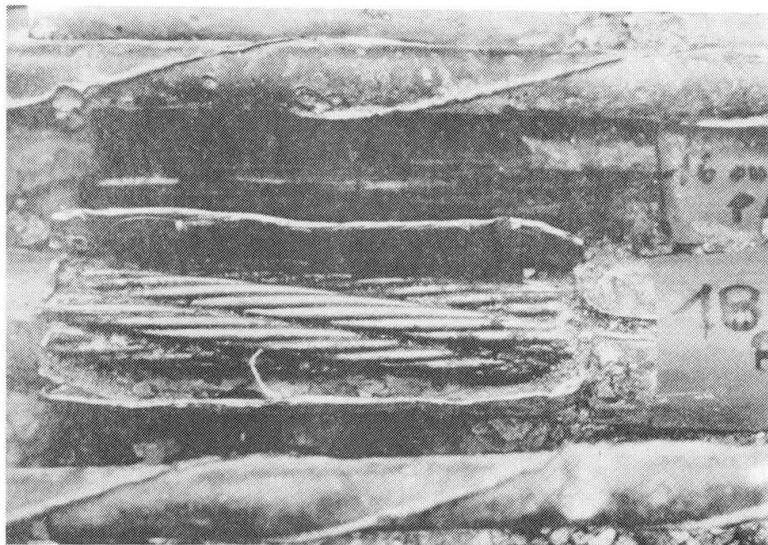
Fig. 6 : Attack of the tendons by corrosion

Finally, the last technique of primary importance to appear in the field of bridge construction is, of course, prestressed concrete. The first structures built in the 1950's were made out of precast in-situ prestressed beams. Many structures of this decade present lack of grouting and insufficient waterproofing, so that the tendons have been severely attacked by corrosion. It has been necessary to replace several structures of this type.

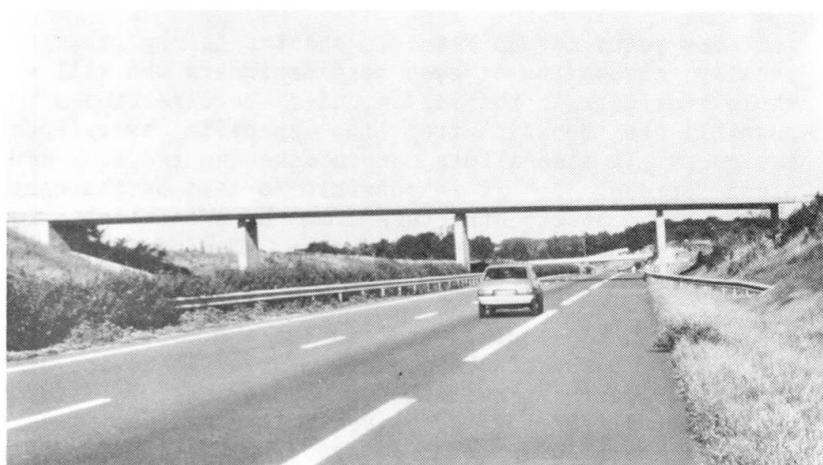
**Fig. 8 : Simplicity of the slab deck for common bridges**

In France both the economical conditions and the climate make it possible to build small structures with cast in-situ concrete. So the major part of the standardized small bridges is composed of slab decks. Their design is quite simple and fast, due to the fact that the calculation of the standard slabs is made at low price in a special public office using specific computer programs.

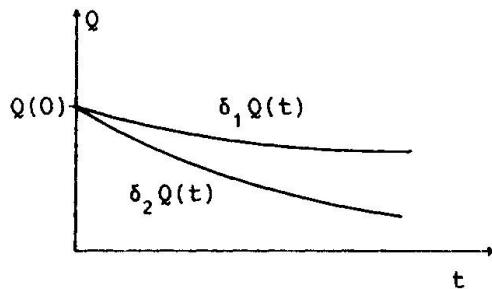
Fig. 1 Successive degradation

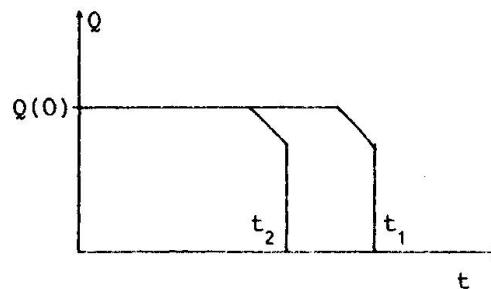
Fig. 2 Sudden failure

on materials or components with a pattern of sudden failure is shown: either a prolongation of service life from  $t_2$  to  $t_1$ , or a more narrow interval of life being predicted.

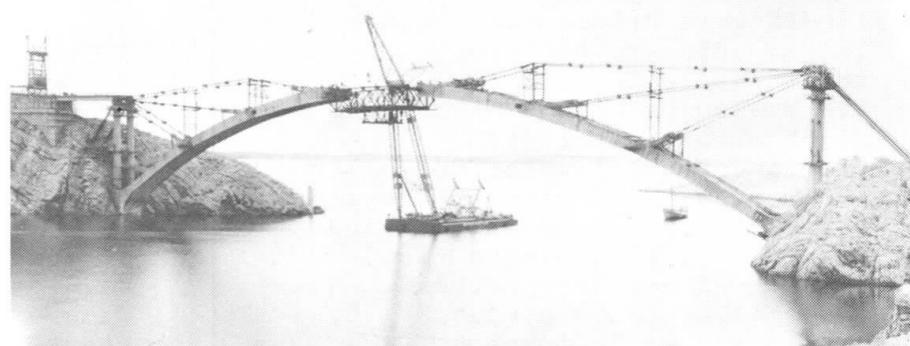
Fig 2. Reinforced concrete arch of Pag Island bridge during construction

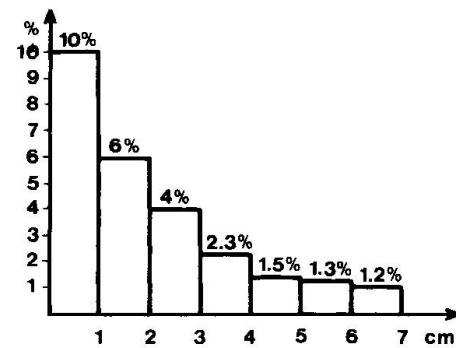
Fig 4. Diagram showing ion content compared with the quantity of cement from surface towards the interior of the Pag Bridge girder

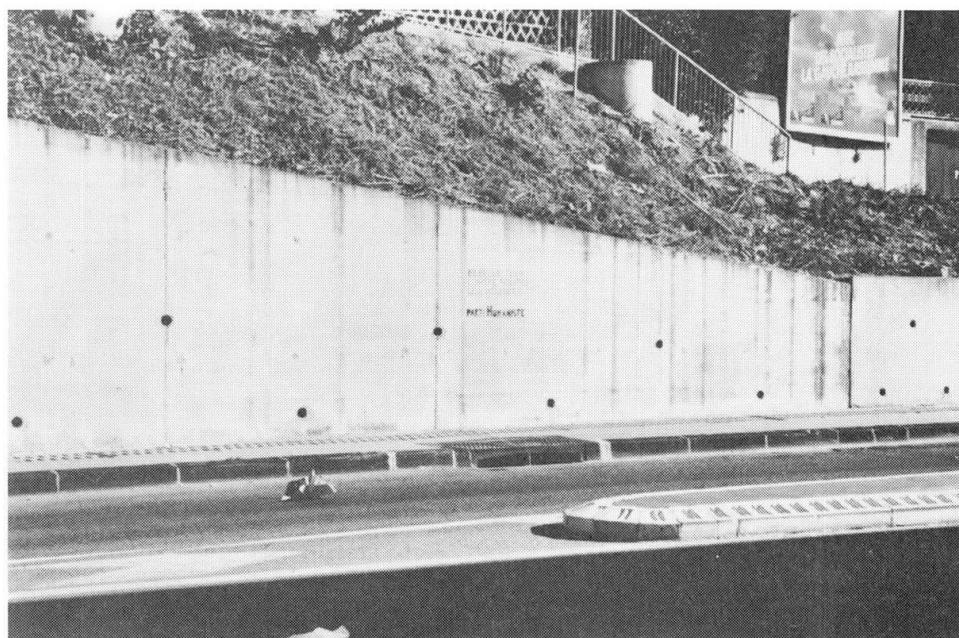
Fig.1 Béton brut sans précautions

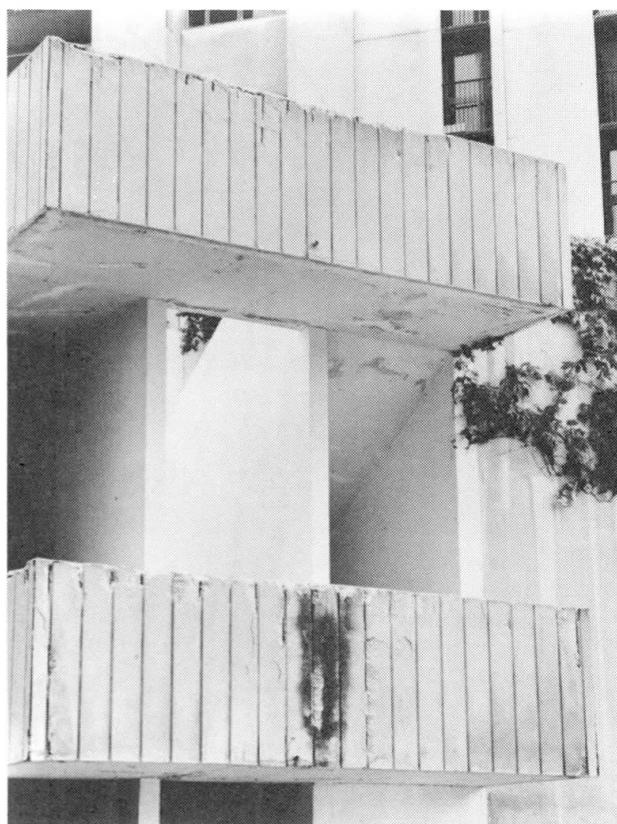
Fig.2 Béton mal traité

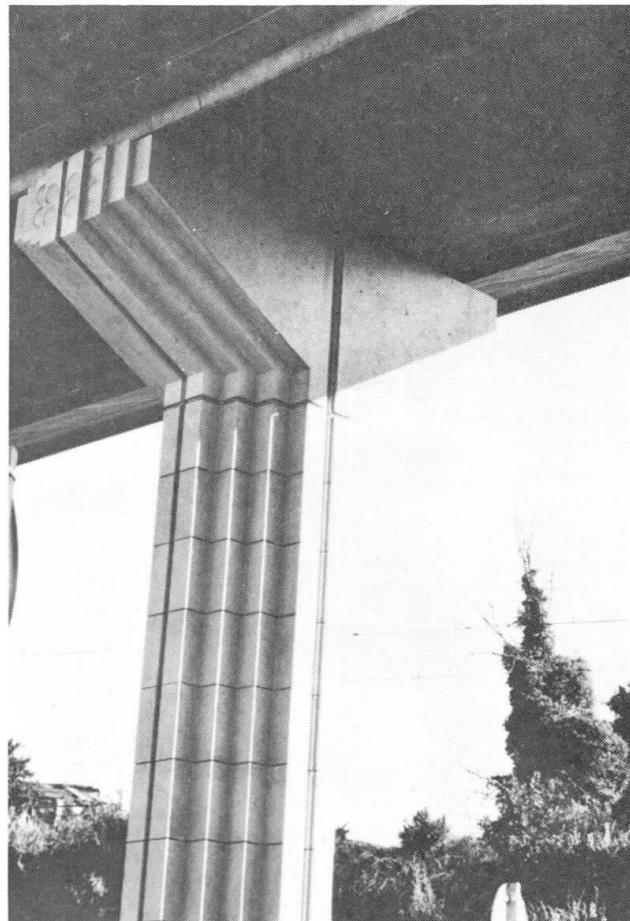
Fig.4 Pile soignée

Enfin il y a la protection des parements contre les graffiti et les affiches. Cette protection a un but essentiellement esthétique, graffiti et affiches ne remettant pas en cause la stabilité chimique et mécanique du béton. En outre, le fait de traiter les surfaces ne dispense-t-il pas d'un suivi régulier des ouvrages et d'interventions rapides de nettoyages et de renouvellement de la protection.

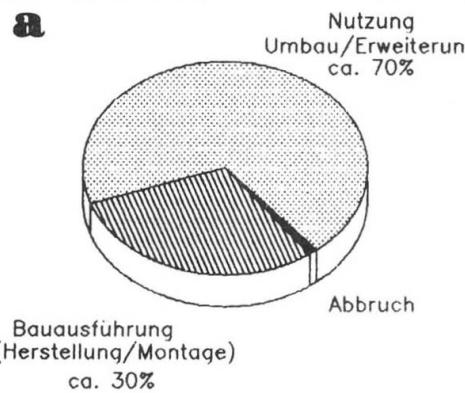
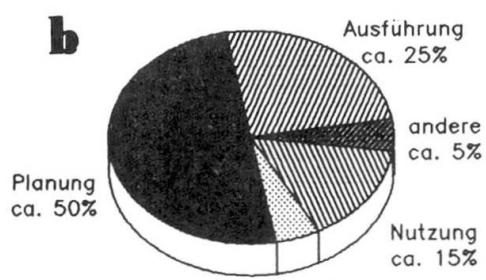
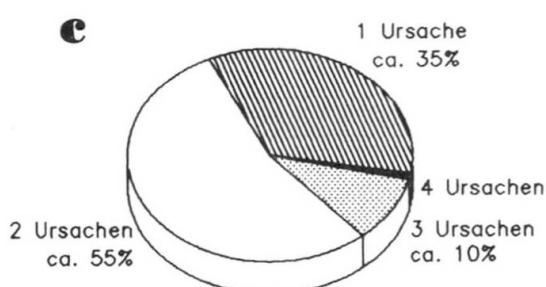
Bild 1 Schadensauswertung

Wenn systematische Schadensanalysen nicht geführt werden oder werden können, ist die Untersuchung von Stichproben meist zweckmäßig. Nachfolgend wird über die Ergebnisse einer Auswertung von über 100 mittleren (d.h. mit erheblichem Aufwand sanierbar oder Personengefährdung) bis großen (d.h. großer finanzieller Verlust oder Personenschaden), in den vergangenen 20 Jahren bekannt gewordenen internationalen Schadensfällen an Stahlhallen berichtet. Kleinere Schäden, die den Bereich der öffentlichen Sicherheit nicht berühren, sind in der Literatur nicht dokumentiert. Die Untersuchung zeigt, wann (Bild 1a)

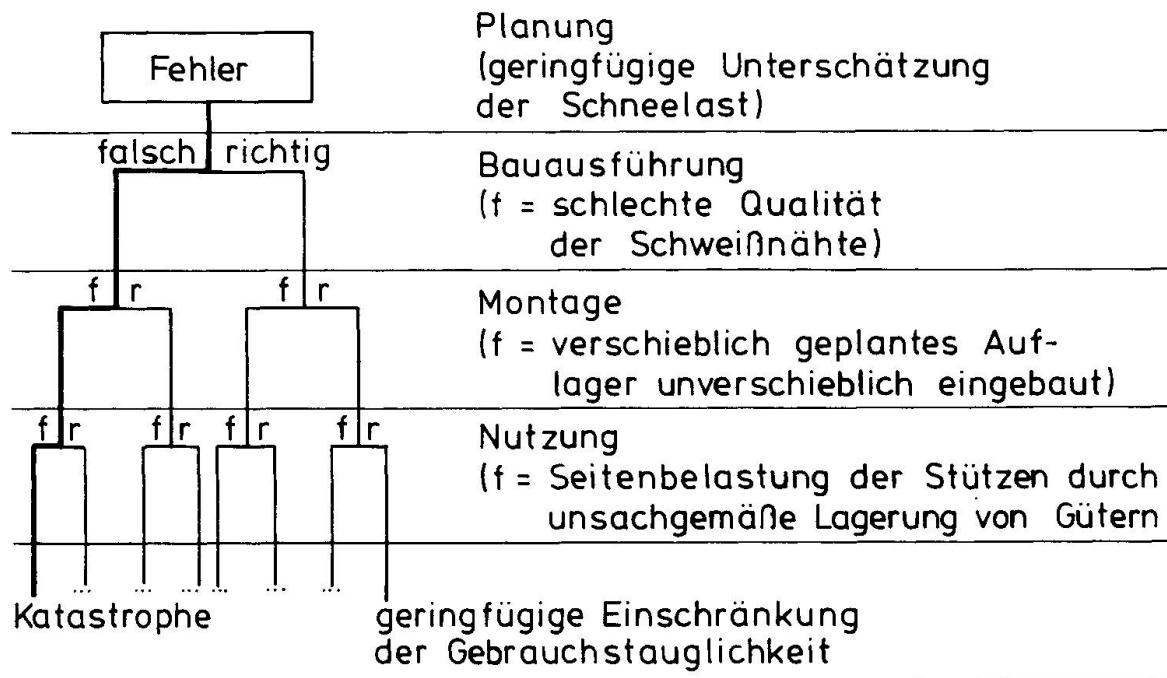
Bild 3 Ereignisbaum Stützen-Binder-System

Bei starker Schnee- und Windbelastung sowie einer Temperatur von  $-22^{\circ}\text{C}$  versagten die Schrauben, mit denen das Zugband eines unterspannten Fachwerkriegels (Spannweite 15 m) an dessen Knotenblech befestigt war. Das führte zum Versagen der (unten eingespannten) Stützen im Unterbereich bzw. zu starken Abweichungen aus dem Lot. Während im Entwurf ein verschiebliches Lager für den Fachwerkbinde vorgesehen war, wurden beide Lager unverschieblich ausgeführt. Das ergab zusätzliche Kräfte aus Wind, Temperatur und unsachgemäß gelagertem Lagergut. Hinzu kam die unzureichende Ausführung mehrerer Schweißnähte. Insgesamt stürzten 10 Riegel ein.

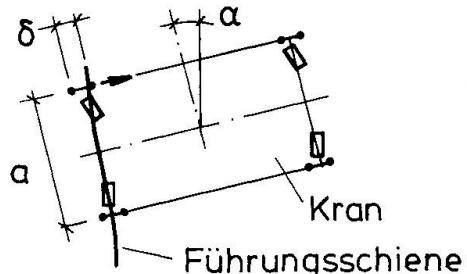
Bild 4 Kranschrägstellung

ne Art Mindeststeifigkeit. Nun ist z.B. die zweite dieser Forderungen berechtigt, etwa um das Herausspringen von Fensterscheiben beim Vorbeifahren eines Brückenkraans (ein Schadensfall in Abschnitt 2) zu verhindern. Was aber bedeuten diese Kriterien für den "Leitgebrauch"?

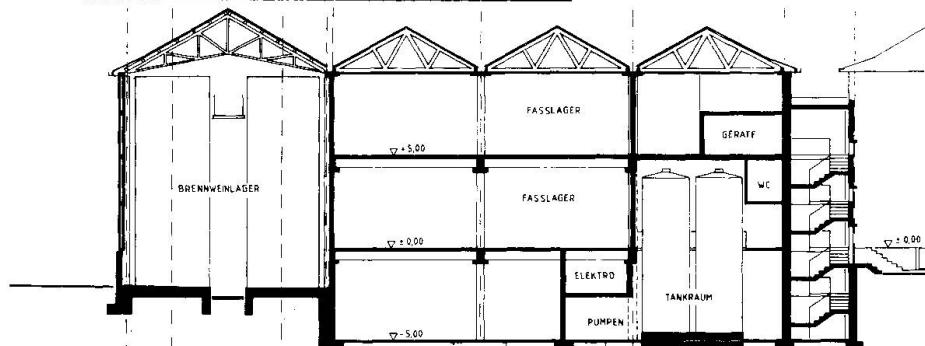
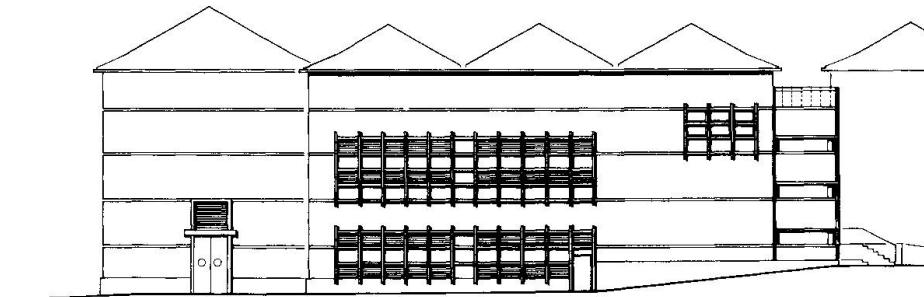
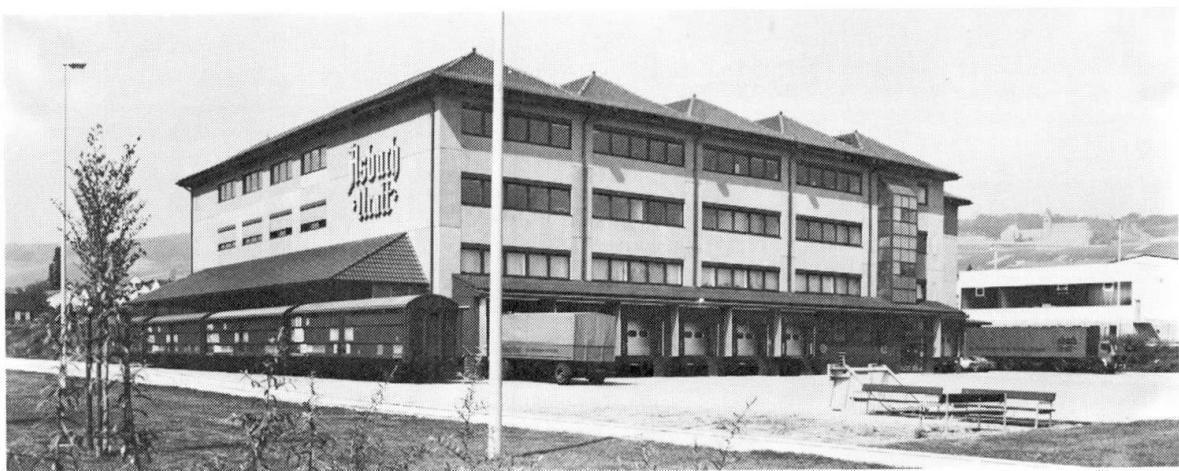
Das Brennweinlager besteht aus zwölf zylindrischen Tanks ( $h=11,2\text{ m}$ ,  $\varnothing=3,8\text{ m}$ ). Das darüber befindliche, geneigte Dach wird von Stahlbindern getragen, wo sich zwischen diesen und oberhalb der Tanks die erforderlichen Arbeitsräume für Wartung und Betrieb ergeben. Die Dachkonstruktion über dem Destillatlager besteht aus hölzernen Nagelbindern mit einer Holzschalung, welche eine Papplage und die Schieferdeckung trägt. Weil an der Unterseite der Nagelbinder eine dem geforderten Feuerwiderstand entsprechende Gipskarton-Bekleidung angebracht wurde, entsteht ein wärmedämmender Dachhohlraum oberhalb der Lagerräume.

Abb. 2 Ein Industriebau mit ziegelgedeckten Walmdächern.

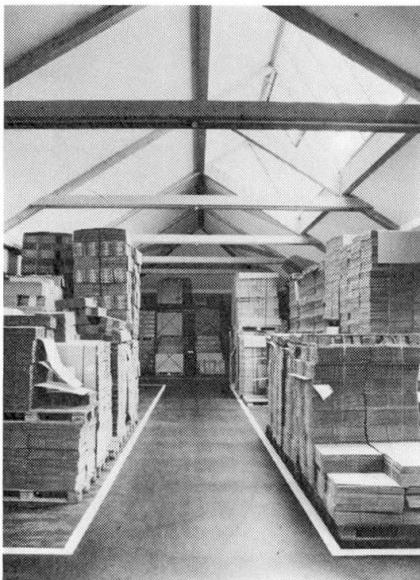
Abb. 3  
Geneigte Dächer vergrößern das nutzbare Raumvolumen.

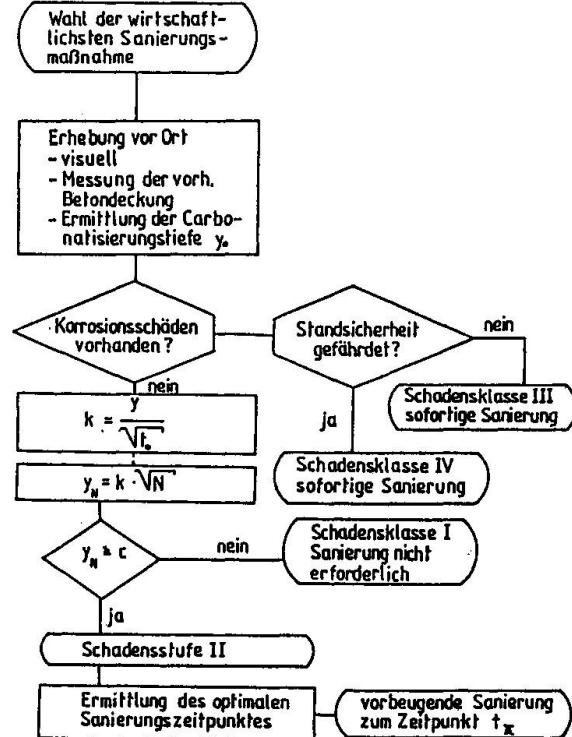
Bild 1 Schematische Darstellung des Entscheidungsvorganges

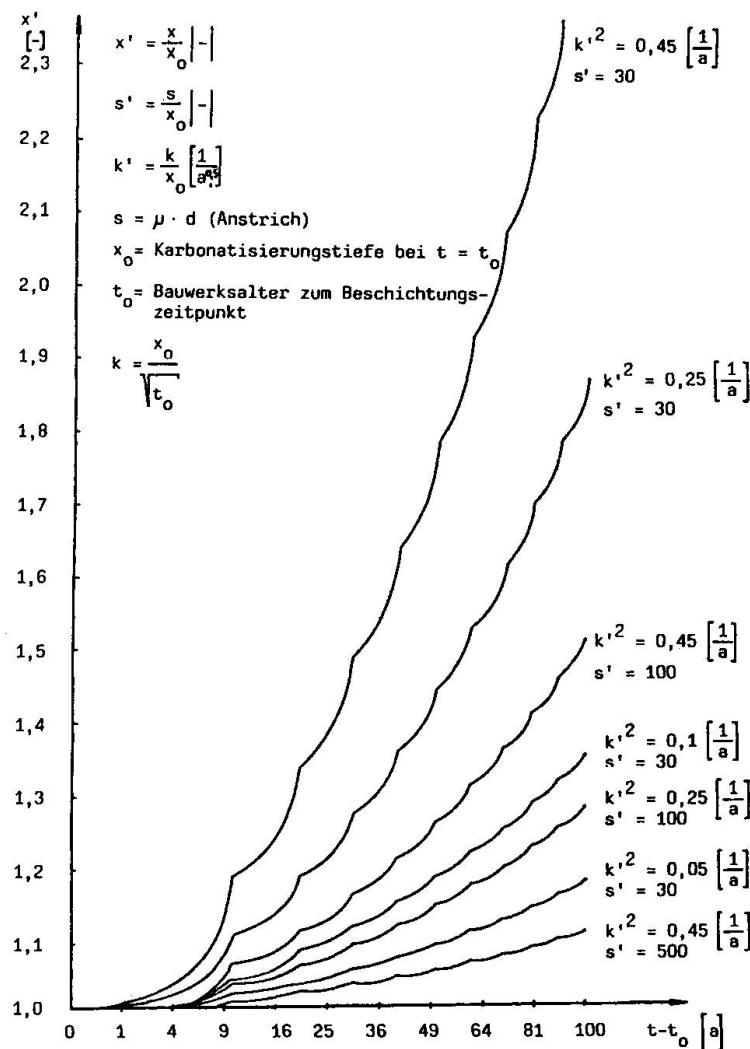
**Bild 2** Karbonatisierung in Abhängigkeit von der Zeit unter Berücksichtigung der Kreidung des Anstriches. Auszug aus [2]

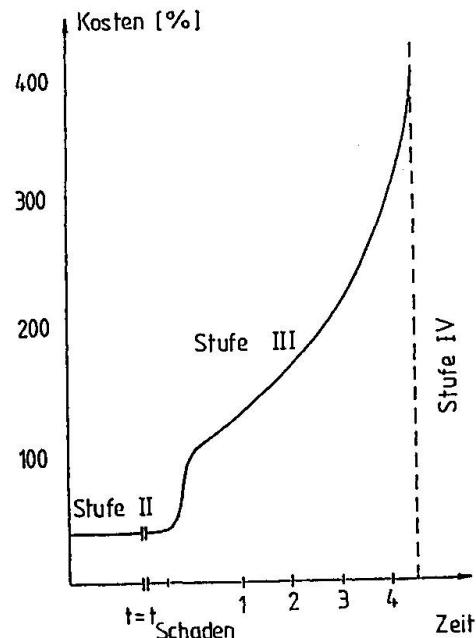
**Bild 3** Entwicklung der Instandsetzungskosten für Beton in Abhängigkeit von der Zeit bei nicht erfolgter Instandsetzung

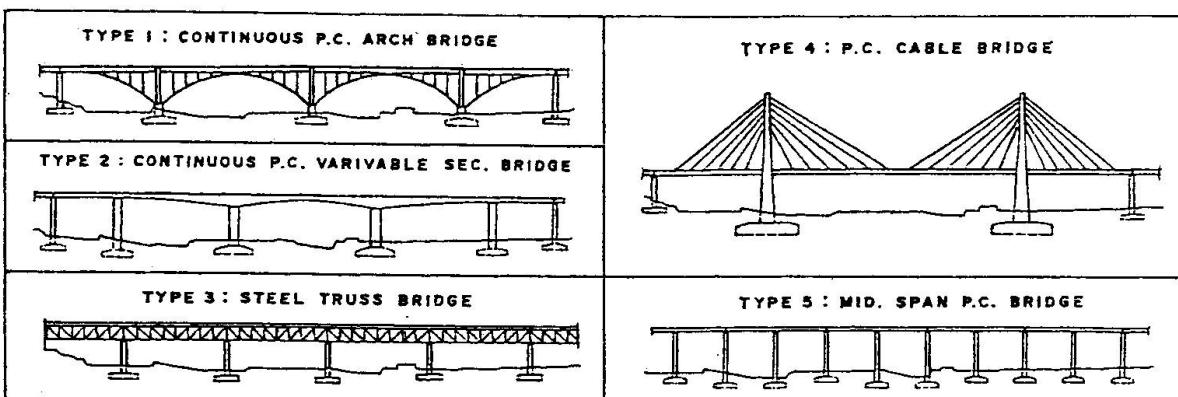
Fig. 1 Five bridge alternatives during the planning stage.

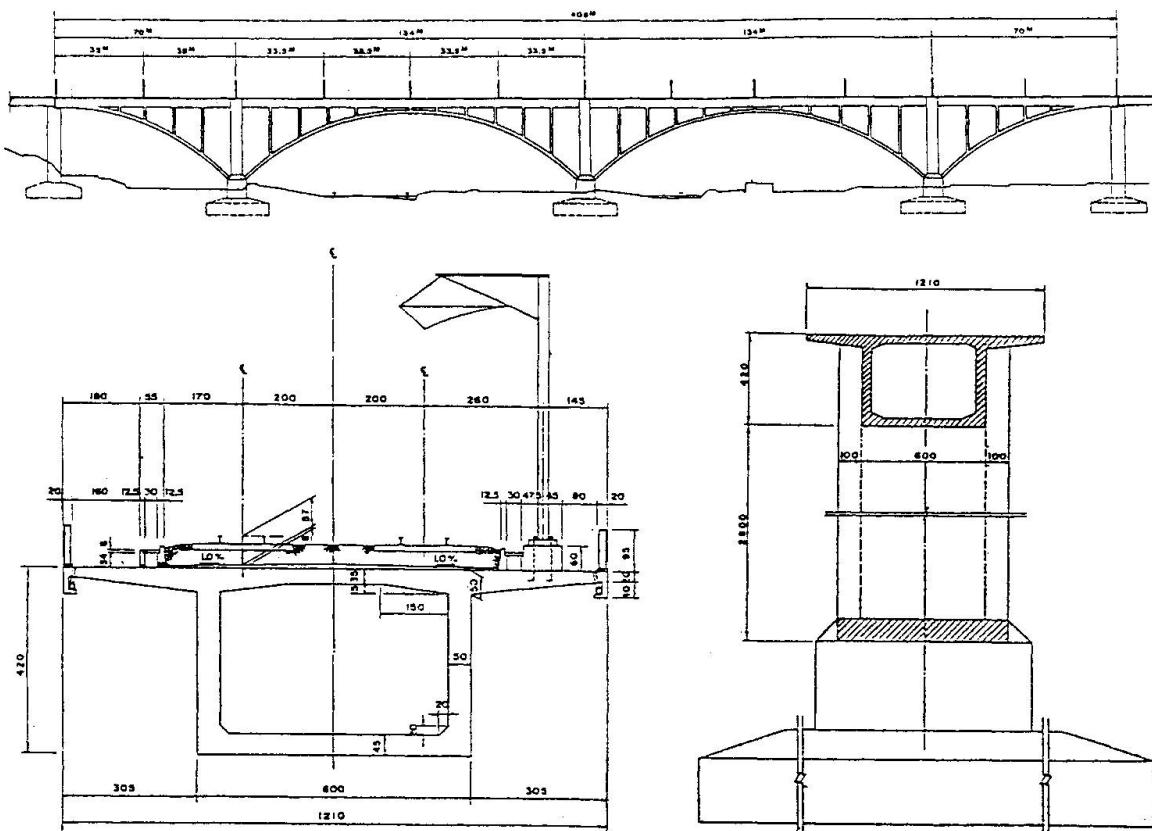
Fig. 2 General configuration of the bridge (Type 1).

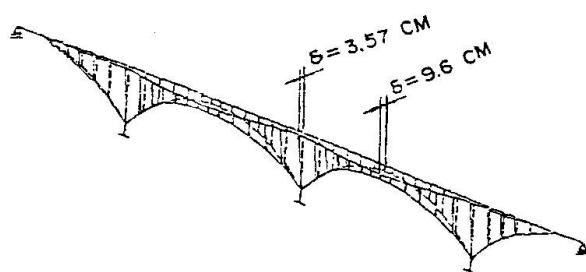
Fig. 4 Horizontal deflection due to horizontal earthquake force.

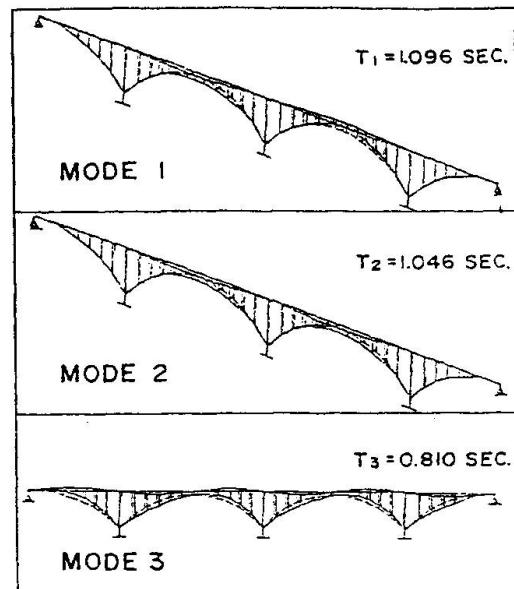
Fig. 5 The first three mode shapes and its natural period in the dynamic analysis.

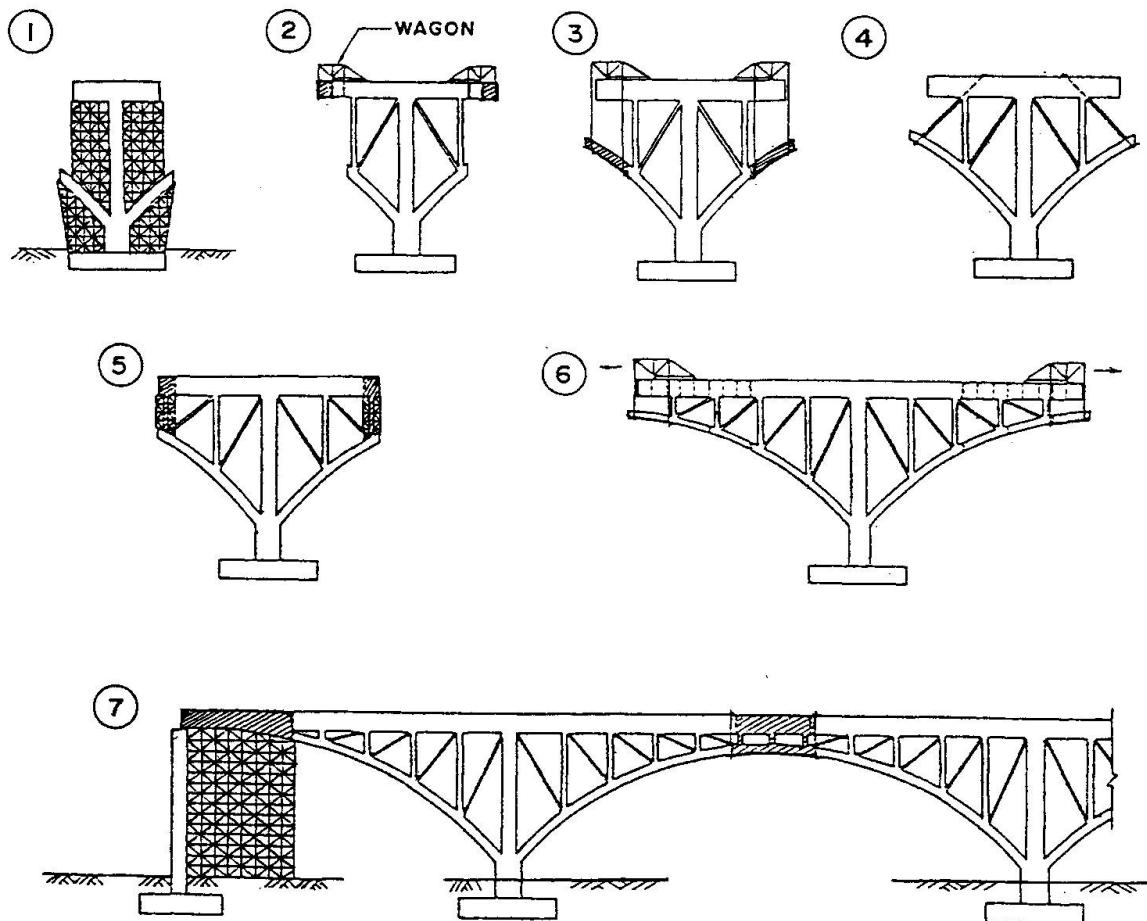
Fig. 6 Erection sequence ( 1. Erection of pier column and first segment. 2. Erection of box girder with moveable wagon. 3. Erection of arch rib with wagon. 4. Placement of oblique constructional PC steel bars. 5. Erection of spandrel strut. 6. Repetition of process from stage 2 to stage 5. 7. Erection of arch crown section with hanging support and end side section with temporary support.).

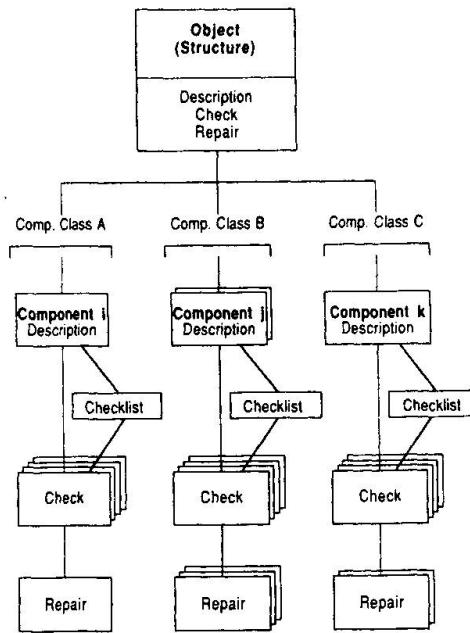
Fig. 1: External data scheme

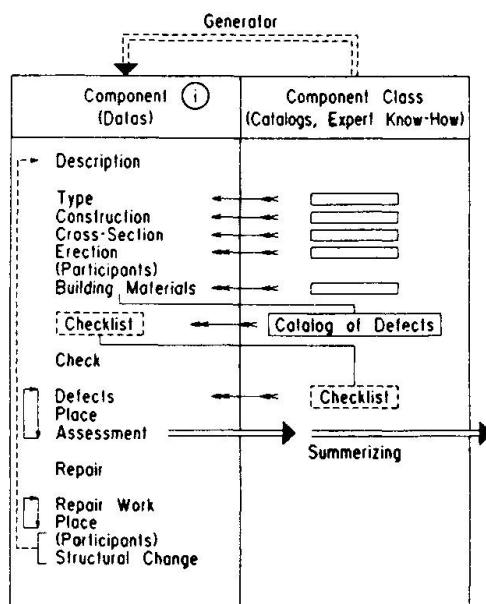
Fig. 3: Component of superstructure
