Zeitschrift: IABSE reports = Rapports AIPC = IVBH Berichte
Band: 57/1/57/2 (1989)

Rubrik: Presentation Session 1: General durability aspects

PRESENTATIONS

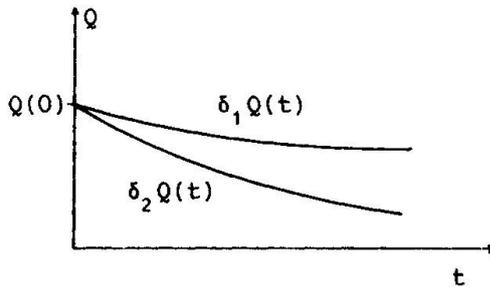
where $m(t)$ is a measure of maintenance resources consumed at time t and $\delta(t)$ is the degradation or depreciation function. If $m(t) = 0$ and $\delta(t) = \text{constant}$, the quality of the structure decays exponentially, as in Fig. 1. The two degradation paths based on δ_1 and δ_2 show the possible effect of durability research: either an improvement in the material so as to attain the δ_1 level or a narrowing of the uncertain area between δ_1 and δ_2 , reducing the risk in choices during the design stage. In Fig. 2, the effect of durability studies

Fig. 1 Successive degradation

two paints A and B with different degradation properties, following as most surface materials do the pattern of Fig. 1, can be based on the ensuing maintenance costs [8]. The calculation is more complicated when assessing the value of risk reduction (in terms of Fig. 1, that the true degradation pattern is δ_1 and not δ_2 , e.g.), and in the situation of Fig. 2 with sudden failure, the emphasis of the analysis is shifted towards a probabilistic approach, identifying risks and their relations. Finally, the potential for spin-off effects owing to new, more fundamental insights into decay mechanisms with a wider application should be assessed, although this is mostly a matter of intuitive judgment.

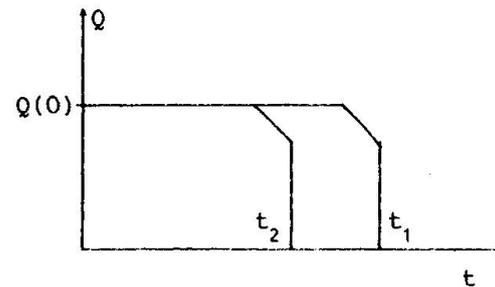
on materials or components with a pattern of sudden failure is shown: either a prolongation of service life from t_2 to t_1 , or a more narrow interval of life being predicted.

Fig. 2 Sudden failure

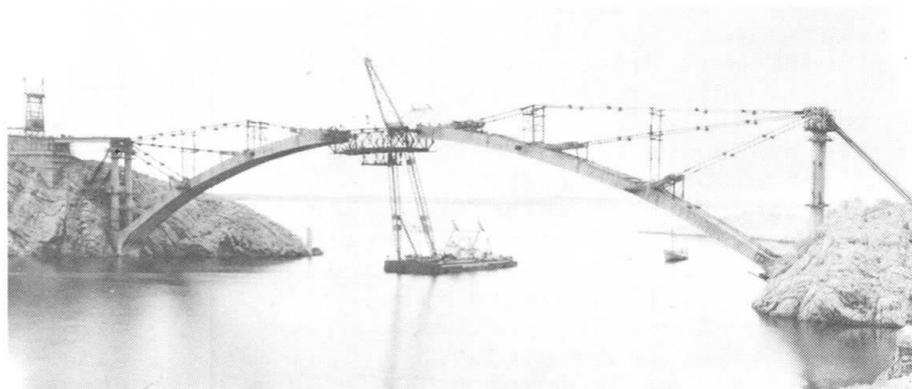
Fig 2. Reinforced concrete arch of Pag Island bridge during construction

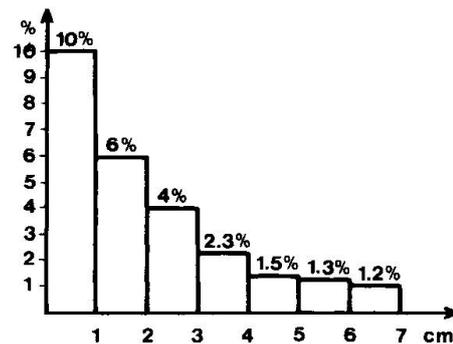
Fig 4. Diagram showing ion content compared with the quantity of cement from surface towards the interior of the Pag Bridge grider

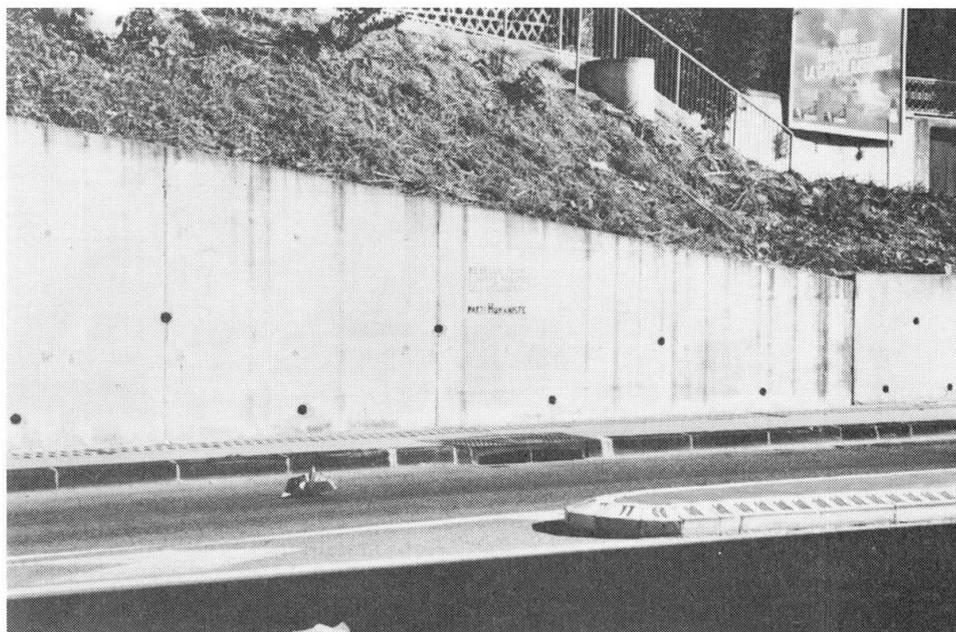
Fig.1 Béton brut sans précautions

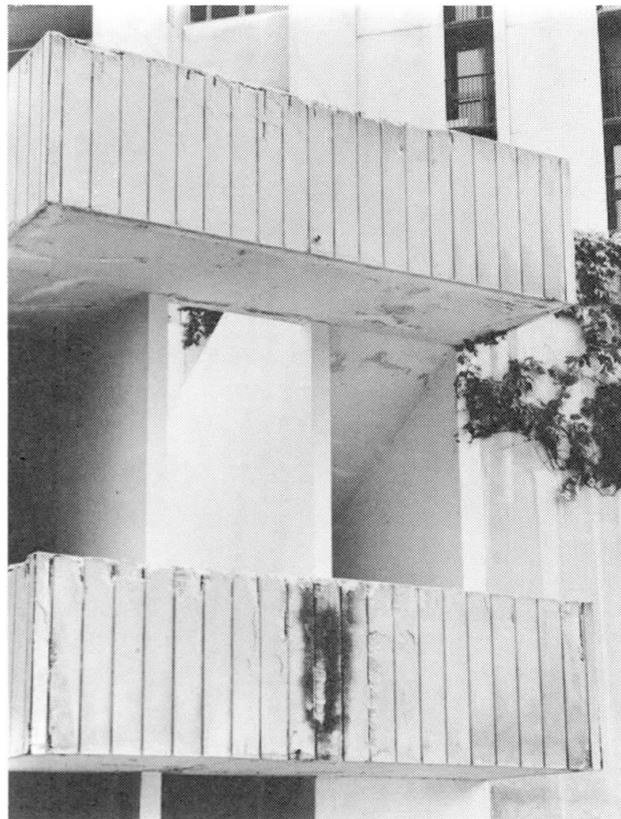
Fig.2 Béton mal traité

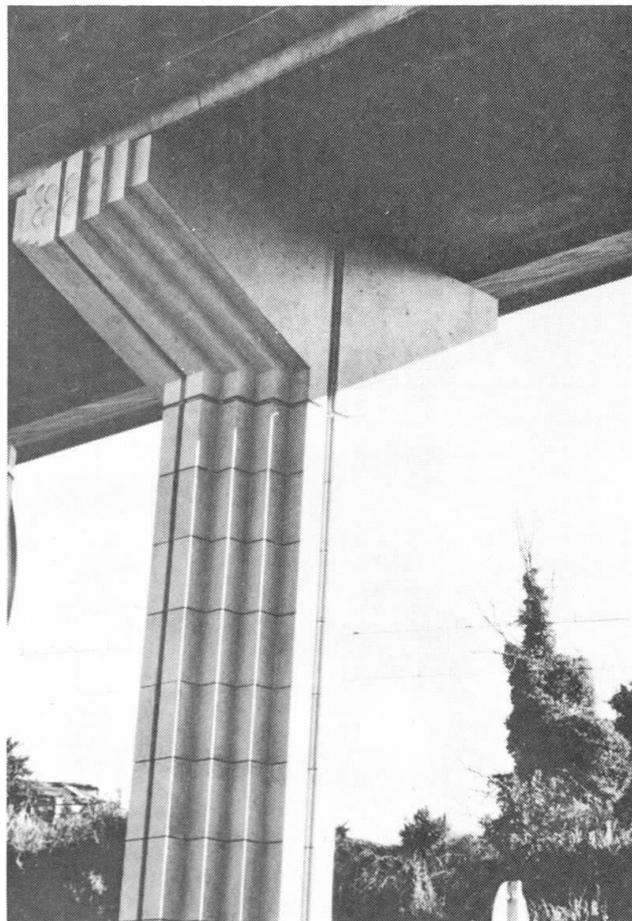
Fig.4 Pile soignée

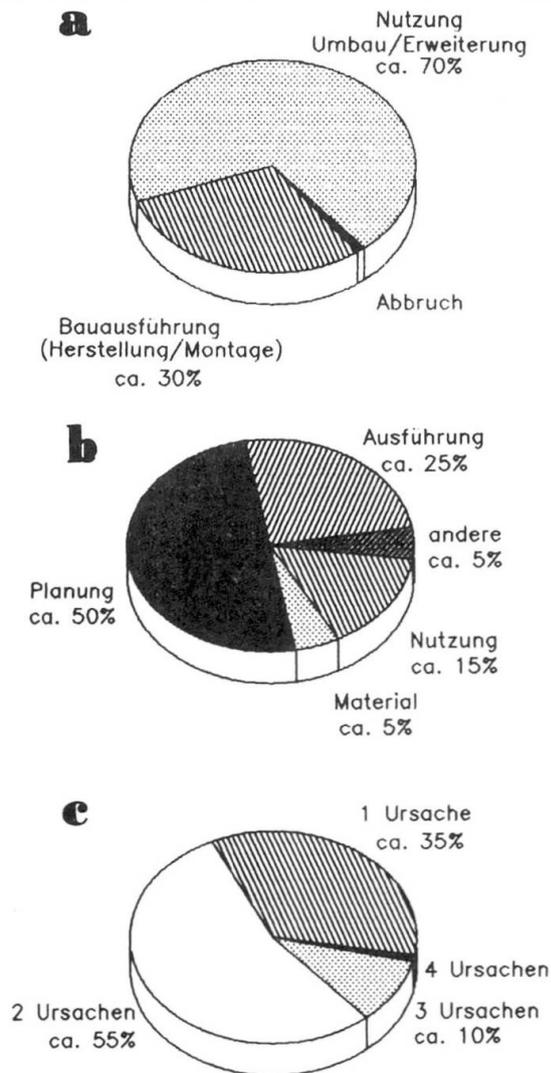
Bild 1 Schadensauswertung

tersuchung zeigt, wann (Bild 1a) bzw. durch welche Fehler (Bild 1b) diese Schäden auftraten - es dominieren die Nutzungsphase bzw. Planungsfehler. Zu letzteren gehören mehrfach nicht zutreffende Schneelastannahmen (teilweise wegen unzureichender Normwerte) und subjektive Fehler wie z.B. Nichtverfolgung von Schnittkräften bis in Verbindungen. Nutzungsfehler treten in erster Linie auf infolge Beanspruchung durch Lasten, die im Entwurf gar nicht vorgesehen waren. Auf Bild 1c ist die prozentuale Häufigkeit der Anzahl der Schadensursachen nach Bild 1b gezeigt; zwei Drittel aller Schäden sind auf eine Fehlerkombination (z.B. aus Planungs- und Ausführungsfehlern) zurückzuführen.

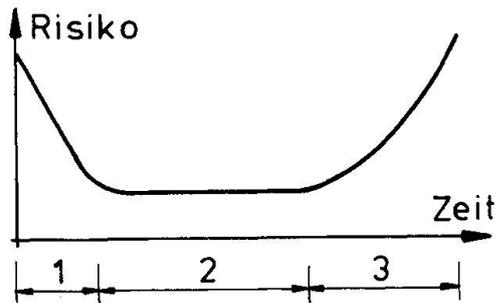
Bild 2 Risiko-Zeit-Funktion

verbleibenden. Weitere Phasen sind die reguläre Nutzung (2) und das Altern (3), über dessen Beginn und Verlauf mit dieser Stichprobe keine ausreichend gesicherten Erkenntnisse gewonnen werden konnten.

tigkeit zumindestens der ersten beiden Abschnitte der klassischen Risiko - Zeit - Funktion (Bild 2); da Hallen keiner perfekten Kontrolle bei der Abnahme unterliegen, setzt mit der Nutzung die natürliche Selektion (1) ein; das verdeutlichen z.B. die Schneelasten: Schäden unter dieser Last sind während der ersten fünf Nutzungsjahre viermal häufiger als in den

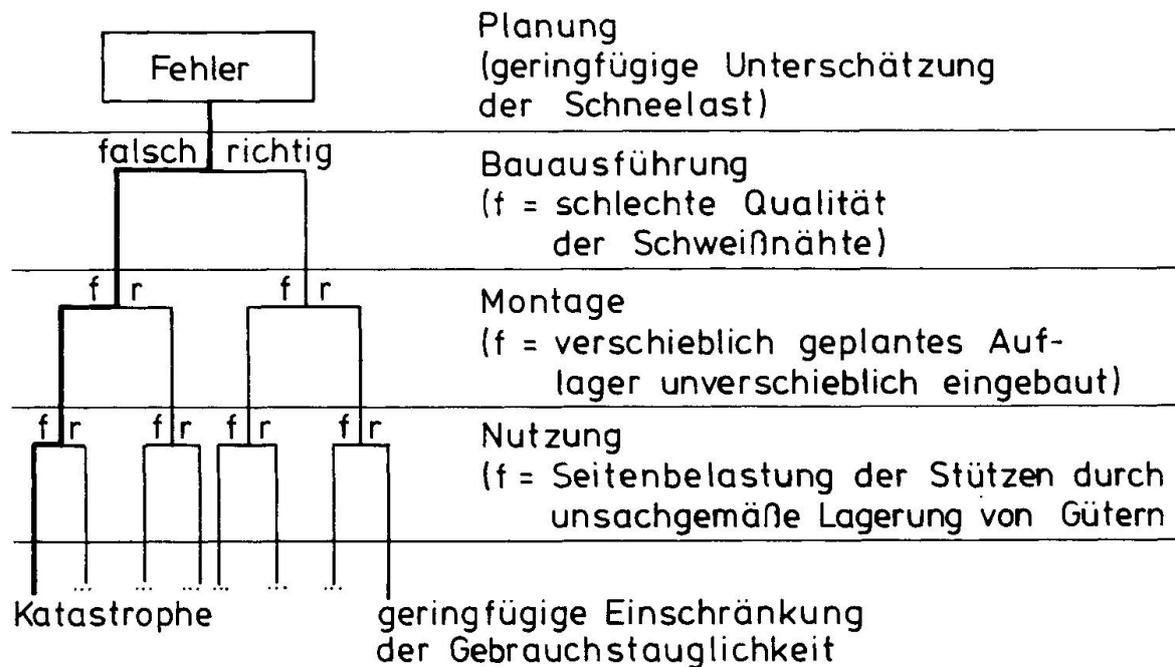
Inwieweit ist die Untersuchung mittlerer und großer Schadensfälle für Dauerhaftigkeitsbetrachtungen relevant? Eine Antwort gibt Bild 3. Es zeigt anhand des nachfolgenden (sicher extremen) Beispiels, daß Fehler, die in dieser Auswertung zum Verlust der Tragsicherheit führten, unter anderen Umständen "nur" eingeschränkte Gebrauchstauglichkeit nach sich gezogen hätten.

Bei starker Schnee- und Windbelastung sowie einer Temperatur von -22°C versagten die Schrauben, mit denen das Zugband eines unterspannten Fachwerkgriegels (Spannweite 15 m) an dessen Knotenblech befestigt war. Das führte zum Versagen der (unten eingespannten) Stützen im Unterbereich bzw. zu starken Abweichungen aus dem Lot. Während im Entwurf ein verschiebliches Lager für den Fachwerkbinder vorgesehen war, wurden beide Lager unverschieblich ausgeführt. Das ergab zusätzliche Kräfte aus Wind, Temperatur und unsachgemäß gelagertem Lagergut. Hinzu kam die unzureichende Ausführung mehrerer Schweißnähte. Insgesamt stürzten 10 Riegel ein.

Bild 3 Ereignisbaum Stützen-Binder-System

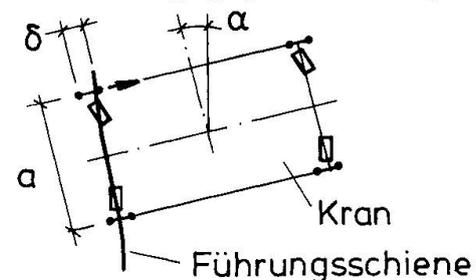
Auch hier wieder ein Beispiel. Über die Dauerhaftigkeit einer Kranbahn entscheiden bekanntlich insbesondere die Schiefstellung der Kranlaufräder sowie dauerhafte und elastische Deformationen in der Horizontalebene der Fahrbahn.

Heutzutage beschränken wir uns beim sog. Gebrauchstauglichkeitsnachweis allein auf die Begrenzung der elastischen Durchbiegung der einzelnen Kranschiene auf z.B. $1/800$, der Kopfauslenkung der einzelnen Kranbahnstütze auf $h/300$ bzw. der Differenz der Kopfauslenkung gegenüberliegender Stützen auf 20 mm, fordern also eine

Bild 4 Kranschrägstellung
